HISTORIC PRESERVATION COMMISSION AGENDA ITEM EXECUTIVE SUMMARY						
APP.		Agenda Item Title/Address:	619 W. Main St. & 622 Walnut St.					
		Proposal:	Discuss concepts for redevelopment of properties					
_	ST. CHARLES SINCE 1834 Petitioner: Ted Meyers, Joe Salamone, Dan Marshall							
		Please check appropriate box (x)						
		PUBLIC HI			MEETING 8/2/17	X		
AGE	NDA ITEM	CATEGORY:						
	Certificate of	of Appropriateness (COA)		F	Façade Improvement Plan			
X	Preliminary	Review		L	Landmark/District Designation			
	Discussion l	n Item		С	Commission Business

MILLINGTON HISTORIC DISTRICT ST. CHARLES, ILLINOIS Date of Survey: 2003

ADDRESS 619 West Main Street

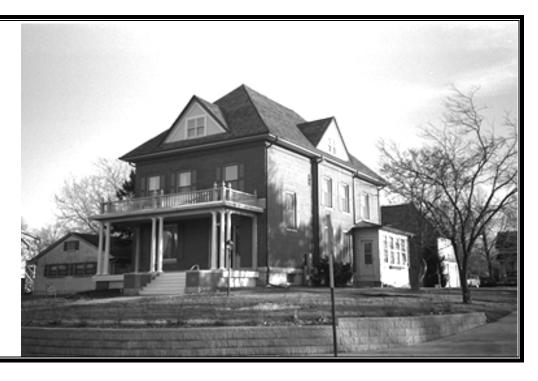
- ► Significant
- ☐ Contributing
- ☐ Non-Contributing
- ☐ Potential for Individual National Register Designation

- Excellent
- ► Good
- Fair
- □ Poor

Architectural Style/Type:	Colonial Revival	Exterior Walls (Current):	Brick
Architectural Features:		Exterior Walls (Original):	Brick
Date of Construction: Source:		•	Stone(orig.),Conc.(Additions) Hipped/Wood shingle (orig.)
Overall Plan Configuration:	Simple w/ additions	Window Material/Type:	Alum/Wd./Dbl. hung

ARCHITECTURAL FEATURES: This is a large imposing façade accentuated by being elevated above the street level and by being located on a very prominent site. The roof is a simple hip with a long ridgeline and is articulated with large triangular roof dormers on the north, east, and west elevations. The east and west dormers crown a two story brick projection serving to break up what could have been an uneventful façade. The top of the stone foundation stops vertically at the first floor line and adds visual interest and character to the massive looking house.

ALTERATIONS: The front porch is an important element of the front façade and has recently been rebuilt using modern materials. The detailing is good and the design appears to be compatible with the main house. Several additions have been made to the west, south, and east sides of the original house. None of these are sympathetic with the original design in any way. There is no sense of scale, material, or detail references in any of these additions. An adjacent one - story house is connected to the main house at the rear.

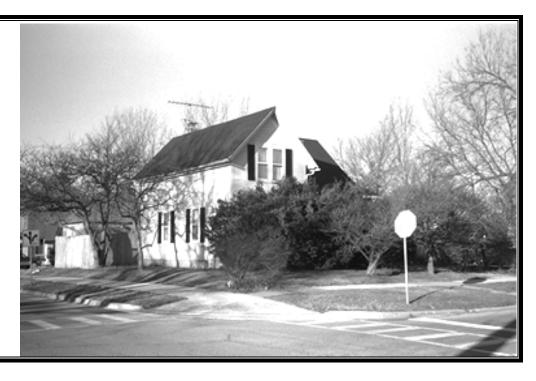
ADDRESS 622 Walnut Street

- Significant
- ► Contributing
- □ Non-Contributing
- ☐ Potential for Individual National Register Designation

- Excellent
- □ Good
- Fair
- ► Poor

Architectural Style/Type:	Folk Victorian	Exterior Walls (Current):	Clapboard
Architectural Features:		Exterior Walls (Original):	Clapboard
	1900 Township Assessor's Office	Foundation:	Parged Masonry Cross gable/Asphalt
Source.	Township Assessor's Office	Root Type/Material.	Cross guote/Aspitalt
Overall Plan Configuration:	Compound L	Window Material/Type:	Aluminum/Double hung

ARCHITECTURAL FEATURES: The front gable has distinct vertical proportions & steep roof slope. There is a partial width front porch that has a shed type roof that is supported by turned columns. All of the windows have simple wood trim. The siding has relatively wide trim @ the eaves and corners. There is a small rear entry that retains the detail character of the front porch. The eaves are open by are soffited in line w/ the roof slope.

ALTERATIONS: This roof probably had wood shakes or shingles originally.
