ST. CHARLES HISTORIC PRESERVATION COMMISSION

ARCHITECTURAL SURVEY ST. CHARLES CENTRAL DISTRICT ST. CHARLES, ILLINOIS

DIXON ASSOCIATES / ARCHITECTS

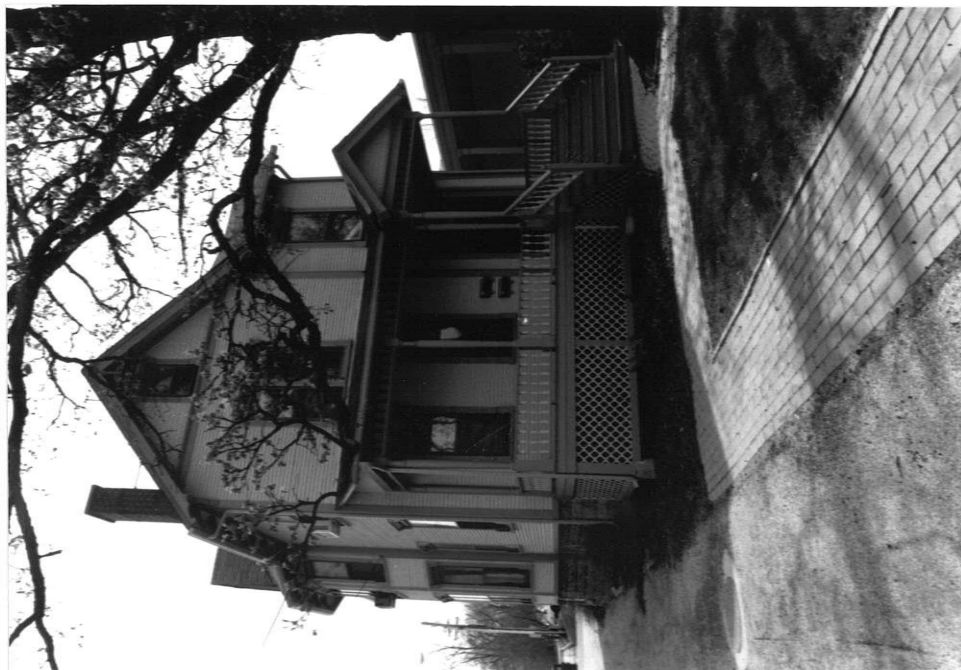
213 West Walnut Street

Style: Stick

Date of Construction: Built: 1849

Moved to current location in 1925

Gabled roof, steeply pitched with cross gables. Decorative elements at apex of gables. Overhanging eaves. Shingles at gables, 4" exposure wood clapboard siding. Full width front porch with gable accent at entry stair.

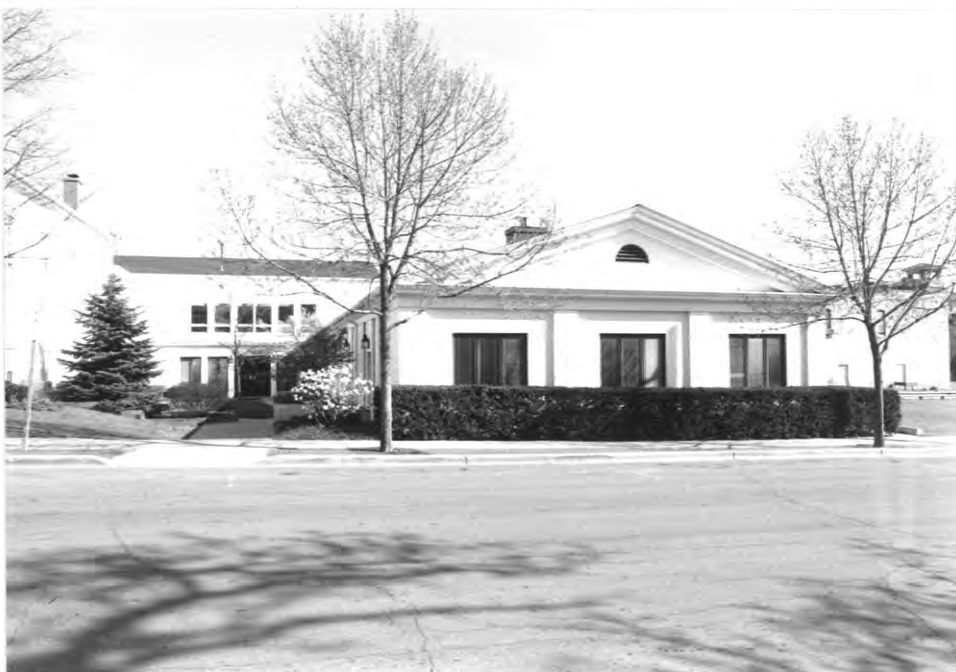
214 West Walnut Street

Style: Neocolonial

Date of Construction: 1960-1970's

Front gable roof, single story masonry structure built to be compatible with Greek Revival Congregational Church. Three pairs of triple casement windows. Semi-circular louver in gable.

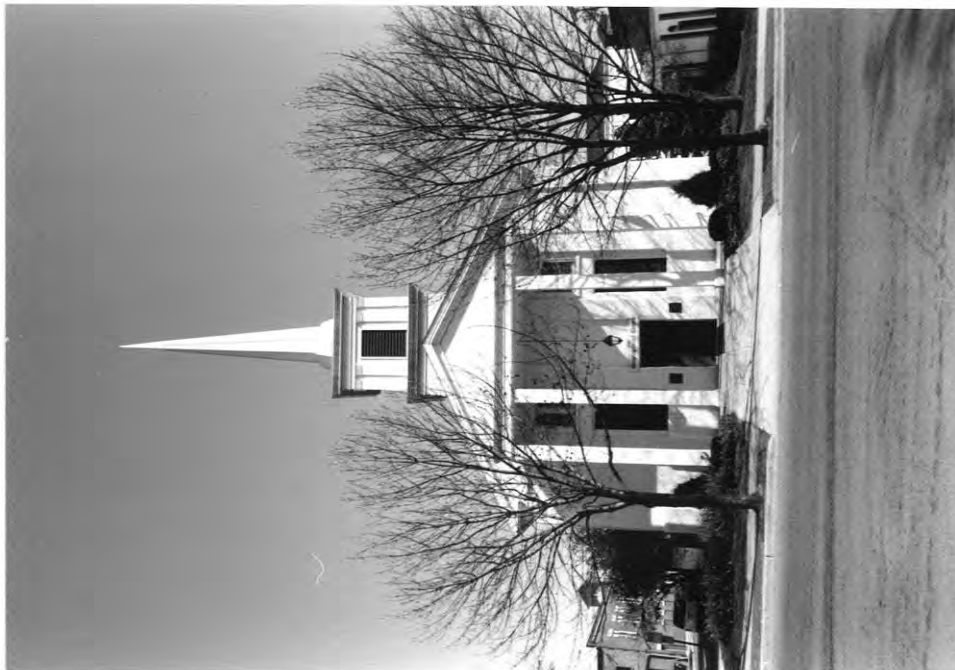
214 West Walnut Street

Style: Greek Revival

Date of Construction: 1848

Simple gable front Greek Revival style with flat roof portico with four square columns. Aluminum spire replaced original wood spire in the late 1980's. Stone building built by mason William Beith, later clad with stucco.

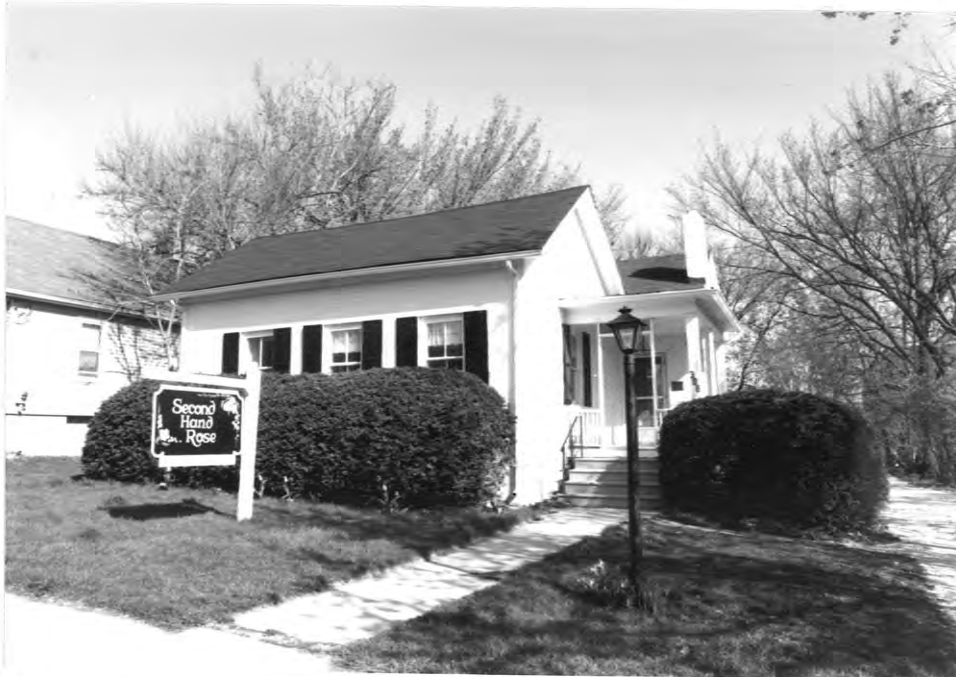
308 West Walnut Street

Style: Greek Revival

Date of Construction: 1845

Simple two over two windows in gable roofed, painted brick structure. Rear gable roofed structure apparently added later.

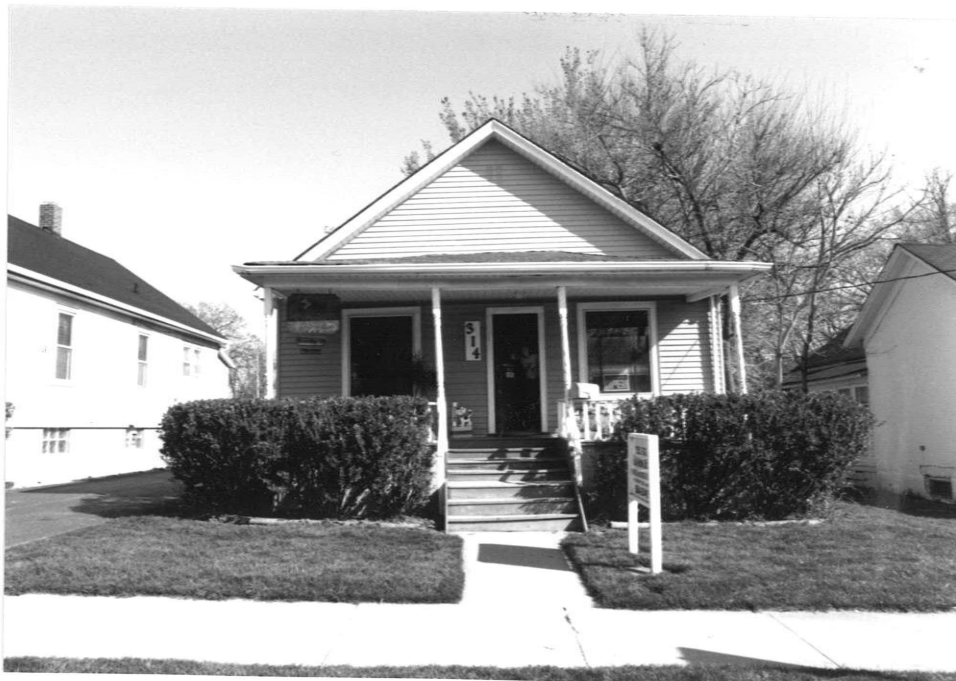
314 West Walnut Street

Style: Folk Victorian

Date of Construction: 1850's-1870's

One story front gabled roof. Lean-to shed addition at rear. Two large front windows suggest Victorian influence. Full width front porch.

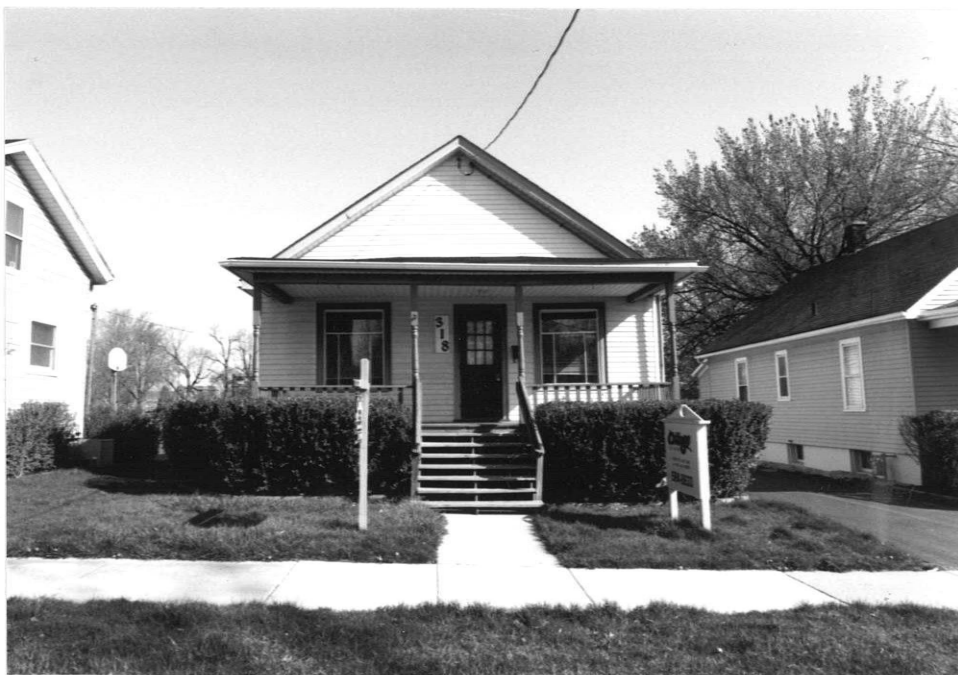
318 West Walnut Street

Style: Folk Victorian

Date of Construction: 1850's-1870's

One story front gabled roof. Lean-to shed addition at rear. Two large front windows suggest Victorian influence. Full width front porch.

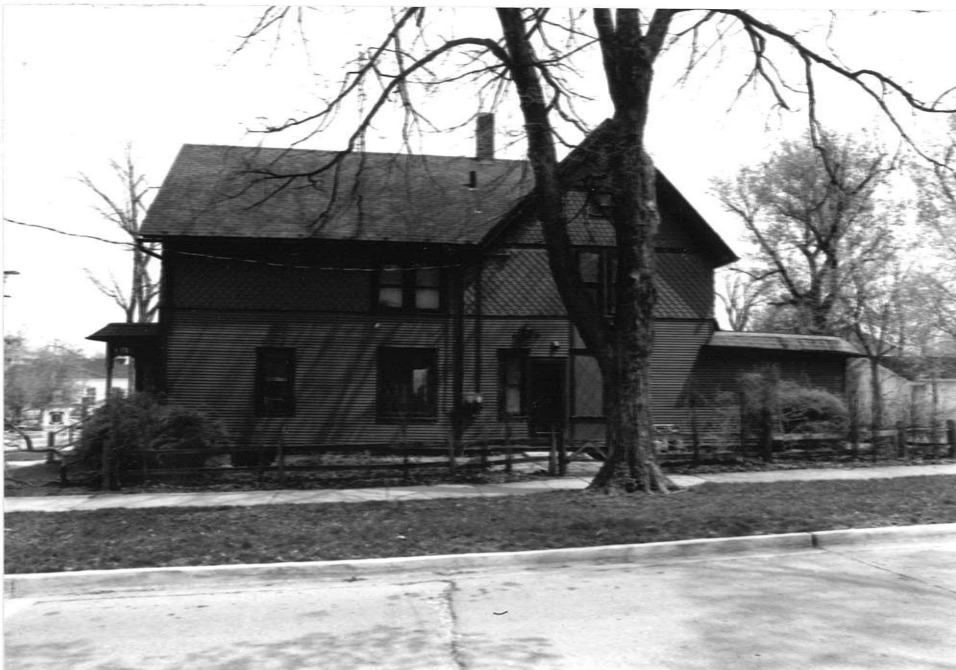
323-325 West Walnut Street

Style: Queen Anne

Date of Construction: 1860-1890

Shingle texture at upper level. Cross gable roofs. 4" clapboard siding.

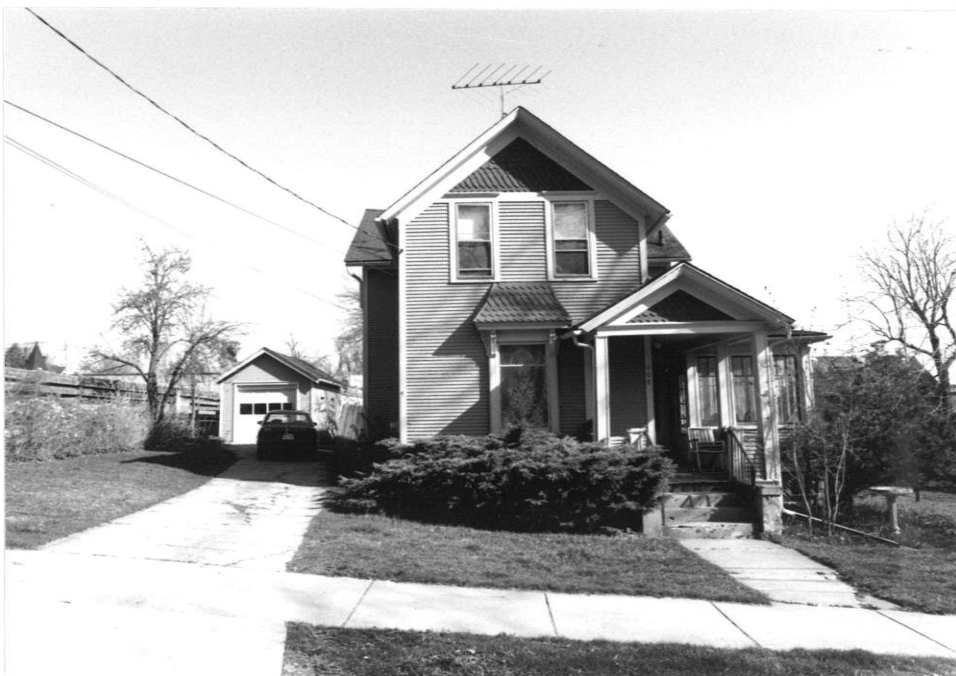
408 West Walnut Street

Style: Queen Anne

Date of Construction: 1890's

Steeply hipped gable roof with cross gable. Textured shingles in gable ends and over box bay window at front. 4" clapboard siding. Projecting gable porch.

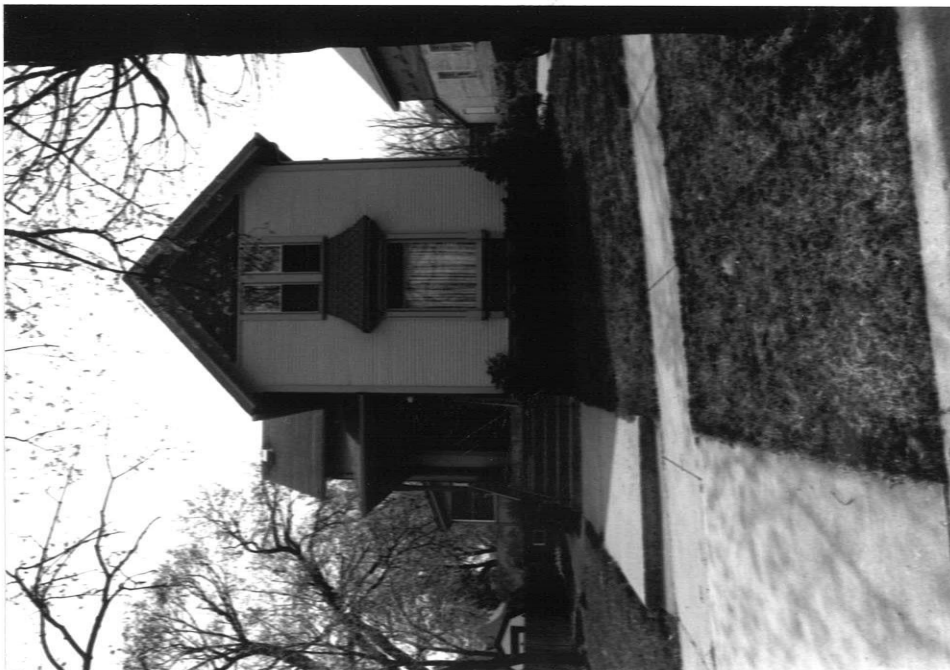
409 West Walnut Street

Style: Queen Anne

Date of Construction: 1860-1890

Steeply pitched front gabled roof with double window at second floor and picture window with shingled hood on first floor. Shingle texture in gable.

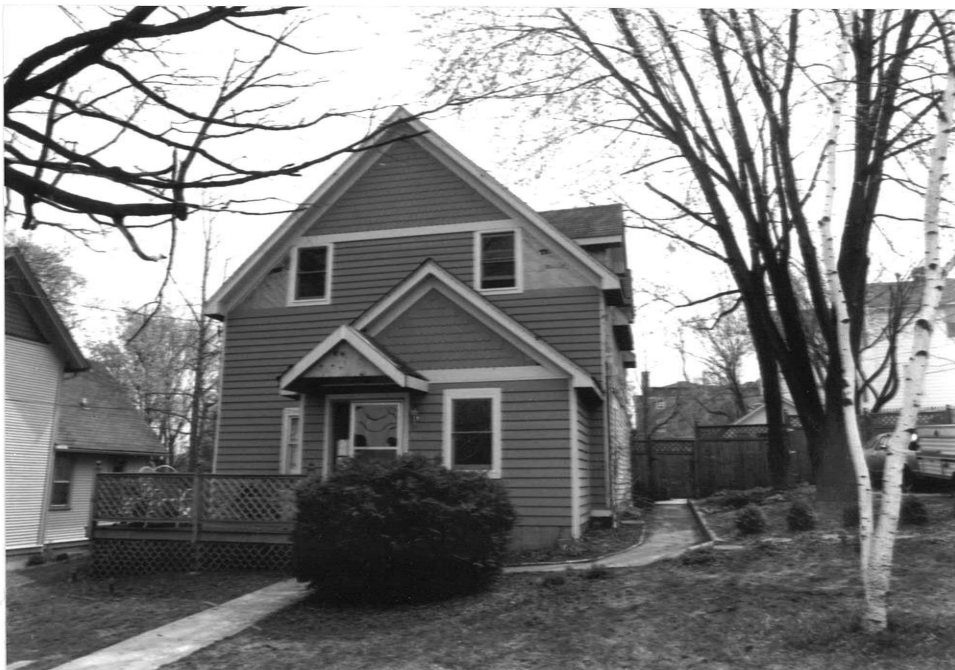
413 West Walnut Street

Style: Folk Victorian

Date of Construction: 1860-1890

Front gabled roof with shingle texture in gable.

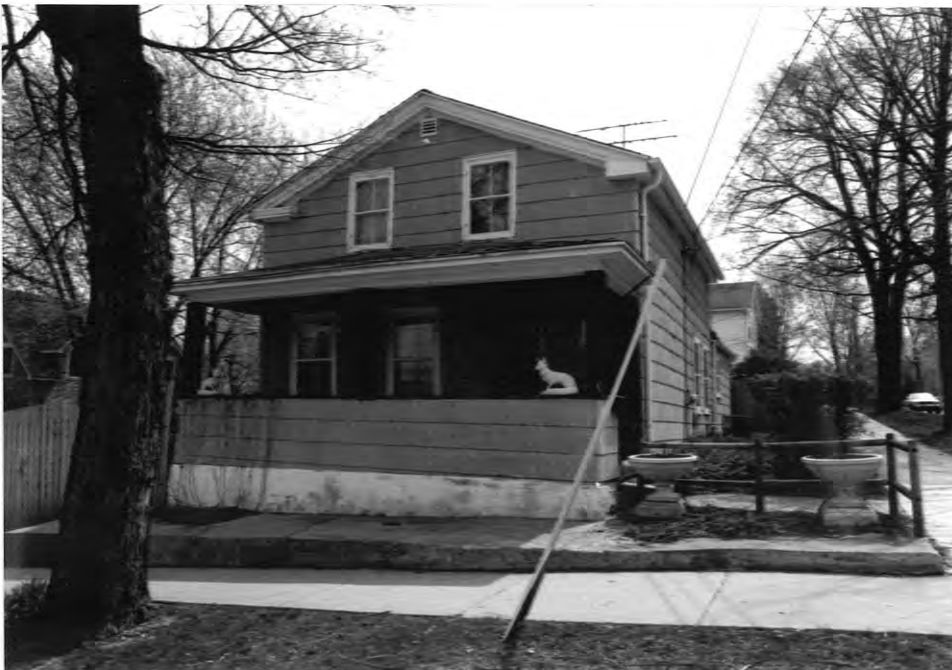
423 West Walnut Street

Style: Greek Revival

Date of Construction: 1825-1860

Front gabled roof on one and one-half story building.
 Full width front porch. House clad with synthetic siding.
