ST. CHARLES HISTORIC PRESERVATION COMMISSION

# ARCHITECTURAL SURVEY ST. CHARLES CENTRAL DISTRICT ST. CHARLES, ILLINOIS

DIXON ASSOCIATES / ARCHITECTS

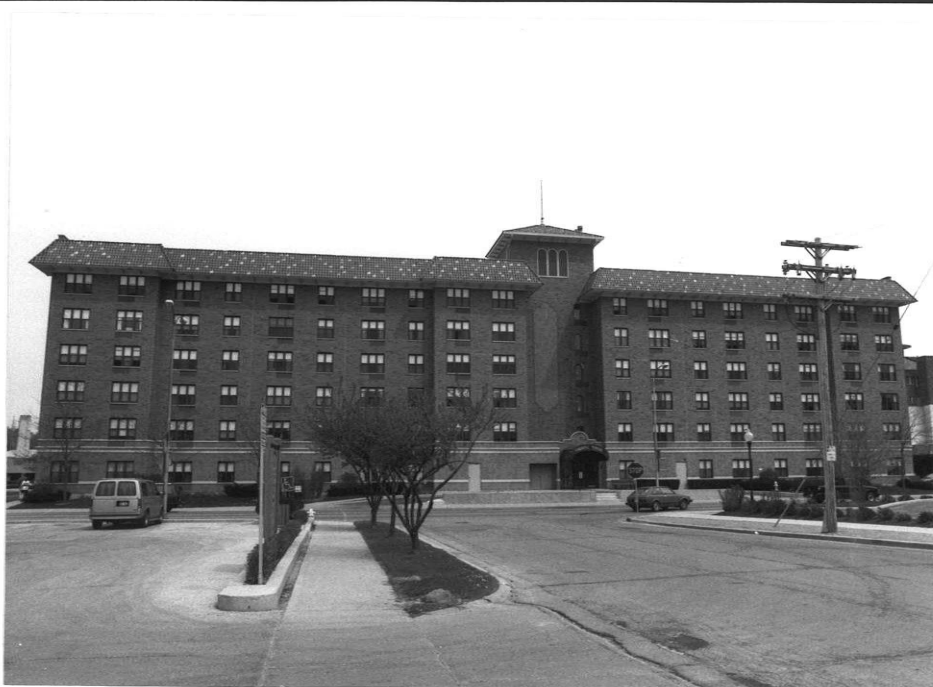
200 North Second Street

Emulates Hotel Baker. This six story structure was built as elderly housing. The clay tile roof and brick with concrete block base was designed to complement the Hotel Baker.

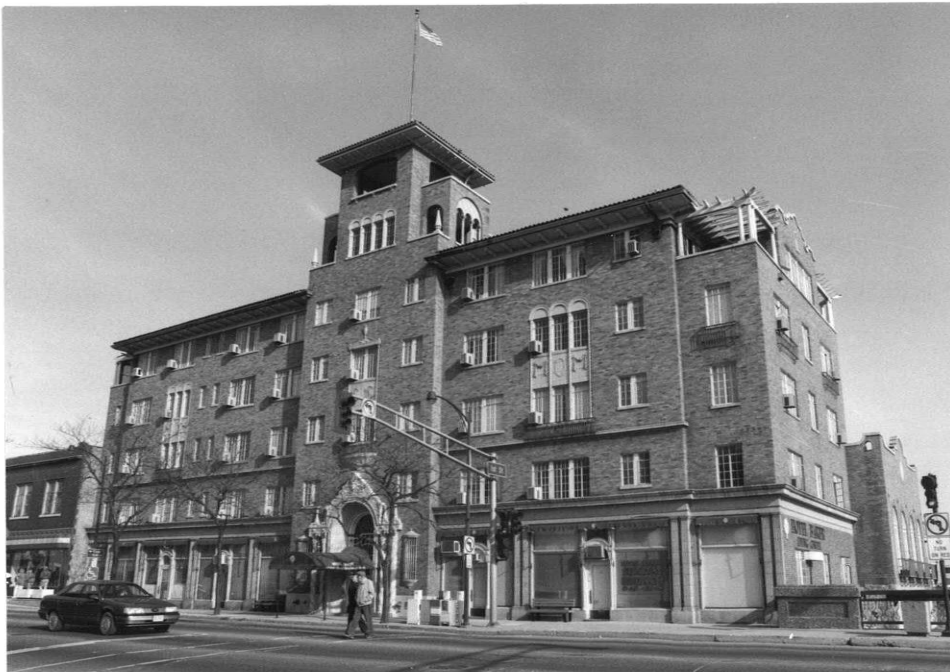
100 West Main Street

Moorish/Spanish Romantic Revival building in brick with beige terra cotta ornamentation. Five stories high plus a square tower projected at the elaborately detailed center entrance. Paired, engaged terra cotta columns flank entrance door. Colored glass "peacock" above the door. Red clay tile roof projects beyond the facade.

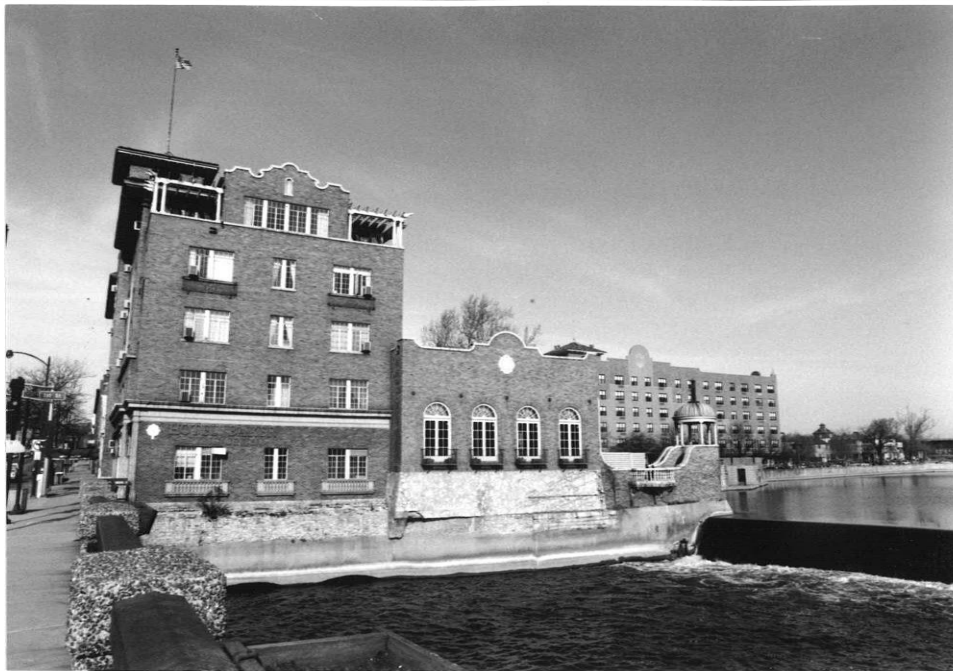
100 West Main Street

East, riverside view showing five story building, Trophy Room exterior and gazebo.

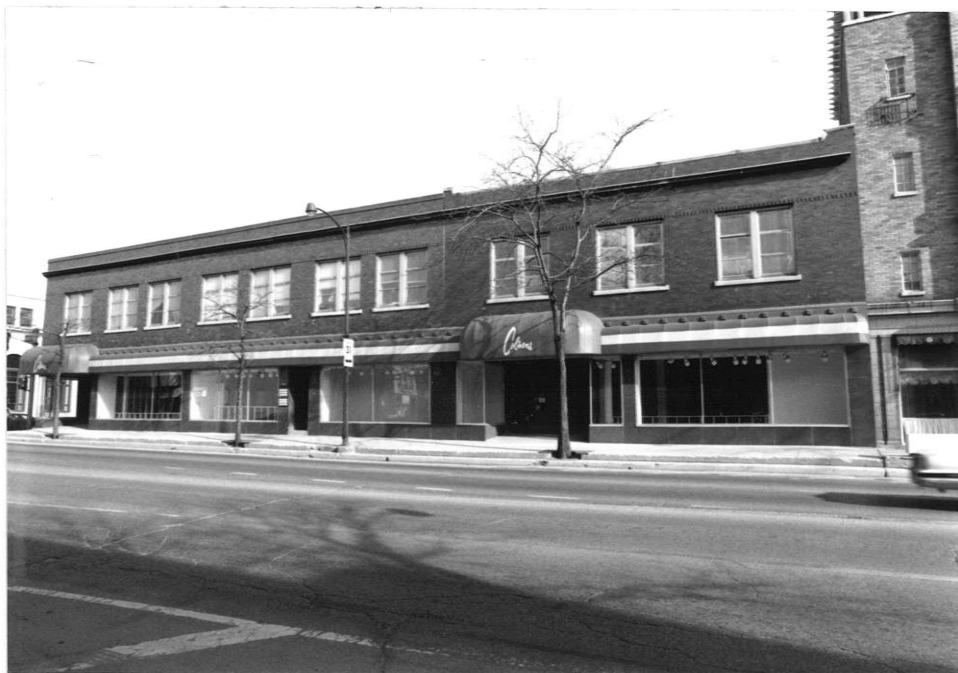
116 West Main Street

Original Colson store established at this site in 1880. A major fire occurred in 1975, followed by a major reconstruction.

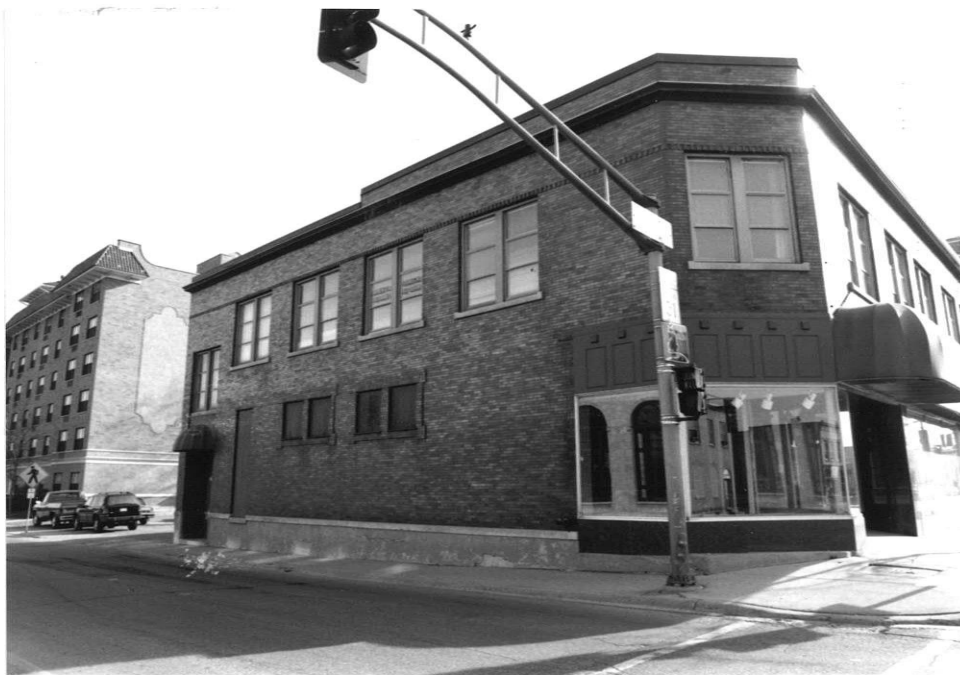
116 West Main Street

West Elevation

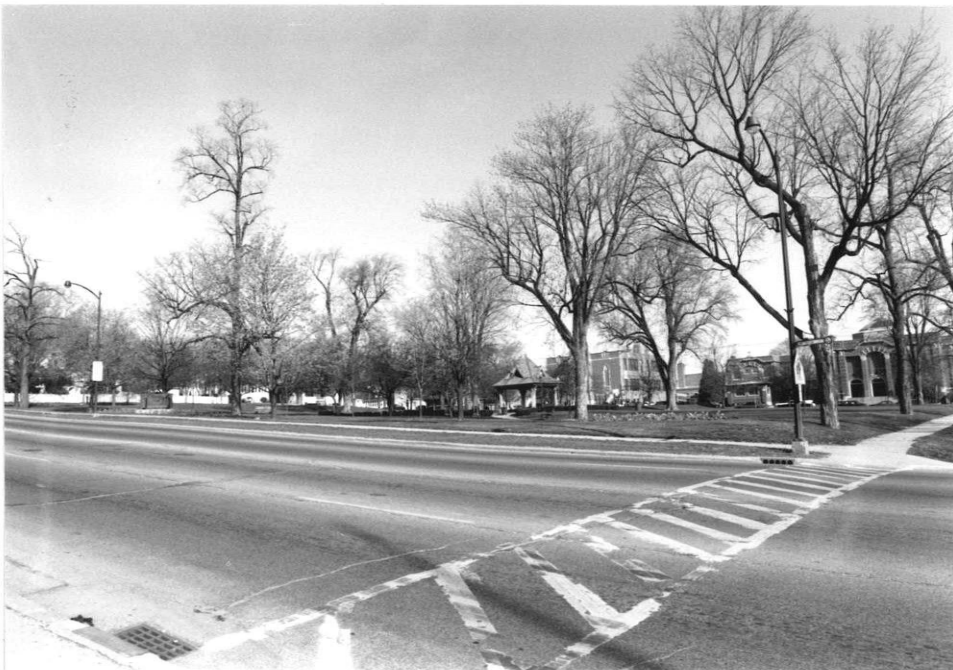
Lincoln Park  
 Fourth at Main Streets

Victorian gazebo in center of park built in 1989 copies pavilion at Pottawatomie Park (1892).
