ST. CHARLES HISTORIC PRESERVATION COMMISSION

ARCHITECTURAL SURVEY ST. CHARLES CENTRAL DISTRICT ST. CHARLES, ILLINOIS

DIXON ASSOCIATES / ARCHITECTS

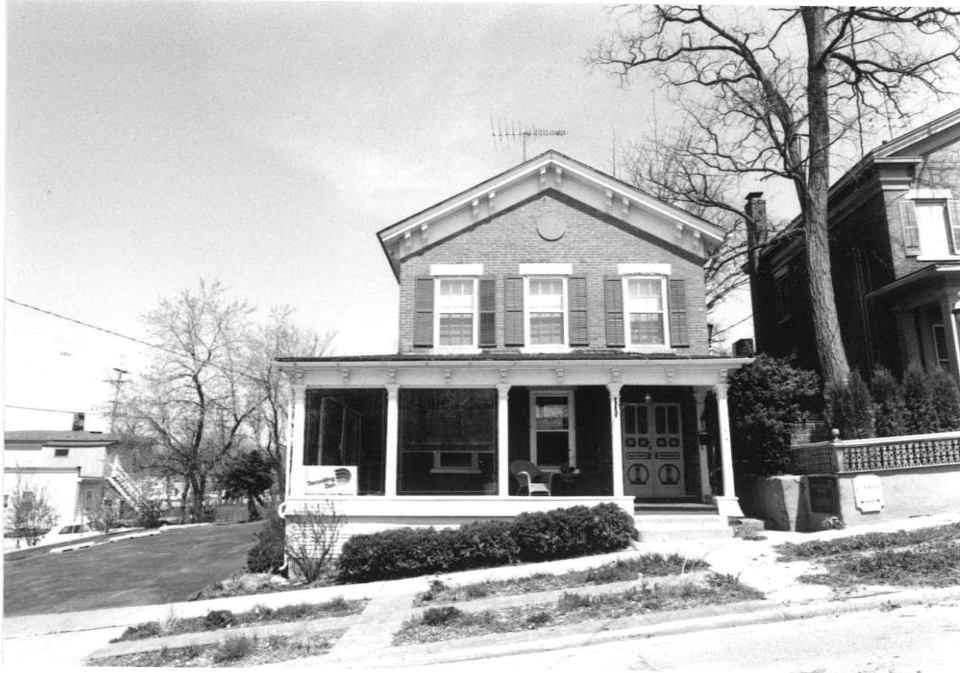
116 East Cedar Avenue

Style: Italianate

Date of Construction: 1853

Double bracketed eave at front gable roof. Wrap around porch. Stone lintels at windows on brick structure.

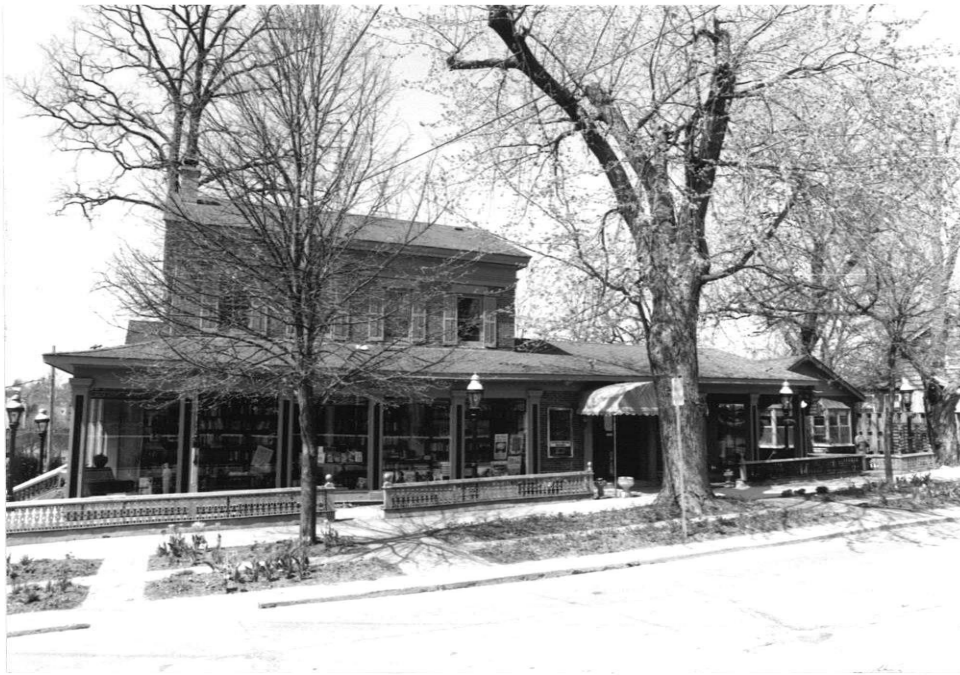
116 East Cedar Avenue

East Elevation.

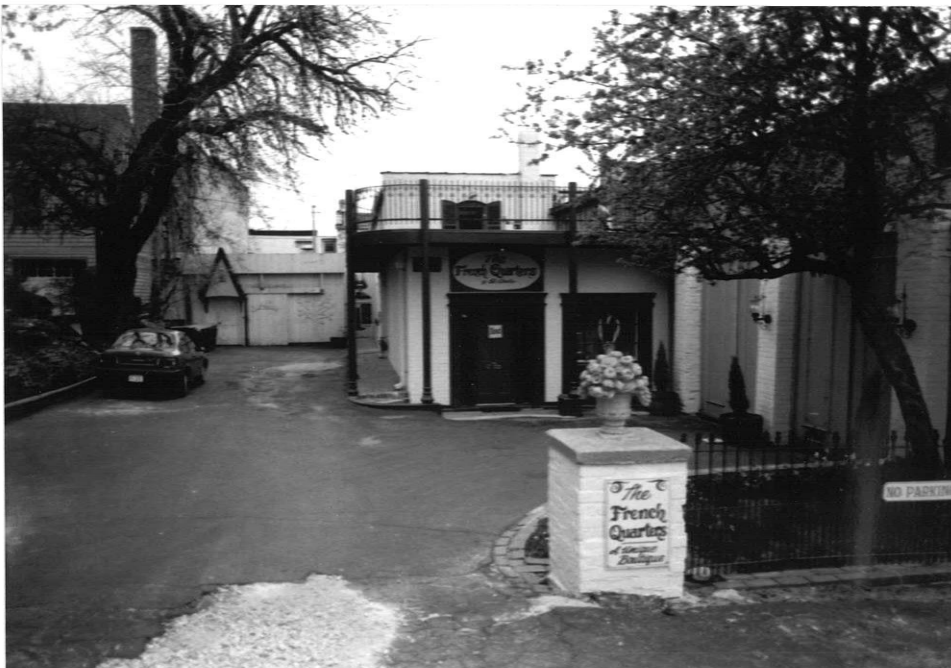
117 East Cedar Avenue

Style: Commercial Vernacular

Wrought iron railing on roof of one story brick structure with wrap around overhang.

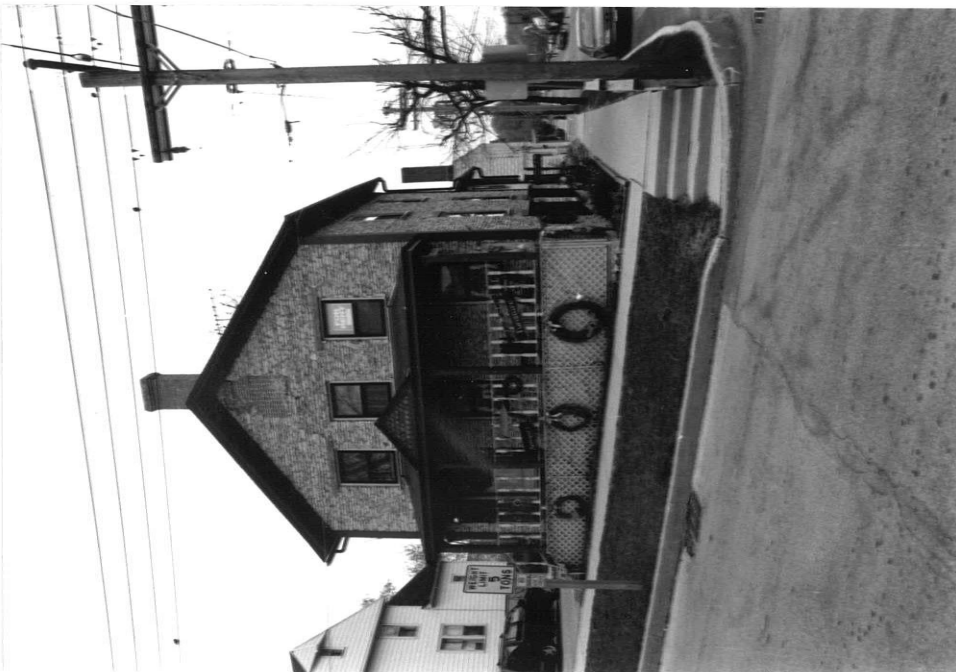
201 East Cedar Avenue

Style: National Style

Date of Construction: 1853

Two story limestone structure with front gable. Appears to have had stucco finish originally. Stucco removed in the 1980's. Originally the home of Thomas and Elizabeth Collins.

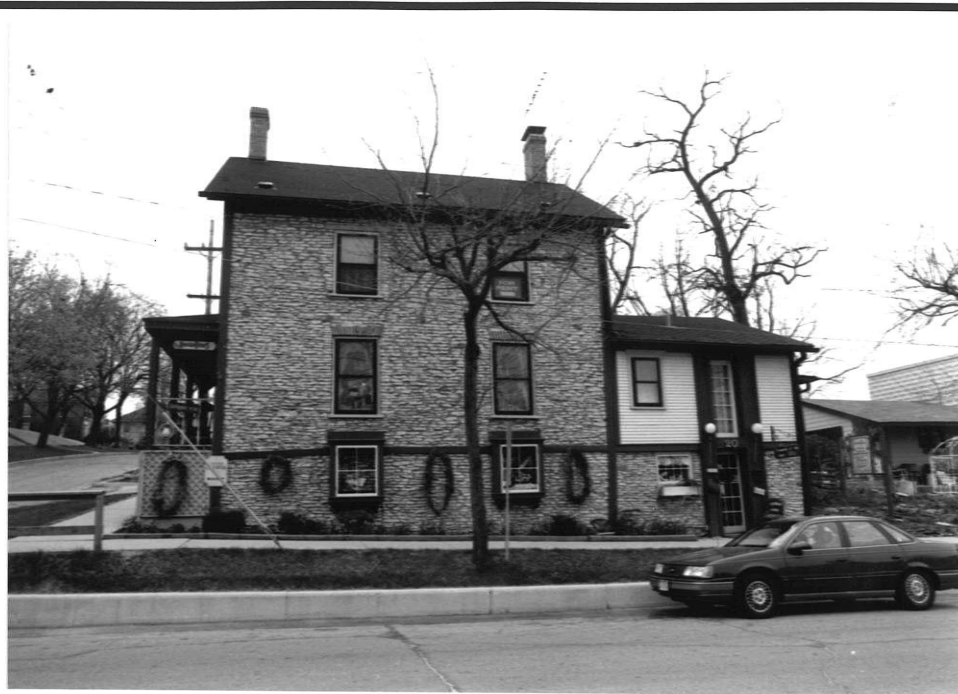
201 East Cedar Avenue

West Elevation.

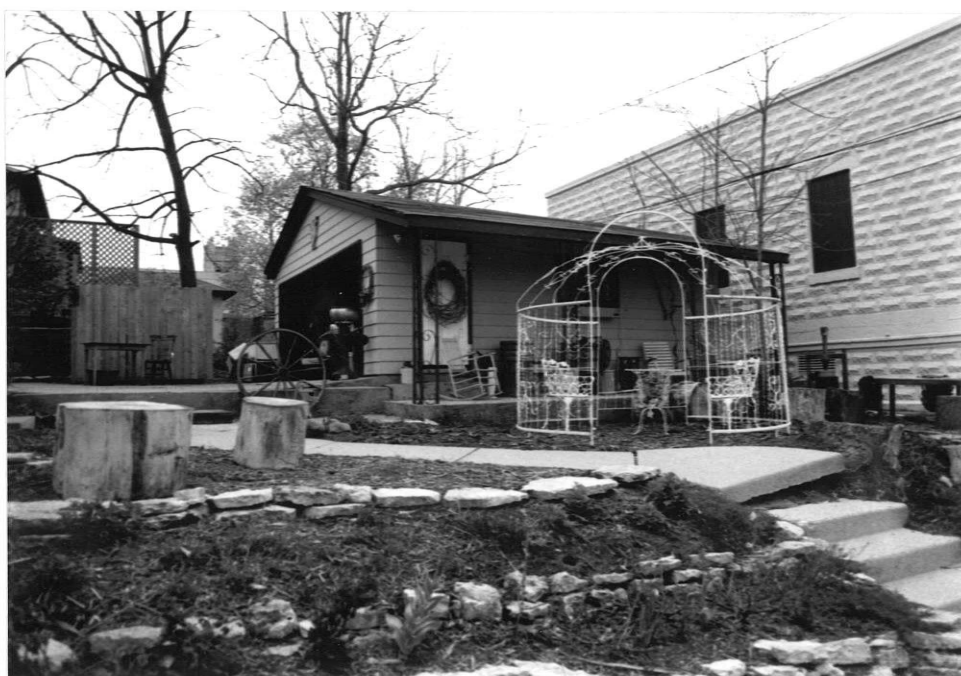
201 East Cedar Avenue

Garage.

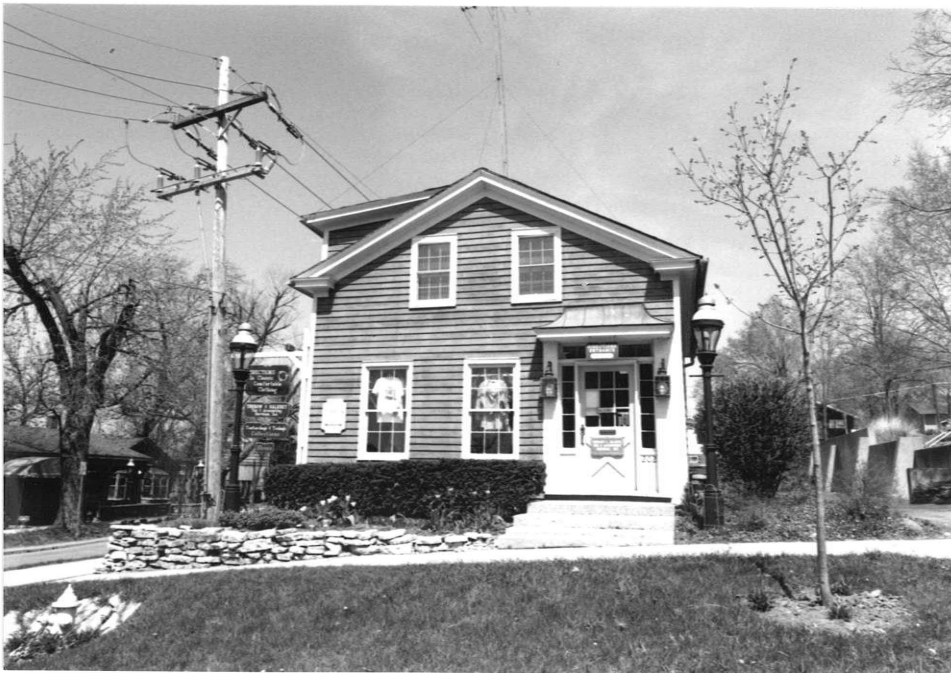
202 East Cedar Avenue

Style: National

Date of Construction: 1870

Front gabled one and one-half story wood frame structure with broken pediment. Six over six double hung windows at front. Box bay added at west elevation. Full width dormer added at west side of roof.

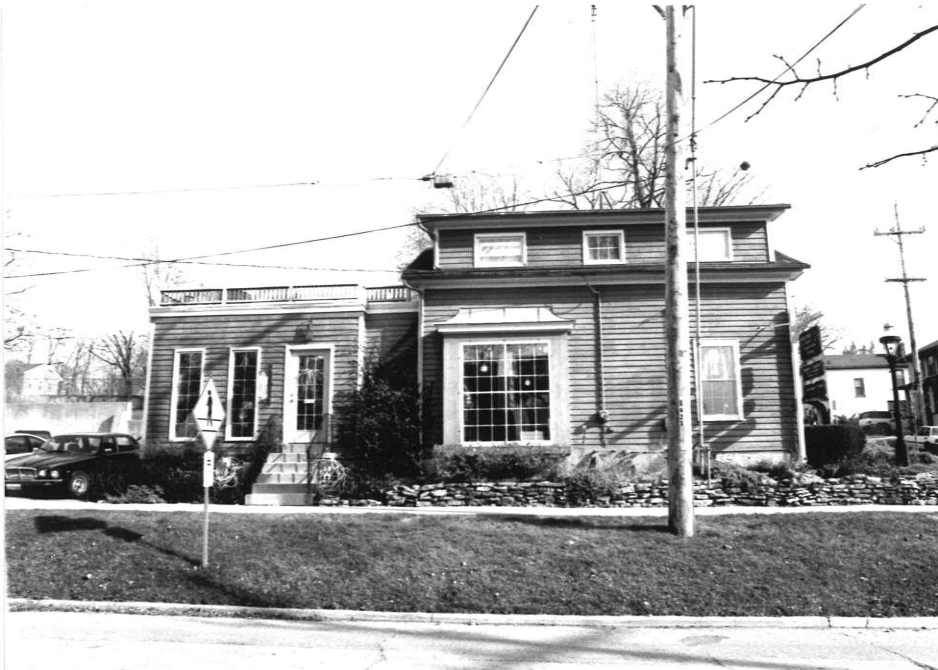
202 East Cedar Avenue

West Elevation.

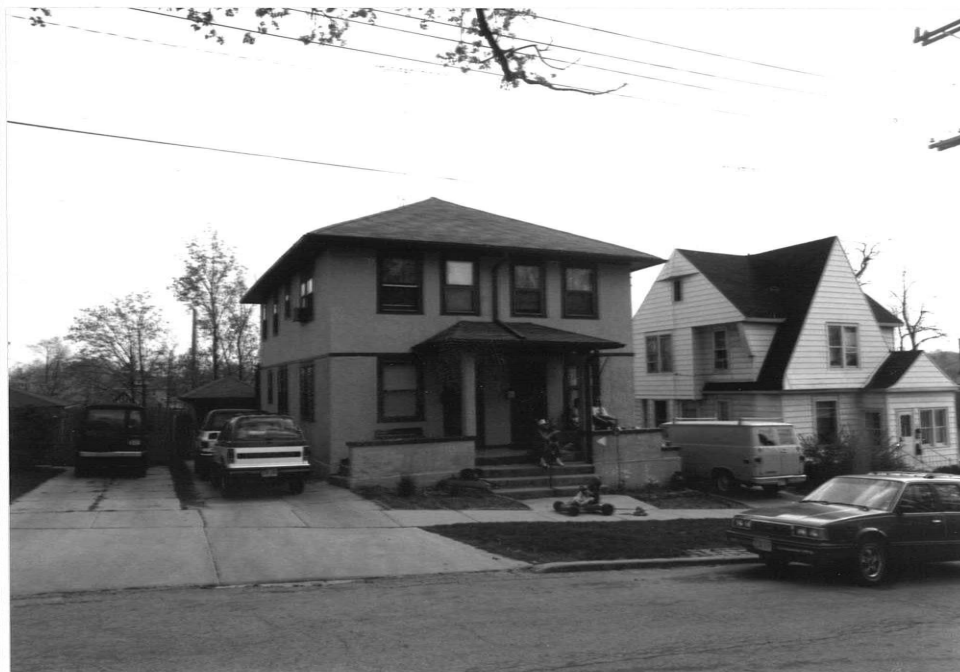
211-215 East Cedar Avenue

Style: Prairie

Date of Construction: 1900-1920

Hipped roof, two story symmetrical front entry house.
 Porch greatly modified. Stucco finish.

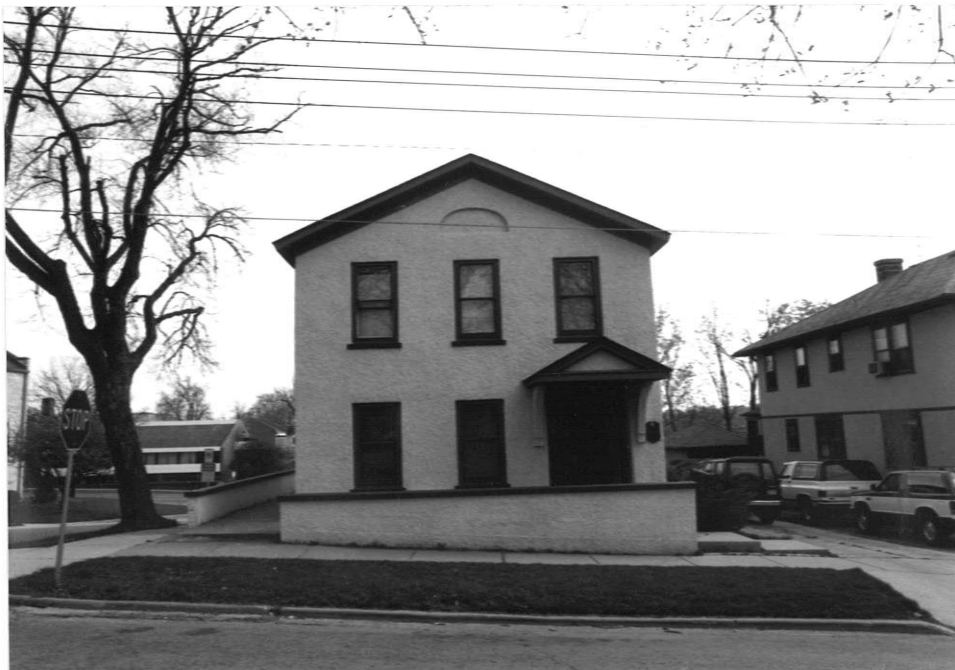
217 East Cedar Avenue

Style: Greek Revival

Date of Construction: 1850

Two story structure with one story addition at south. Front gabled roof. Stucco exterior filled in fan light and greatly affected the appearance.

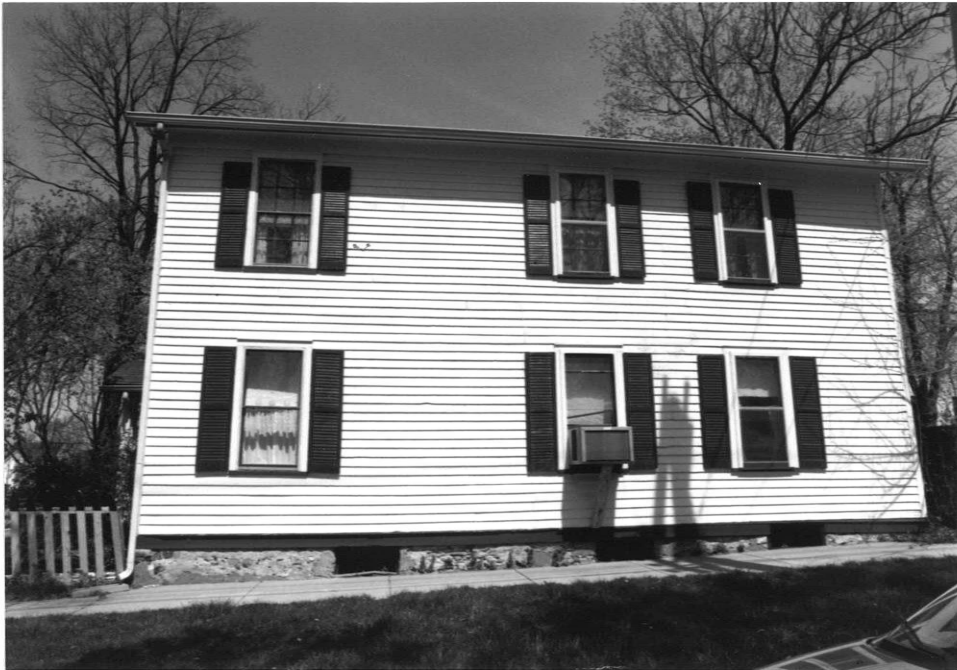
18 South 3rd Avenue

West Elevation.

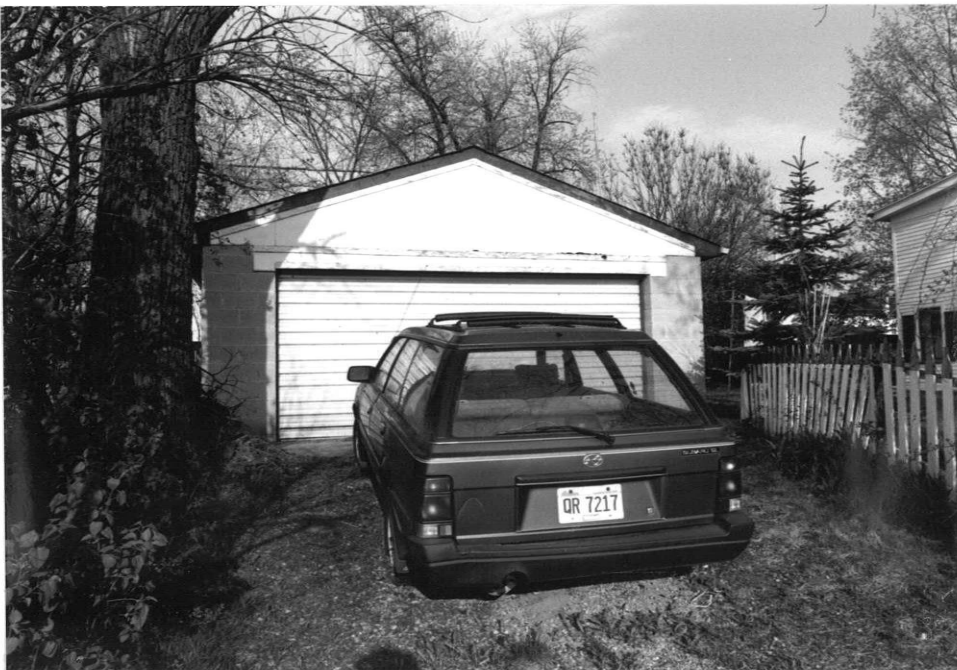
18 South 3rd Avenue

Garage.

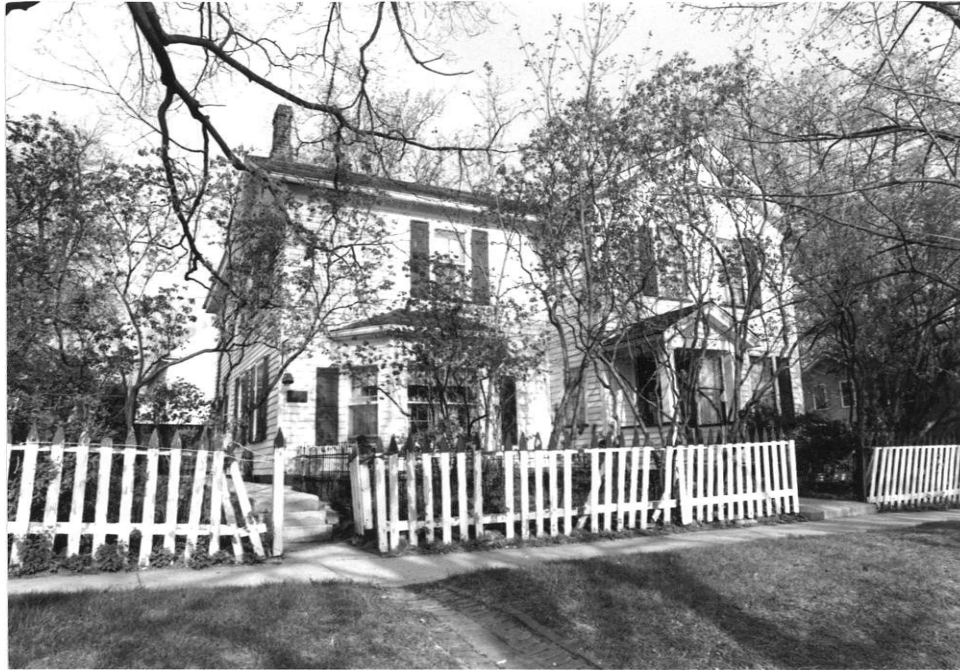
18 South 3rd Avenue

West Elevation.
