ST. CHARLES HISTORIC PRESERVATION COMMISSION

**ARCHITECTURAL SURVEY**  
**ST. CHARLES CENTRAL DISTRICT**  
**ST. CHARLES, ILLINOIS**

DIXON ASSOCIATES / ARCHITECTS

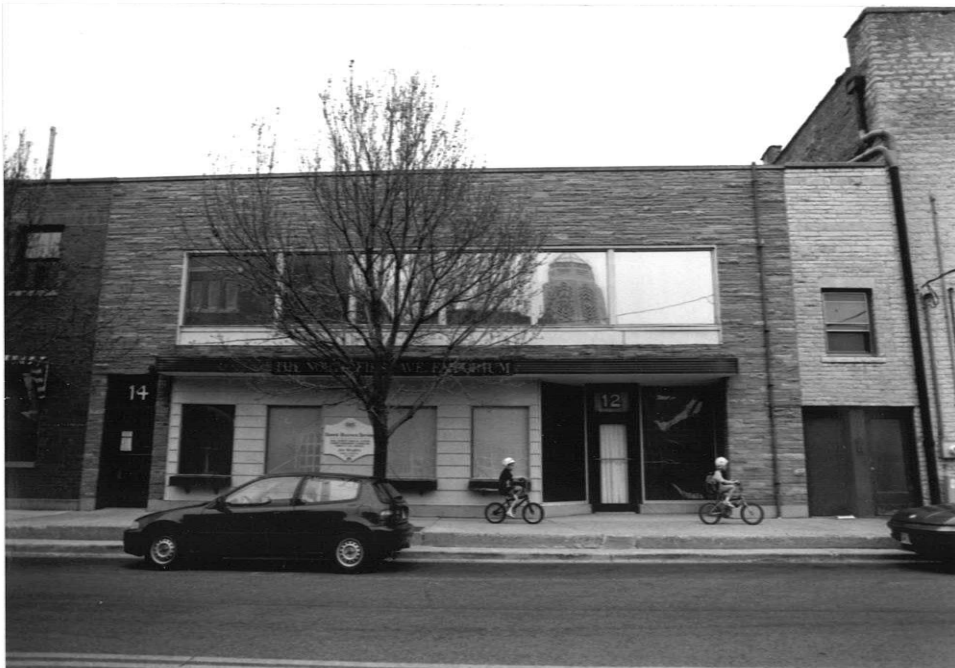
12-14 North 1st Avenue

**Style:** Commercial Vernacular

**Date of Construction:** 1880-1910

Two story, greatly modified structure. Synthetic siding at first floor, lannon stone cladding at second floor. Large picture windows at second floor.

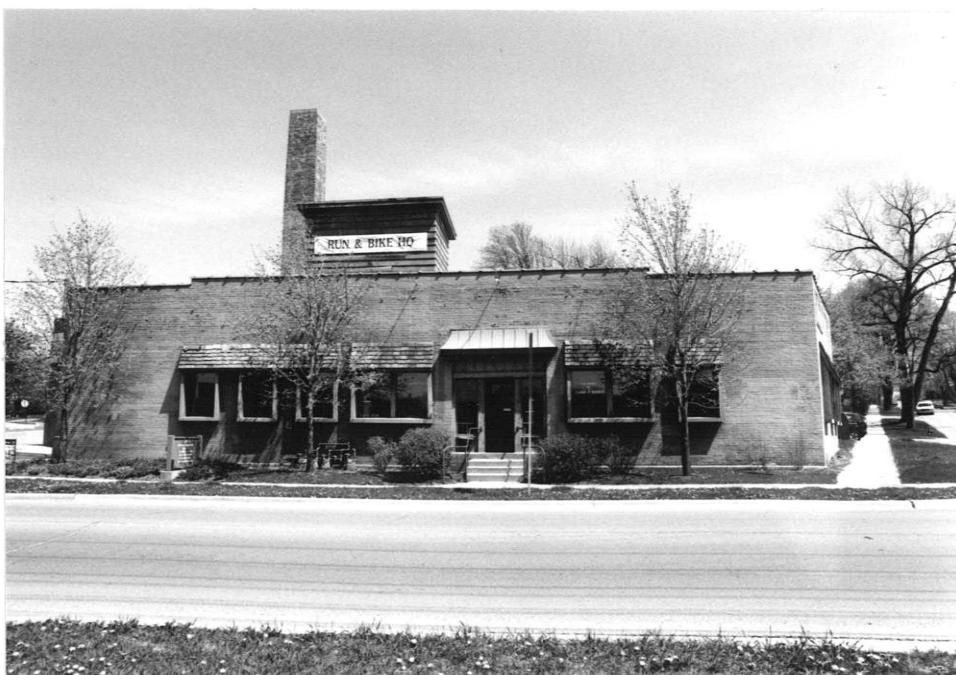
216-218 South 1st Avenue

**Style:** Utilitarian

**Date of Construction:** 1900-1920

Former daily building of brick, one story with wood tower and brick chimney.

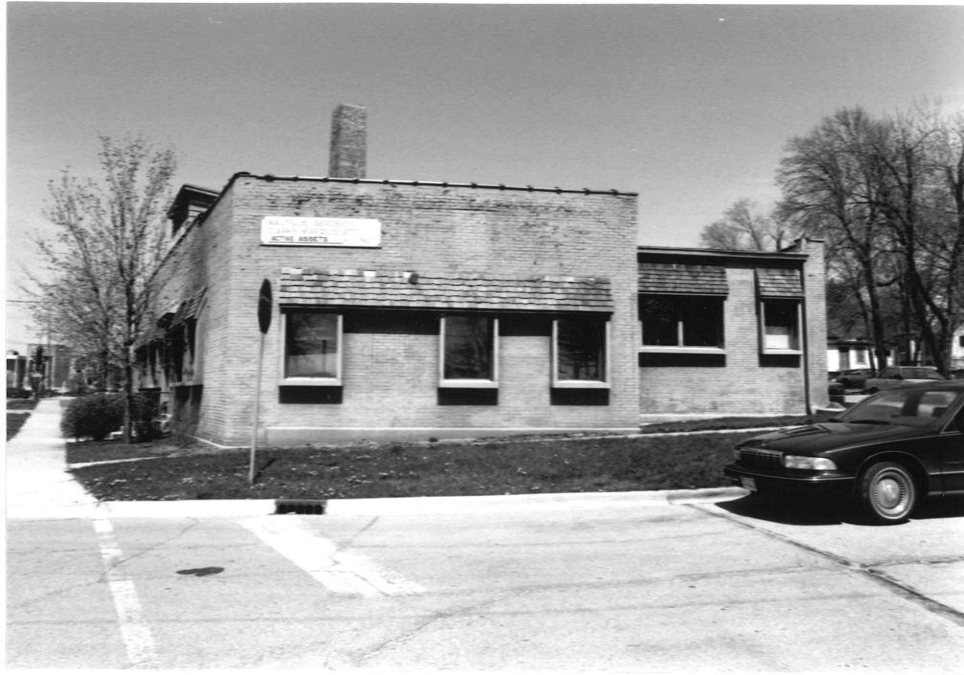
216-218 South 1st Avenue

South Elevation.

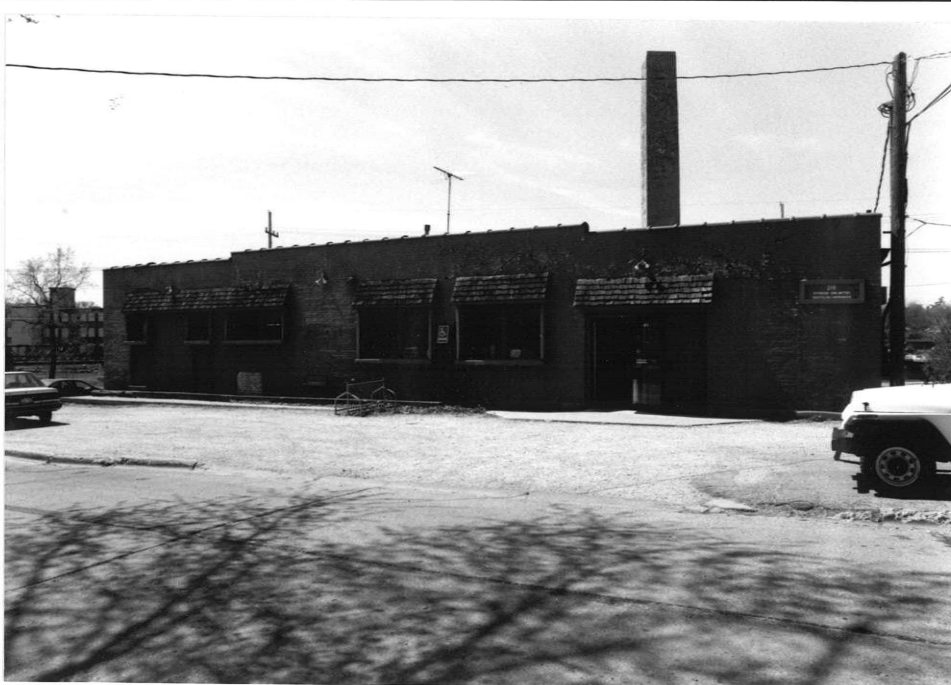
216-218 South 1st Avenue

East Elevation.

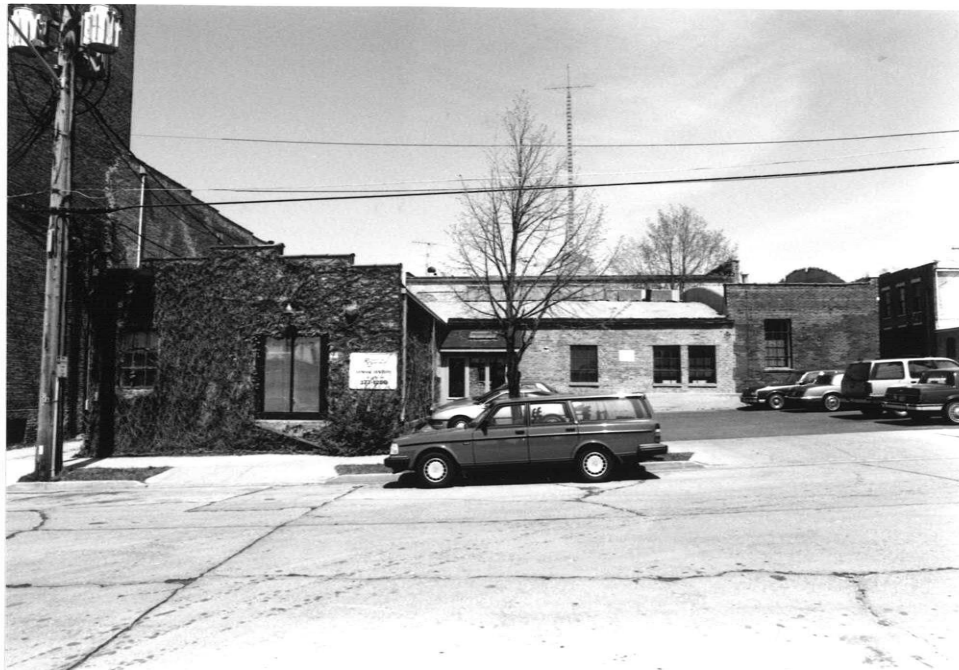
11 South 2nd Avenue

South Elevation.

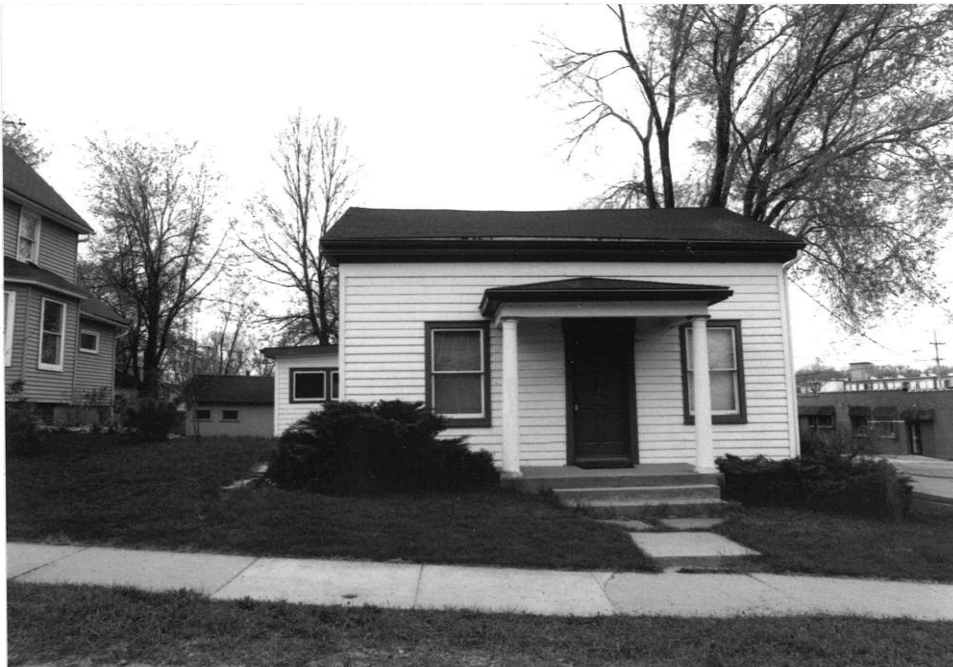
203 East Illinois Avenue

**Style:** National

**Date of Construction:** 1860-1880

Side gable form. Classical entry porch. Porch details altered.

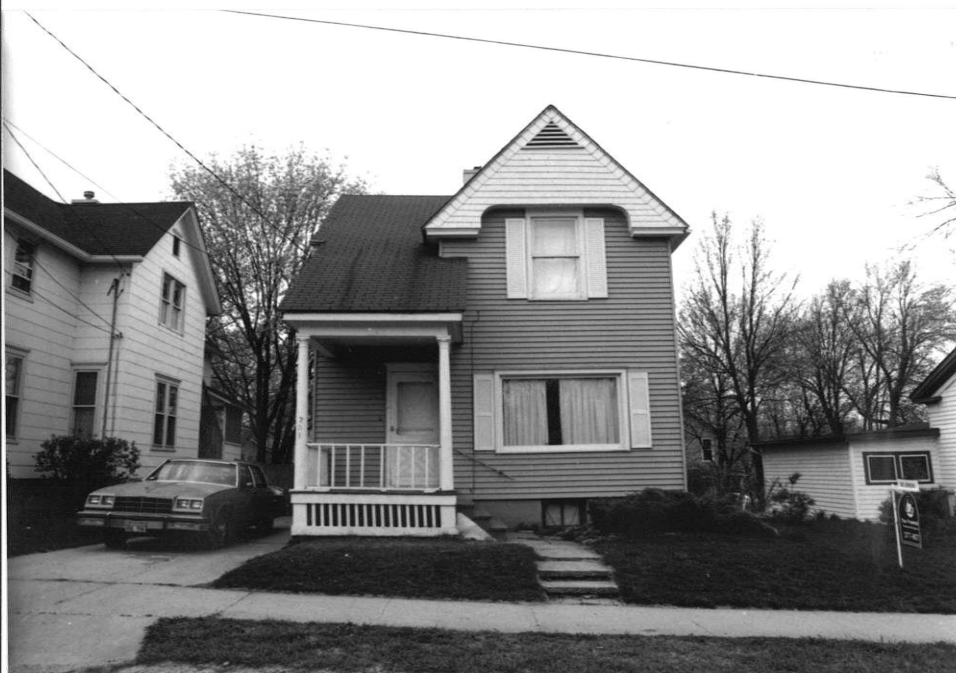
207 East Illinois Avenue

**Style:** Queen Anne

**Date of Construction:** 1880-1910

Two-story cross gable structure. Entry porch with shed roof. Projecting gable end with wood shingles.

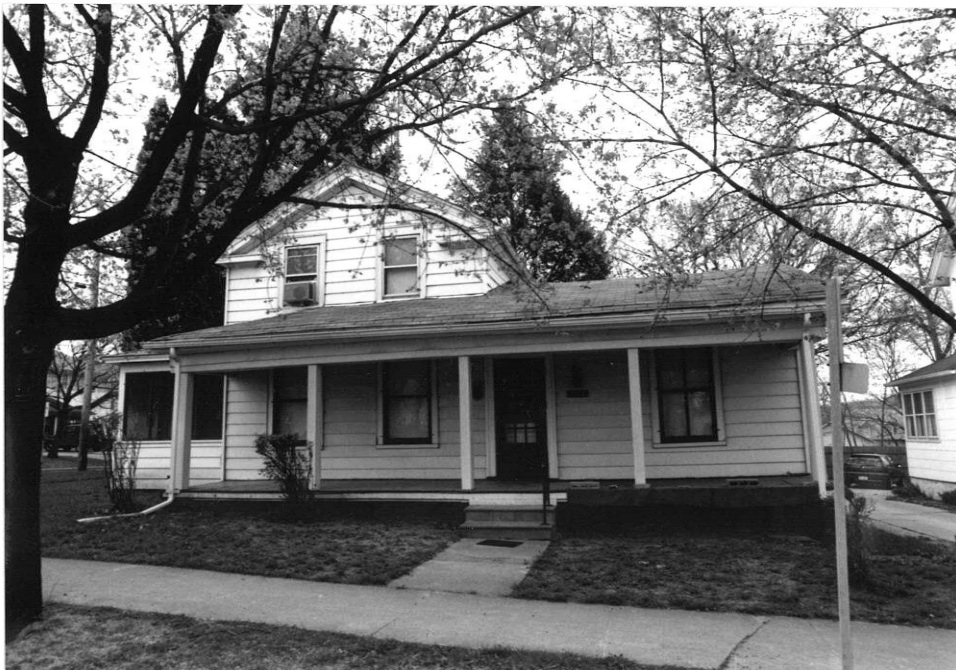
215 East Illinois Avenue

**Style:** National

**Date of Construction:** 1860-1880

Gable front and wing form. Horizontal siding. Details have been removed or altered. Full width porch with shed roof. One story additions to side and rear.

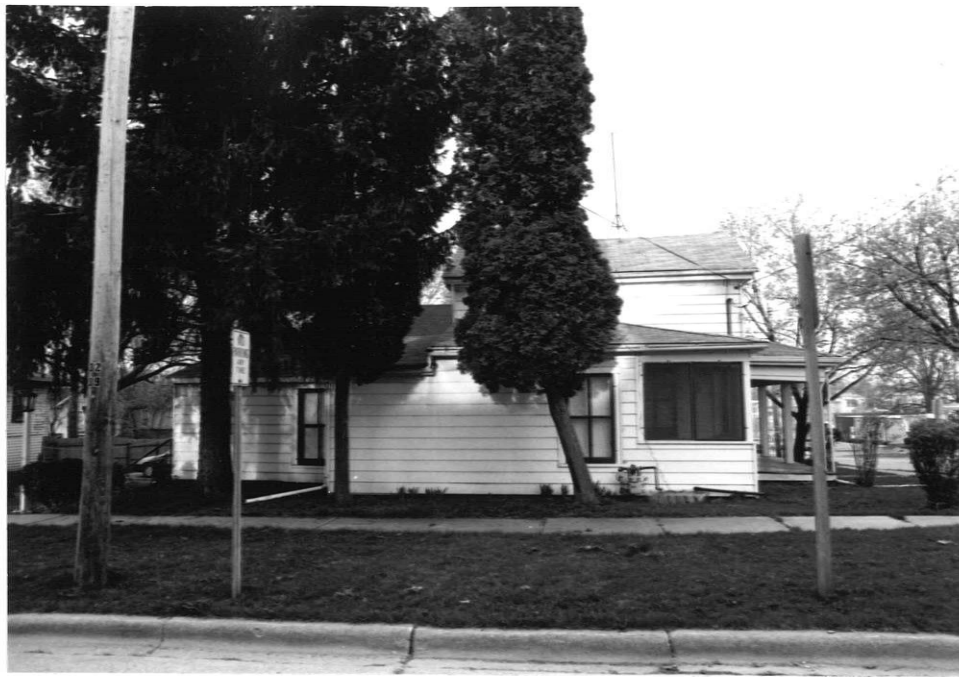
215 East Illinois Avenue

East Elevation
