ST. CHARLES HISTORIC PRESERVATION COMMISSION

ARCHITECTURAL SURVEY
ST. CHARLES CENTRAL DISTRICT
ST. CHARLES, ILLINOIS

DIXON ASSOCIATES / ARCHITECTS

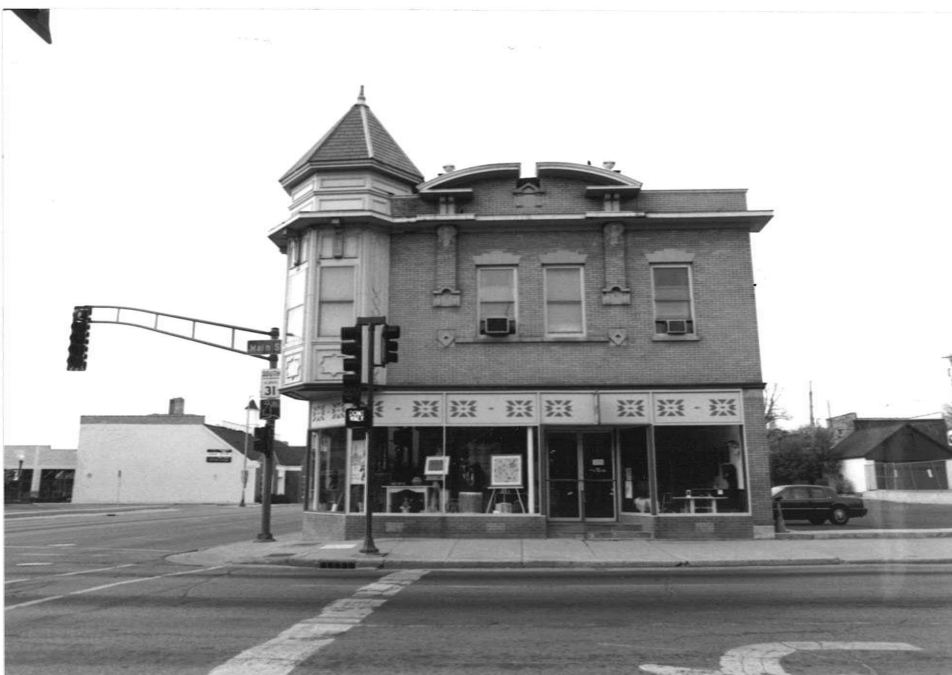
203 West Main Street

Style: Late Victorian

Date of Construction: 1900-1920

Two story brick structure with stone accents.
 Predominant turret with conical roof at northeast corner.

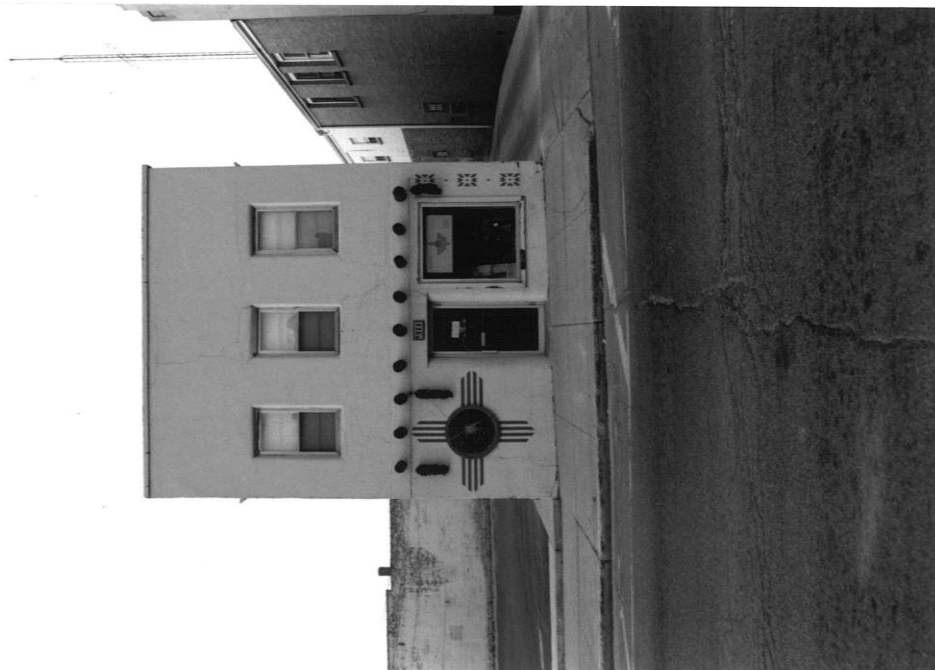
211 West Main Street

Style: Commercial Vernacular, Southwest theme

Date of Construction: 1920-1950

Greatly modified two story structure. Cement plaster finish with false log beam projections for appearance as "Southwest" store. Curved walls at entry door and round window at first floor.

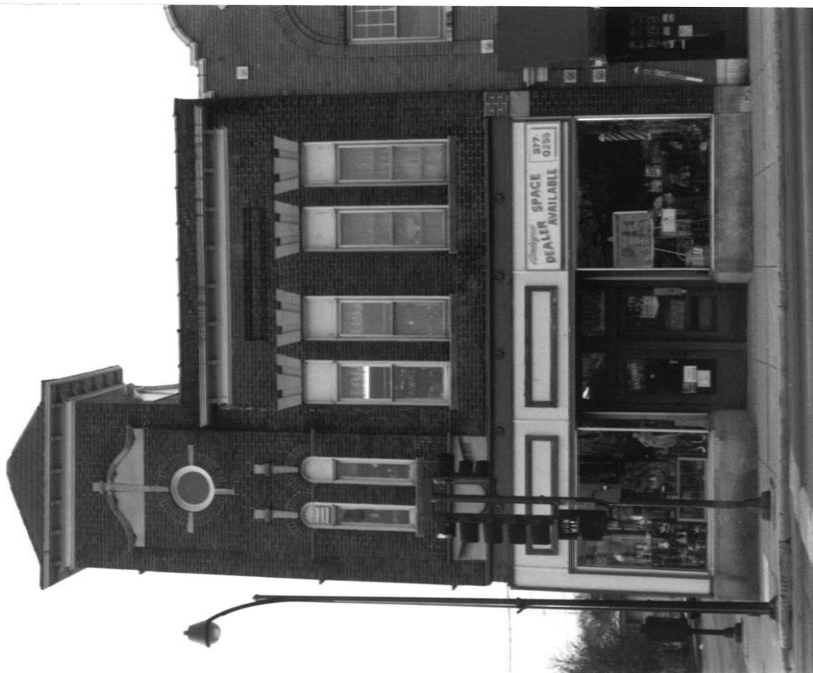
301 West Main Street

Style: Italian Renaissance

Date of Construction: ca. 1900

Masonry building, brick with significant stone accents above windows. Circle windows, two sides of corner square tower. Tall, narrow windows at second floor. First floor windows at east side with full semi-circle arches.

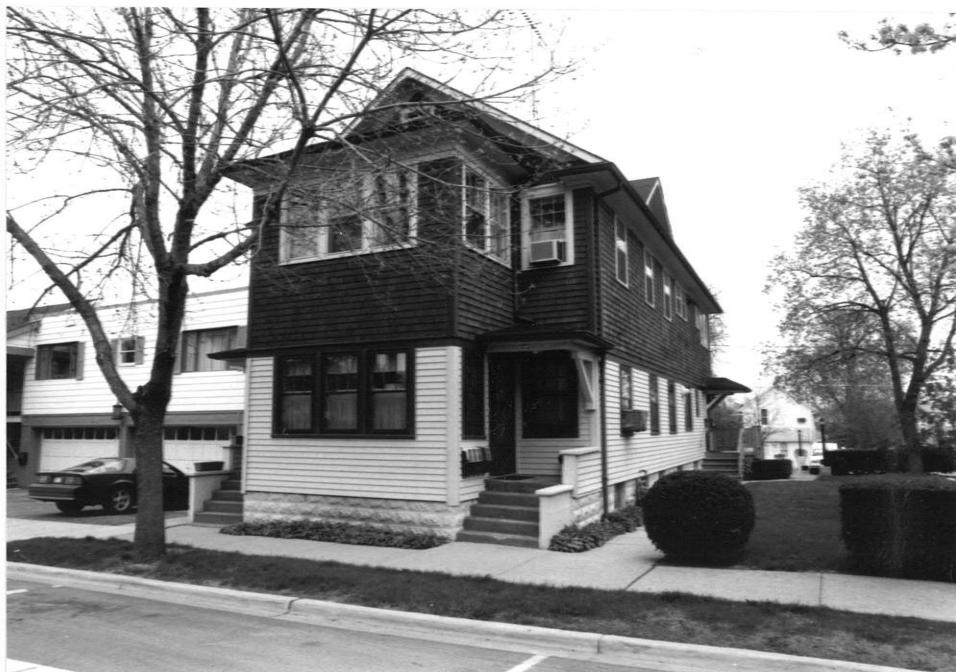
112/114 South 3rd Street

Style: Shingle

Date of Construction: 1880-1920

Shingle texture at second level, clapboard at first level.
 Rock face block foundation.

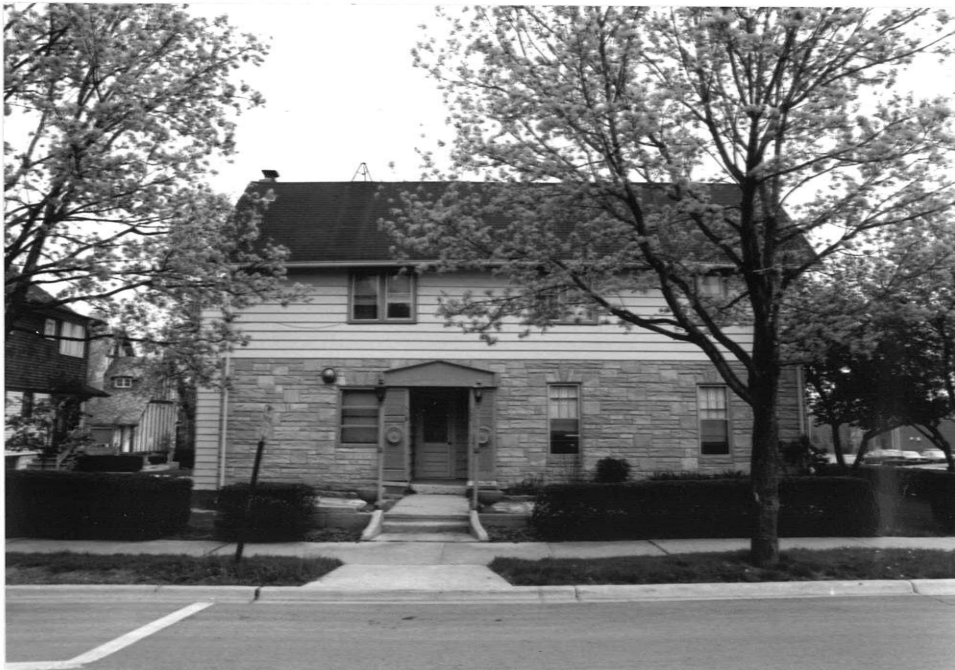
118/120 South 3rd Street
220 West Illinois Street

Style: Neoclassical

Date of Construction: 1895-1950

Lannon stone first floor with large dimension siding at second floor.

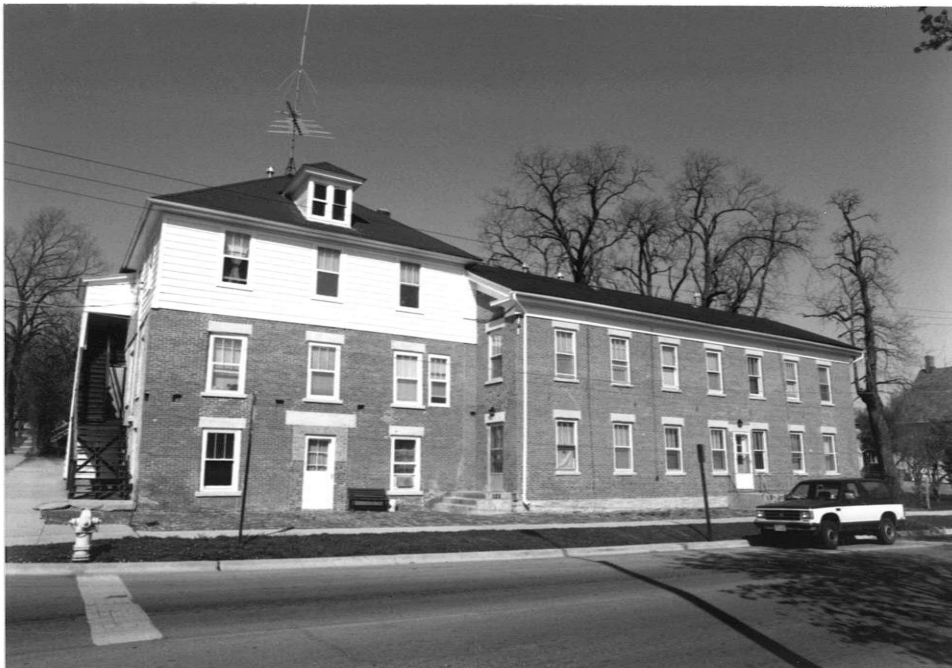
123 South 3rd Street

Style: Greek Revival

Date of Construction: 1848

North section built first. South section added in 1850. Evidence of original two level wrap around porch in brick beam pockets. Mary Todd Lincoln stayed here after Abraham Lincoln was assassinated. Called the Howard House. Mrs. Caroline Howard was a psychic.

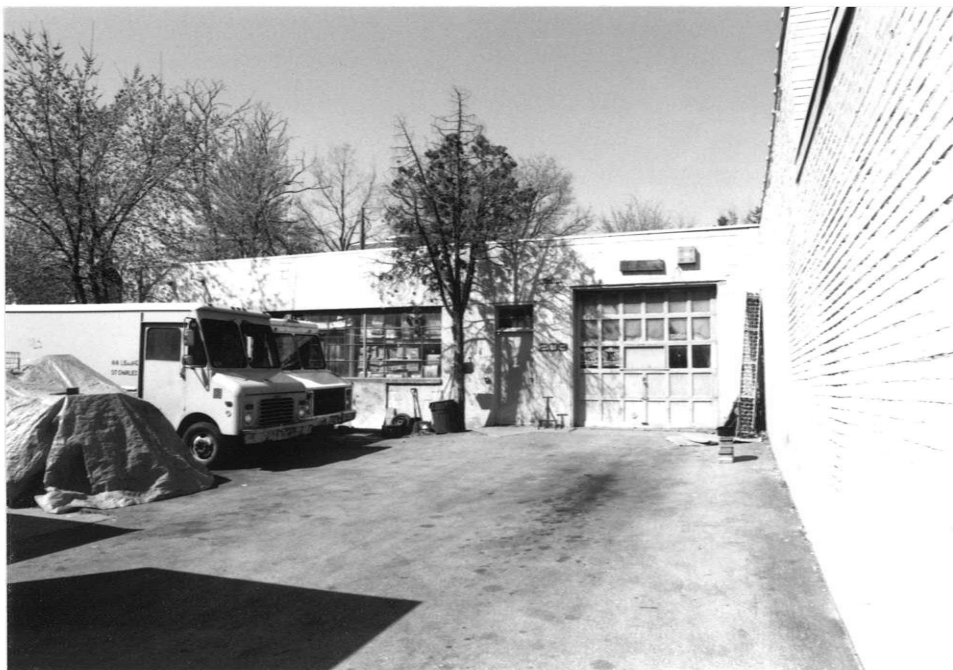
201-203 South 3rd Street

Style: Utilitarian

Date of Construction: 1920-1960

Brick one story building with steel frame windows and garage door.

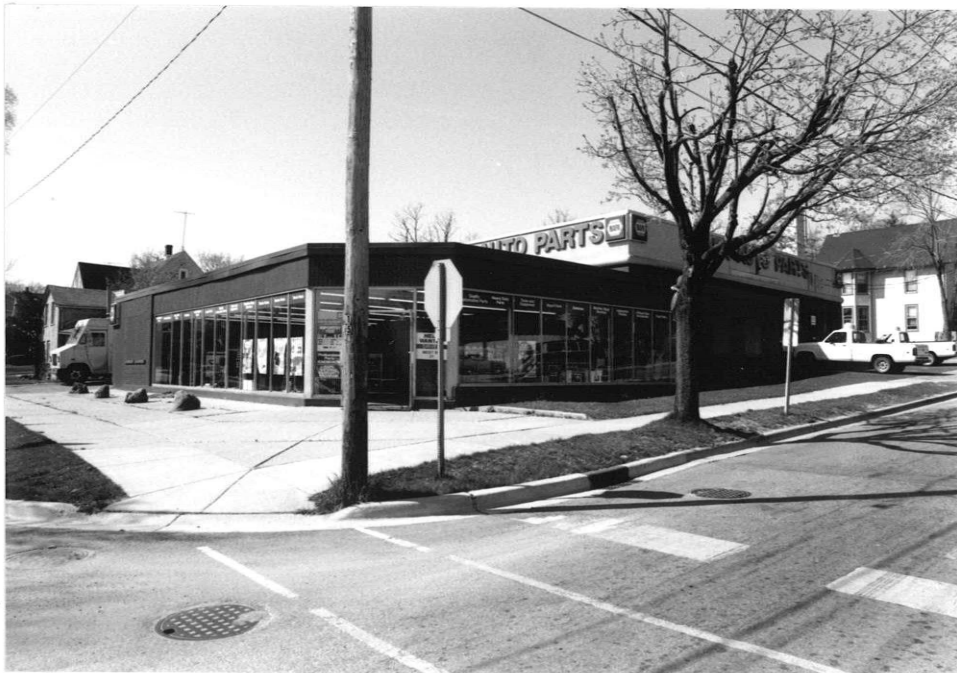
201-203 South 3rd Street

Style: Commercial Vernacular

Date of Construction: 1950-1970

Aluminum and glass storefront in brick building. Taller garage section to the west.

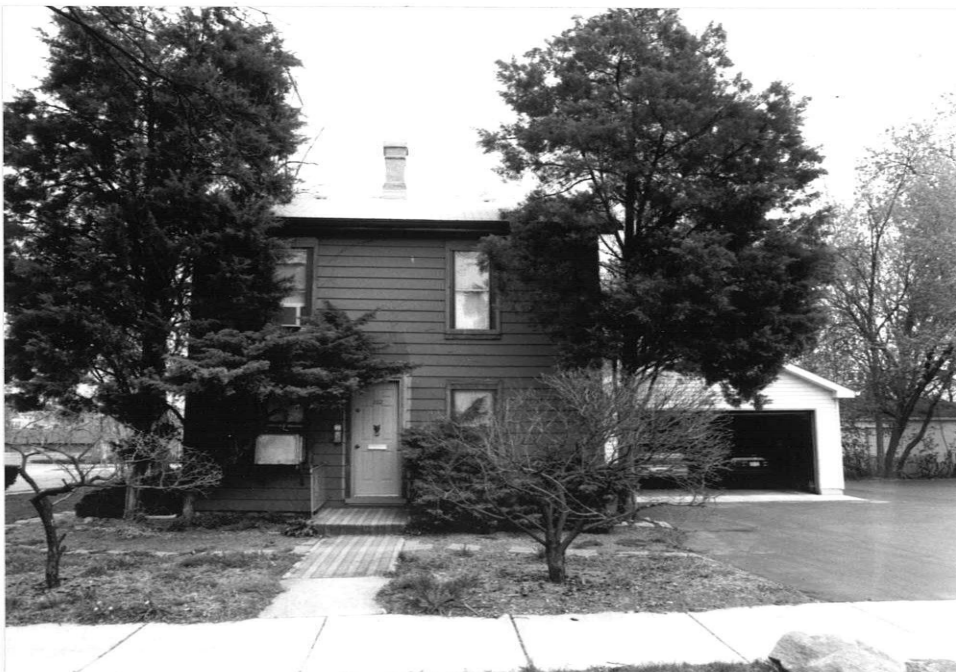
202 South 3rd Street/
 217 West Illinois Street

Style: Neoelectic

Date of Construction: Post 1944

Simple side gable roof on two story house reducing to one story at rear. Wide board siding.

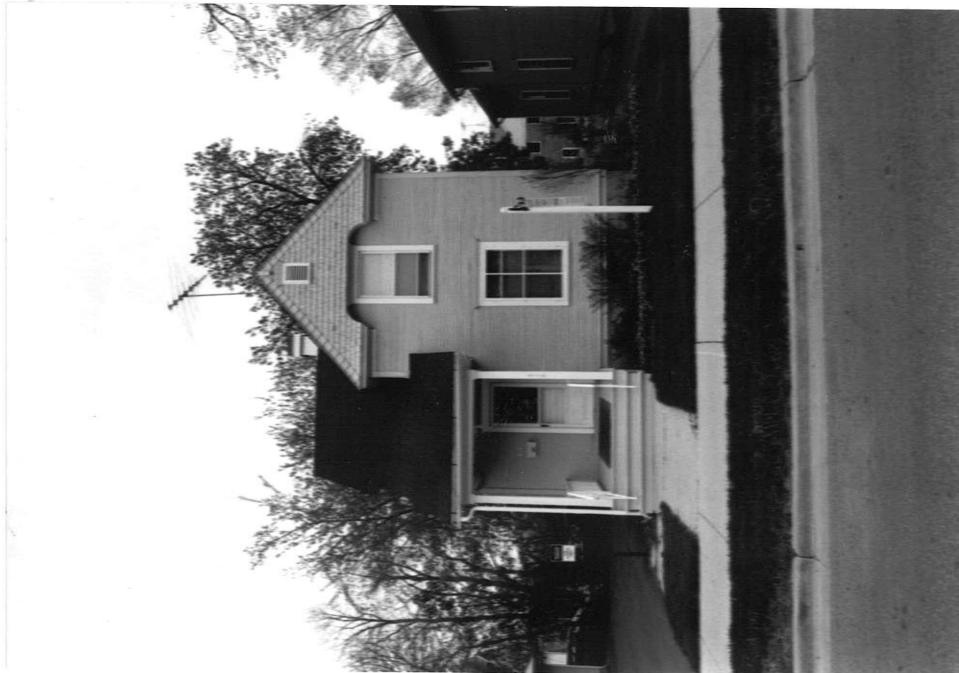
210 South 3rd Street

Style: Queen Anne

Date of Construction: 1880-1910

Two story wood clapboard sided house with steeply pitched roof. Front gable has shingle texture.

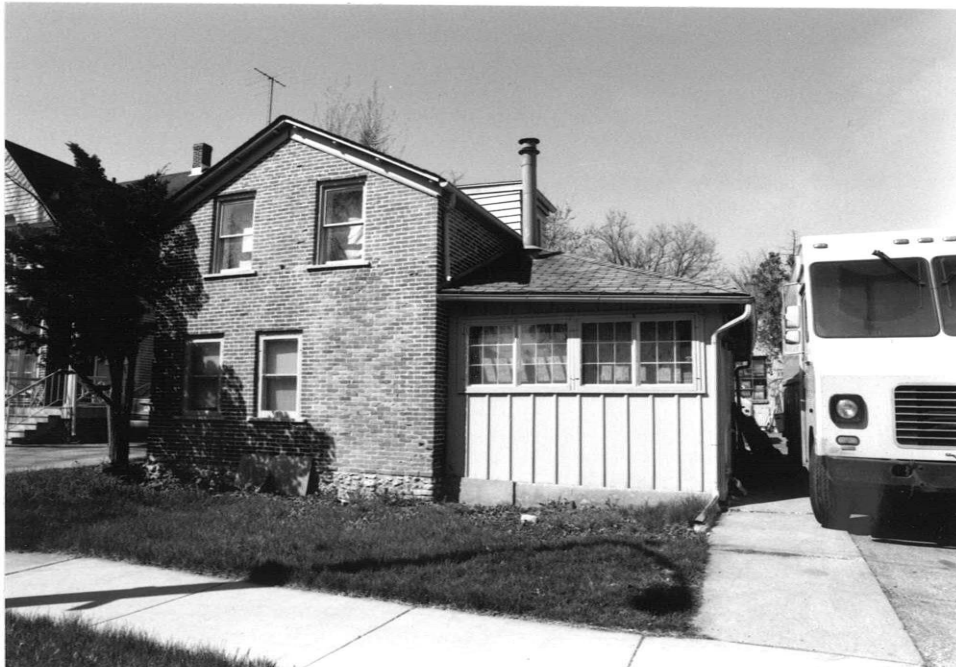
211 South 3rd Street

Style: Greek Revival

Date of Construction: 1825-1860

One and one-half story brick building with board and batten sided addition to the north. Front gabled building with front entrance changed to side.
