ST. CHARLES HISTORIC PRESERVATION COMMISSION

**ARCHITECTURAL SURVEY**  
**ST. CHARLES CENTRAL DISTRICT**  
**ST. CHARLES, ILLINOIS**

DIXON ASSOCIATES / ARCHITECTS

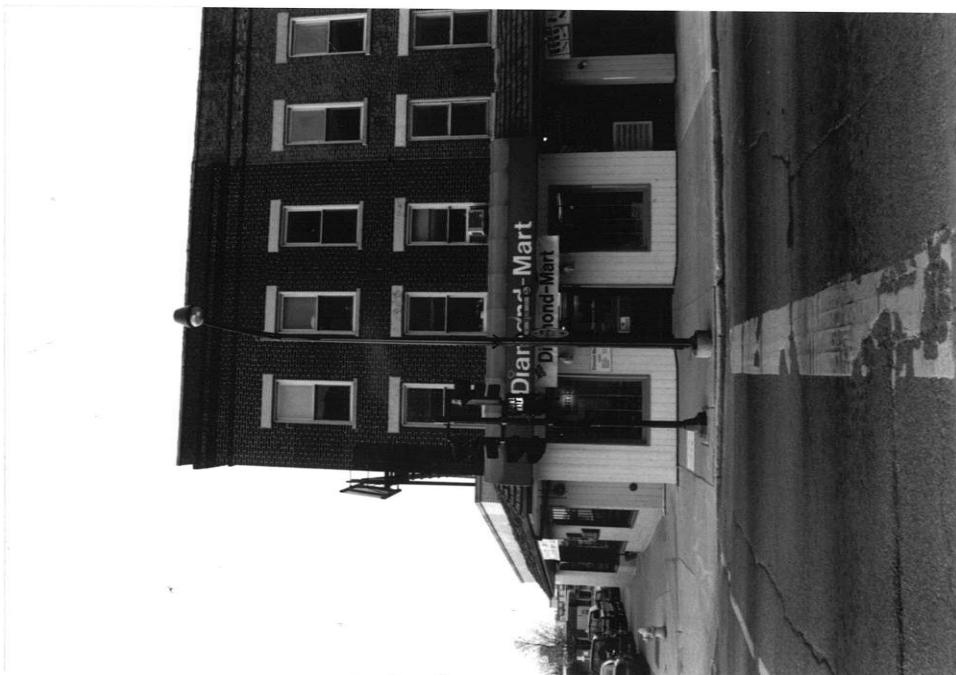
103 West Main Street

Three story brick building with stone lintels at one over one double hung windows at second and third floors. Simple, unadorned parapet. Plywood cladding and plastic awning at first floor.

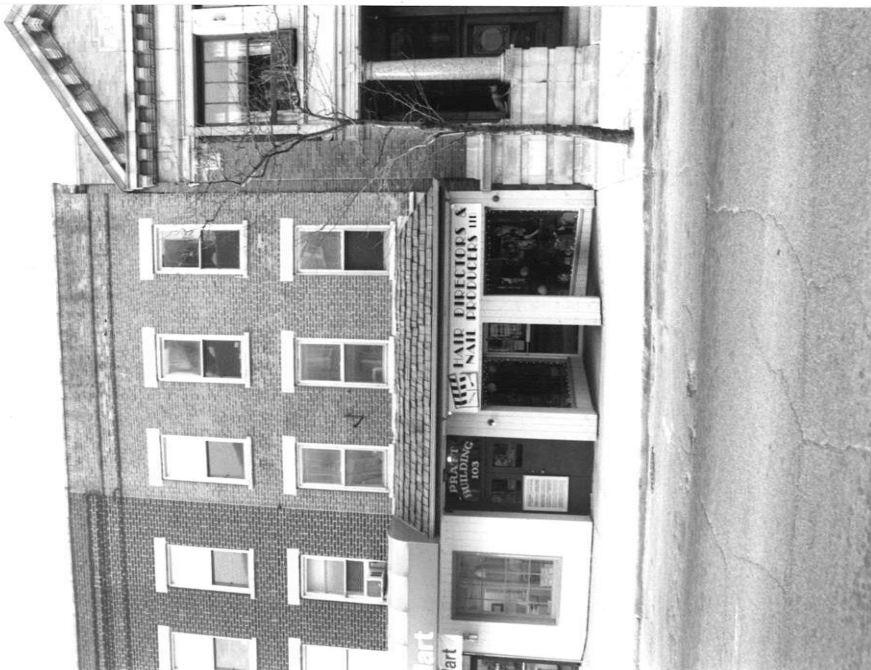
105 West Main Street

Three story brick building with stone lintels at one over one double hung windows at second and third floors. Simple, unadorned parapet. Added wood shingle mansard roof and plywood cladding at first floor.

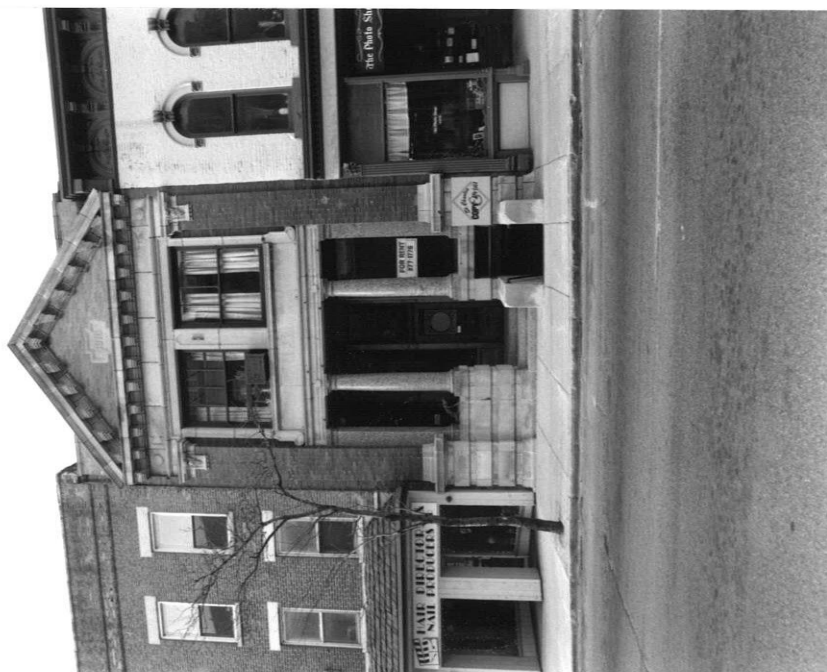
107 West Main Street

Original bank building (St. Charles National Bank) with glazed brick and stone facade. Gable end to front with two round columns flanking deeply recessed central entrance. Two large four over one double hung windows at second floor. Classical ornaments in stone. Deep joints in rusticated stone at base.

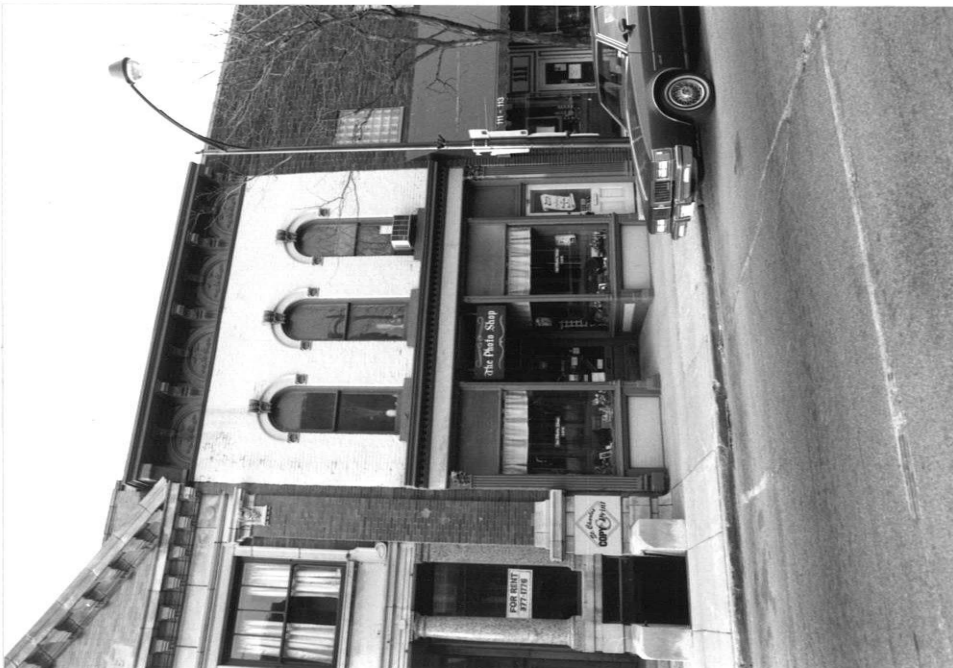
109 West Main Street

Two story masonry structure with cast iron storefront  
 Metal cornice at first floor level and elaborate, bracketted  
 cornice at roof. Arch top second floor windows have  
 elaborate stone lintels.

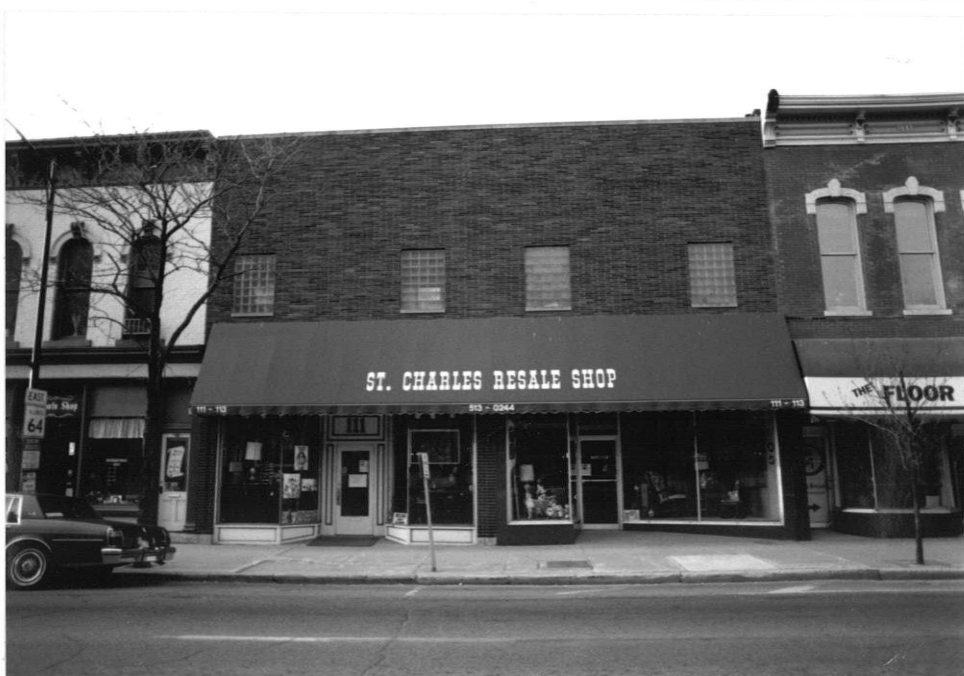
111/113 West Main Street

Extensively remodelled second story with brick and glass block windows.

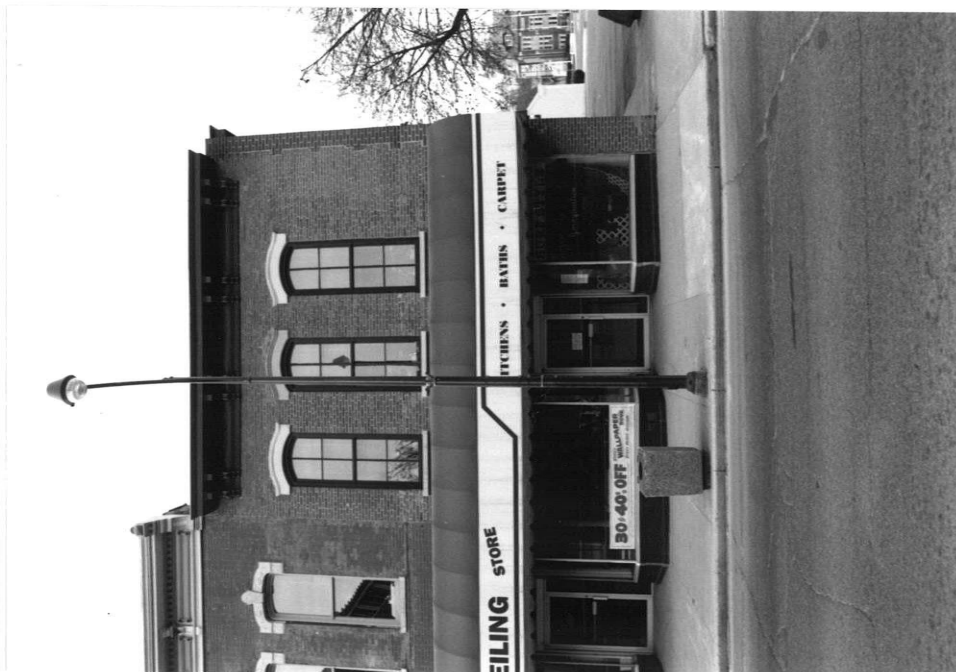
117 West Main Street

Two story brick front structure with tall second floor windows on Main Street elevation. Four over four windows. Center stone window lintel replaced with synthetic material to match stone. Elaborate metal cornice.

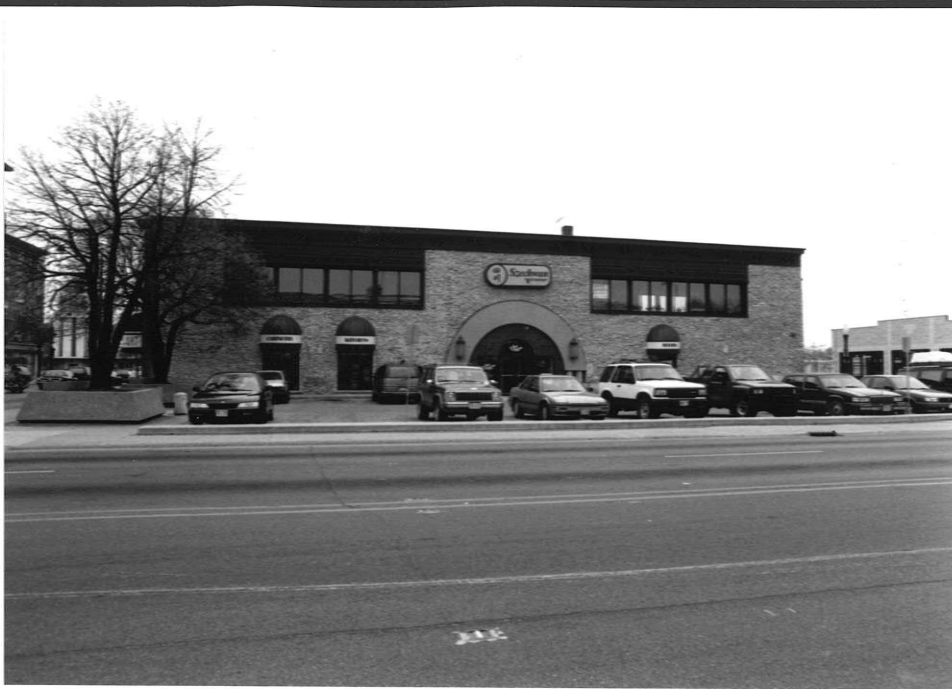
117 West Main Street

West Elevation, showing  
1988 fenestration to  
previously total random  
limestone wall.

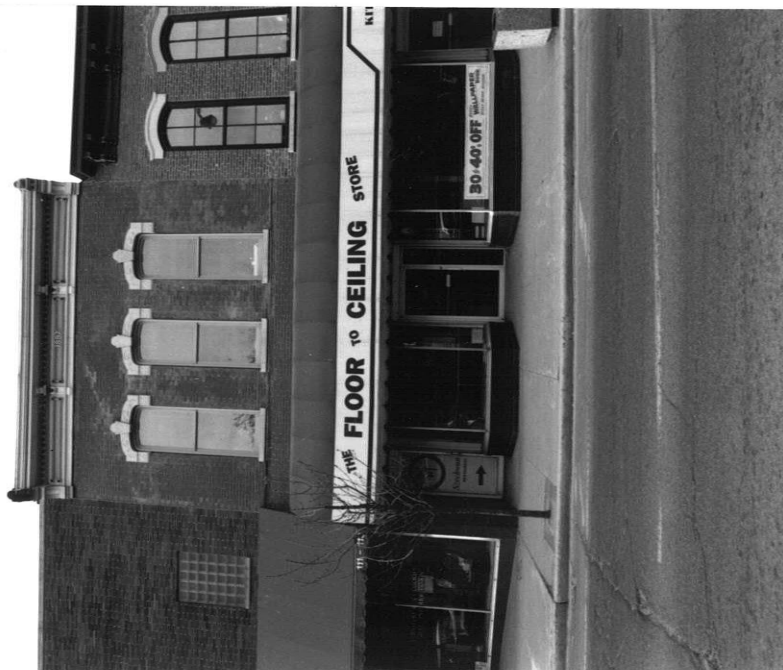
117 West Main Street

Two story brick front structure with tall one over one second floor windows. Elaborate metal cornice with date. Carved stone lintels at second floor windows.

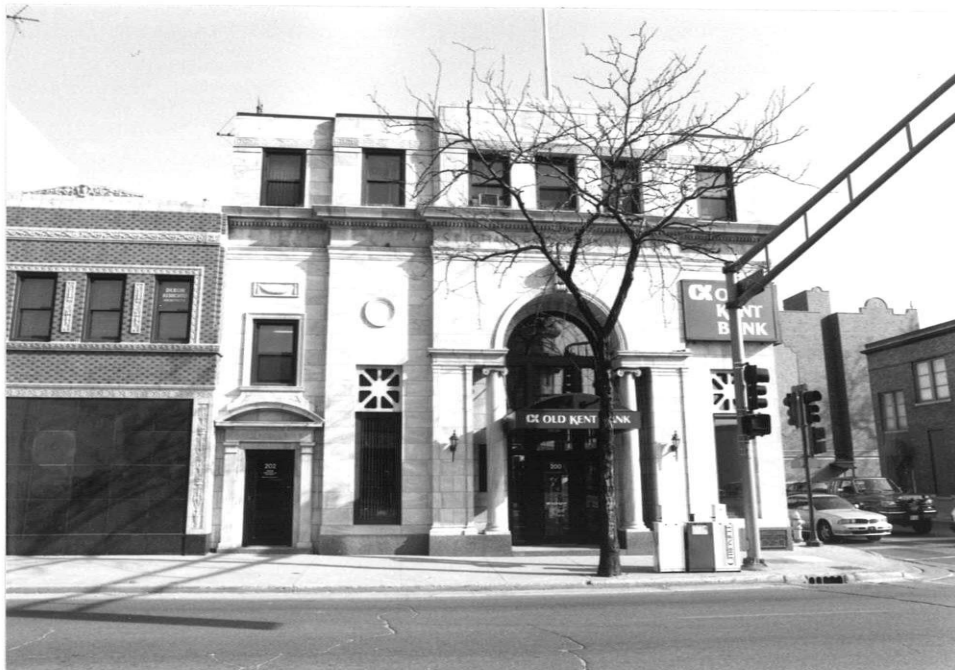
200 West Main Street

Erected by Col. Edward Baker as the St. Charles National Bank. Windows changed to aluminum from steel in late 1980's. Major interior remodeling added a second floor which was later removed in the late 1980's. Marble exterior with Ionic columns flanking arched entry on south facade.

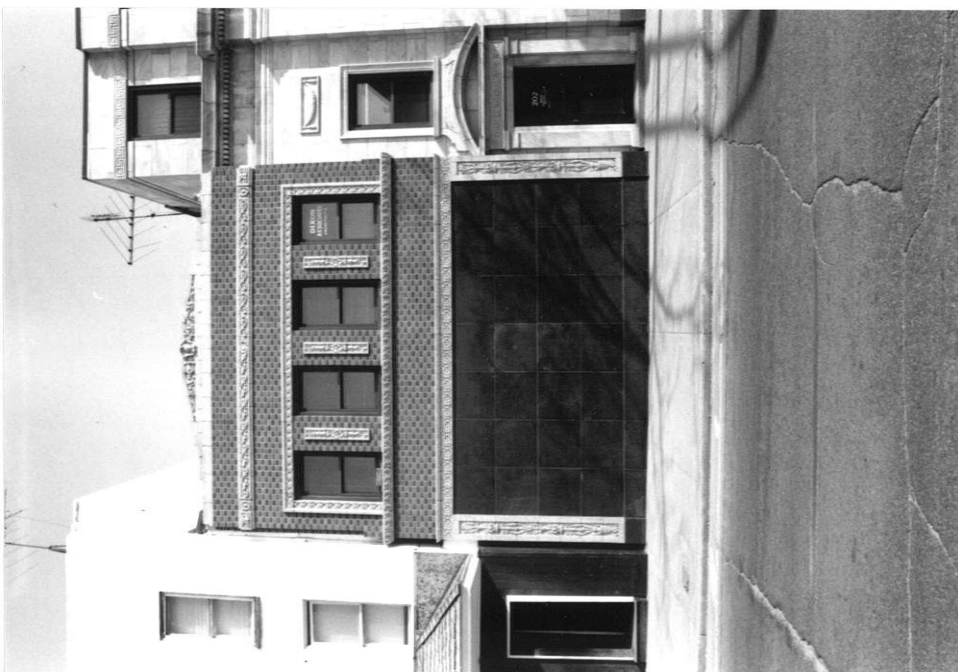
202 West Main Street

First floor store front filled in with black granite panels, but still has beige terra cotta frame. Brick upper facade all headers in checkerboard pattern of alternating dark and light colors. Terra cotta parapet missing two finials at ends. Windows replaced in 1988 with dark bronze aluminum.

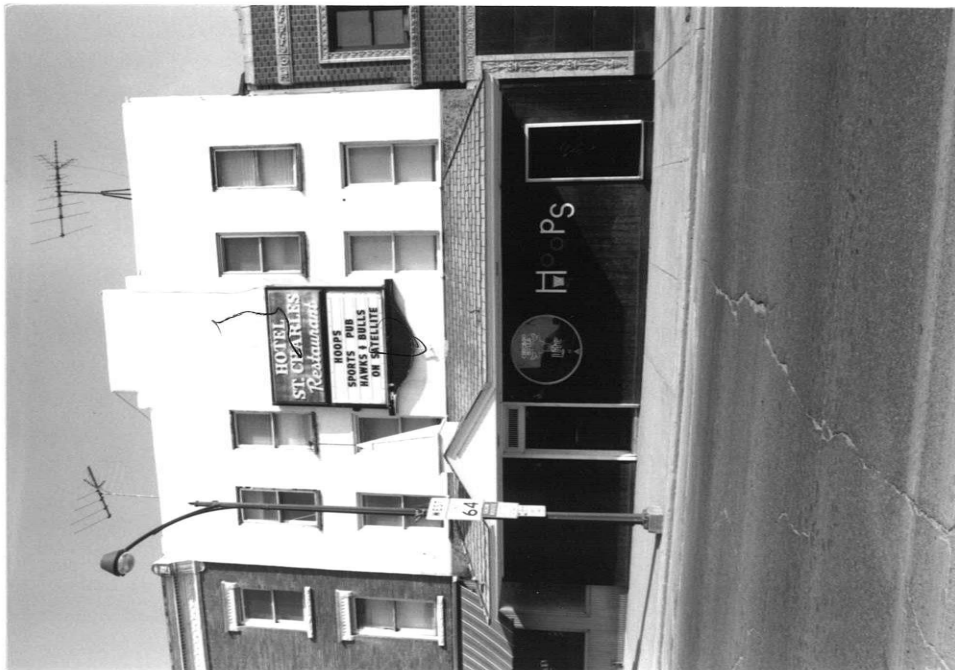
204/206 West Main Street

Greatly modified exterior with cement plaster at two upper stories, plywood at first floor. Part of White Front Hotel to the west, now called the Hotel St. Charles. Two level balcony with front facing gable removed.

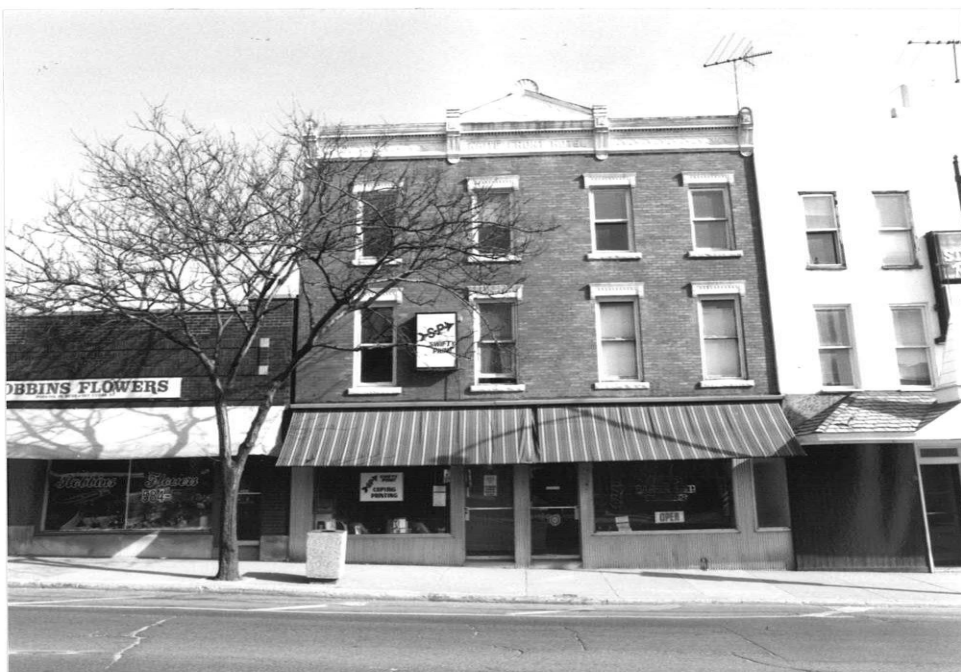
208/210 West Main Street

Elaborate metal cornice and window heads on three story building. First floor clad with aluminum. Extension of the White Front Hotel to the east. Cornice is crowned with a projecting gable and adorned with brackets and inscription.

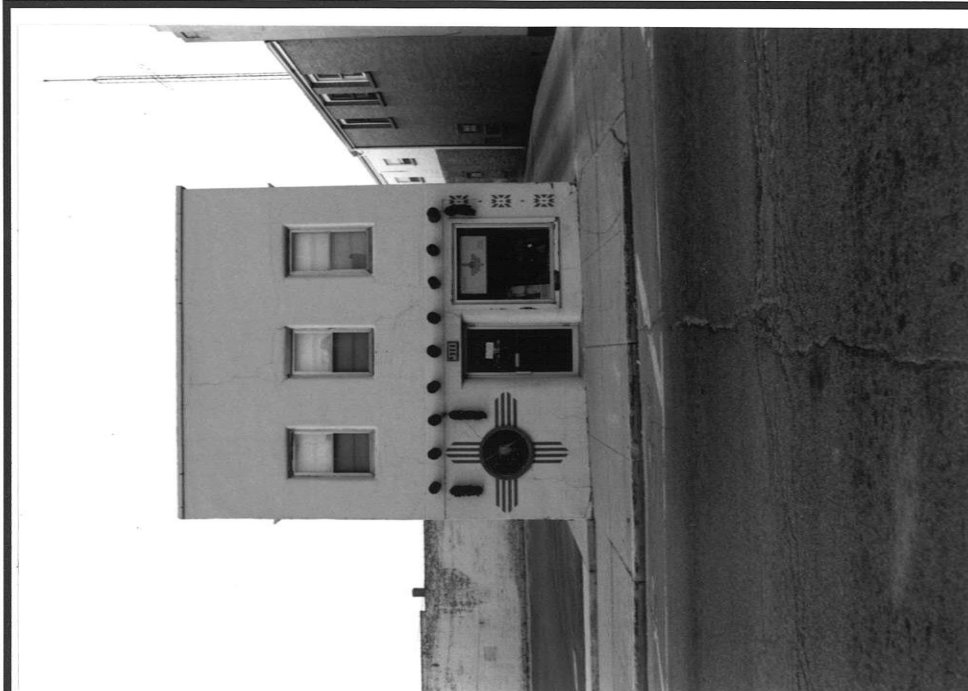
211 West Main Street

Greatly modified two story structure. Cement plaster finish with false log beam projections for appearance as "Southwest" store. Curved walls at entry door and round window at first floor.

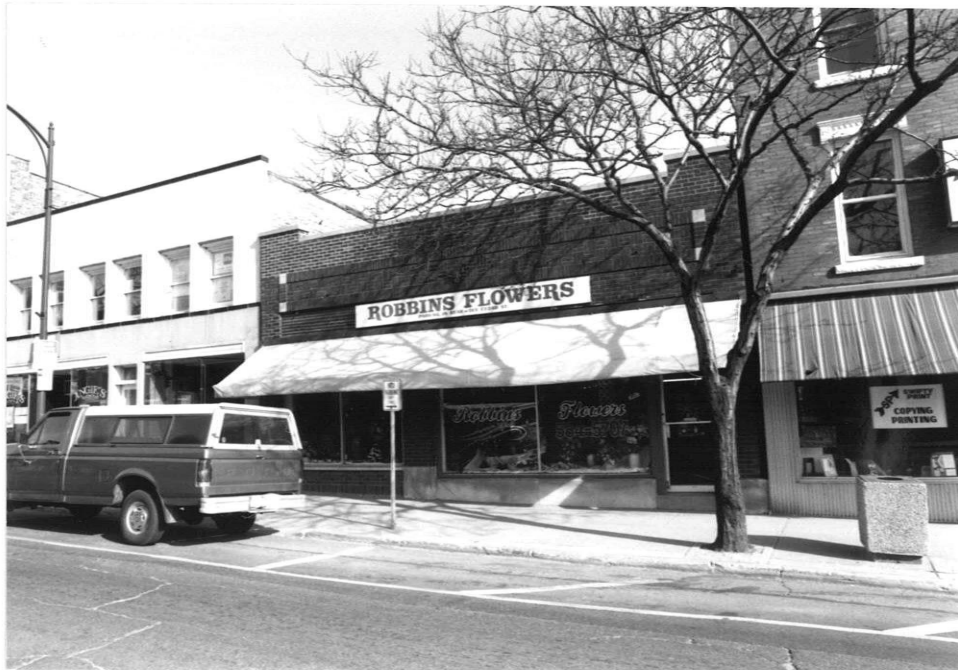
212 West Main Street

Masonry one story structure with stone parapet cap and accents. Recessed panel in upper facade has herringbone brick pattern.

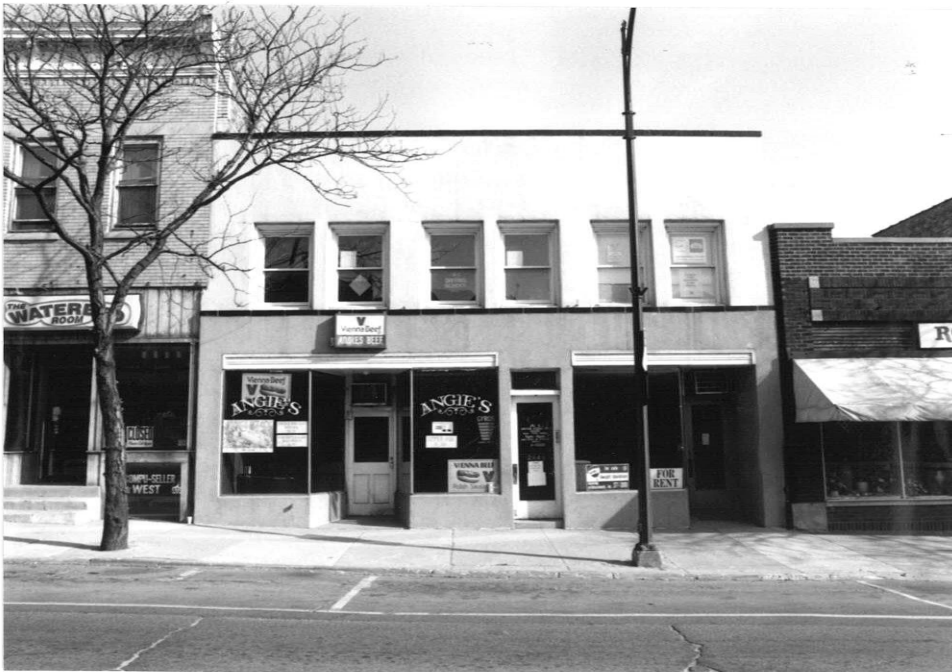
214/216 West Main Street

Two story structure with cement plaster finish added in 1980's.

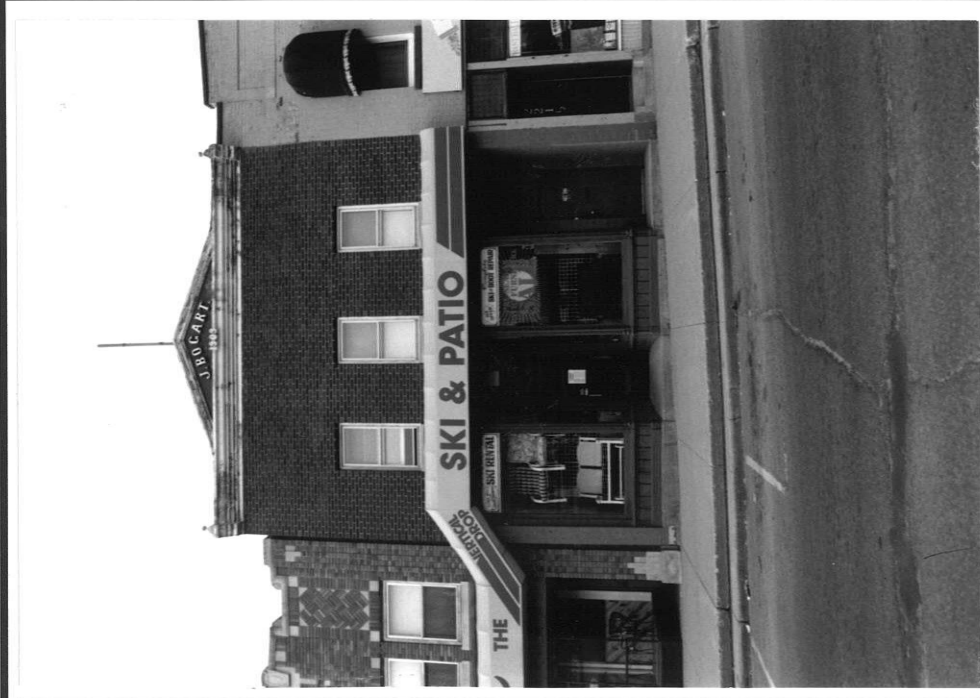
219-219 1/2 W. Main Street

Cast iron storefront extant. Upper level of this two story structure has simple brick facade, unadorned windows. Cornice is metal with small gable. Lettering indicates "J. BOGART" and "1909".

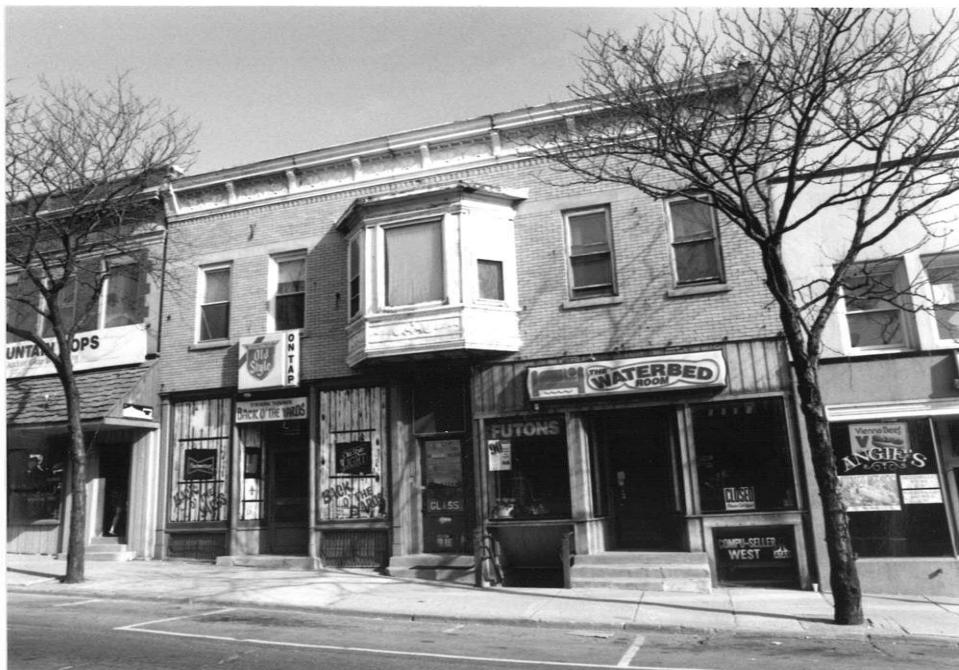
220/222 West Main Street

Two story brick structure with metal cornice and projecting bay window at second floor. Stoneband above second floor windows. Cast iron storefront remains at west store, covered over at east store.

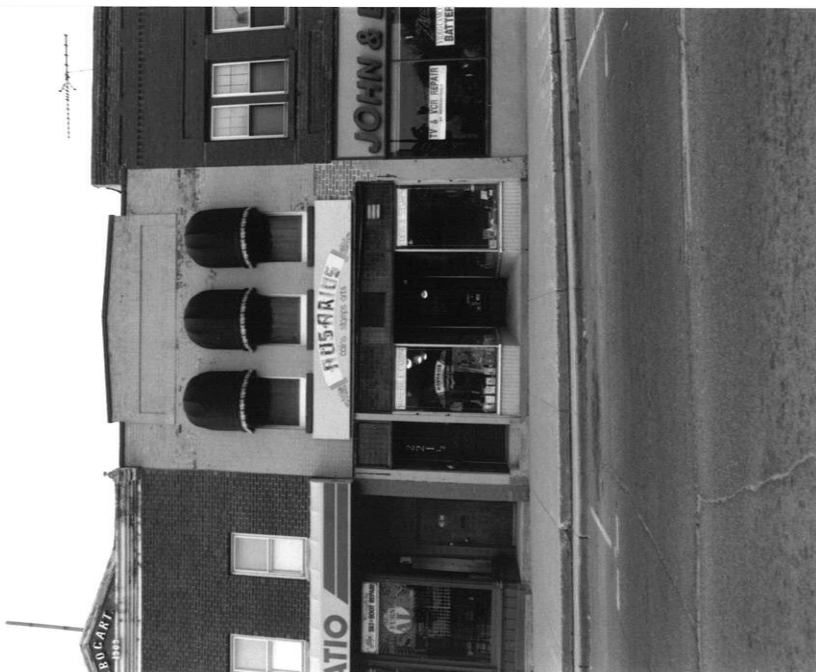
221-221 1/2 W. Main Street

Two story masonry structure with painted brick front.  
 Recessed brick panel at parapet. Recessed entry doors.

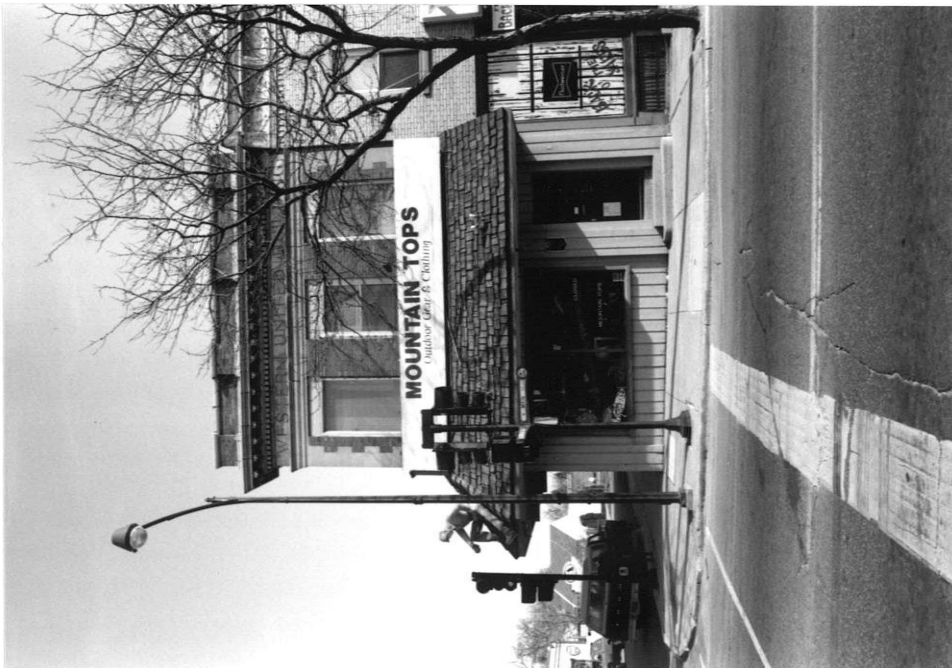
228 West Main Street

Finely detailed stone cornice with brick parapet. Stone quoins at corners of south upper facade with "Western United Building" inscription. Storefront facade greatly modified with wood shake projecting roof and board and batten siding.

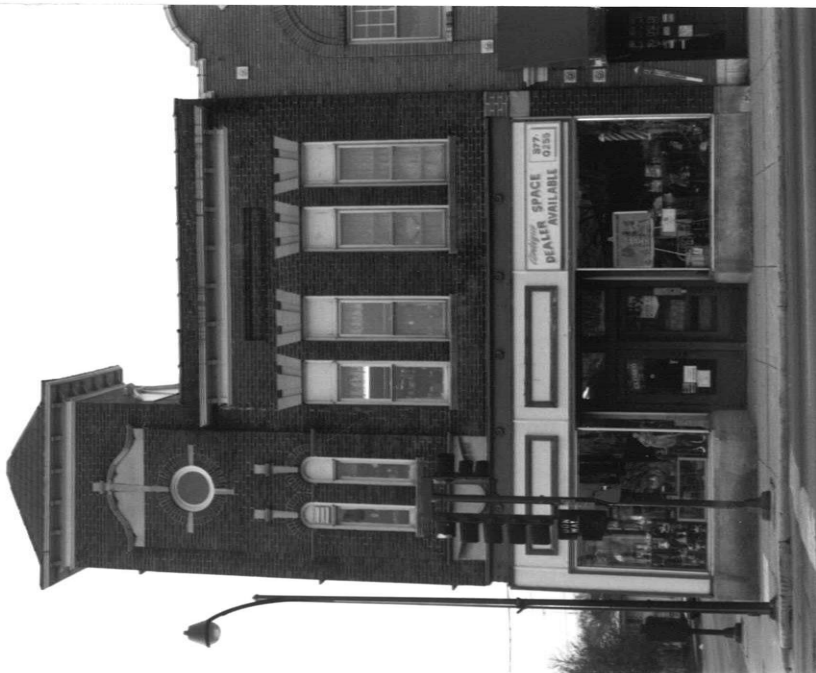
301 West Main Street

**Style:** Italian Renaissance  
**Date of Construction:** ca. 1900  
**Source:** A Field Guide to American Houses  
**Features:**  
Masonry building, brick with significant stone accents above windows. Circle windows, two sides of corner square tower. Tall, narrow windows at second floor. First floor windows at east side with full semi-circle arches.

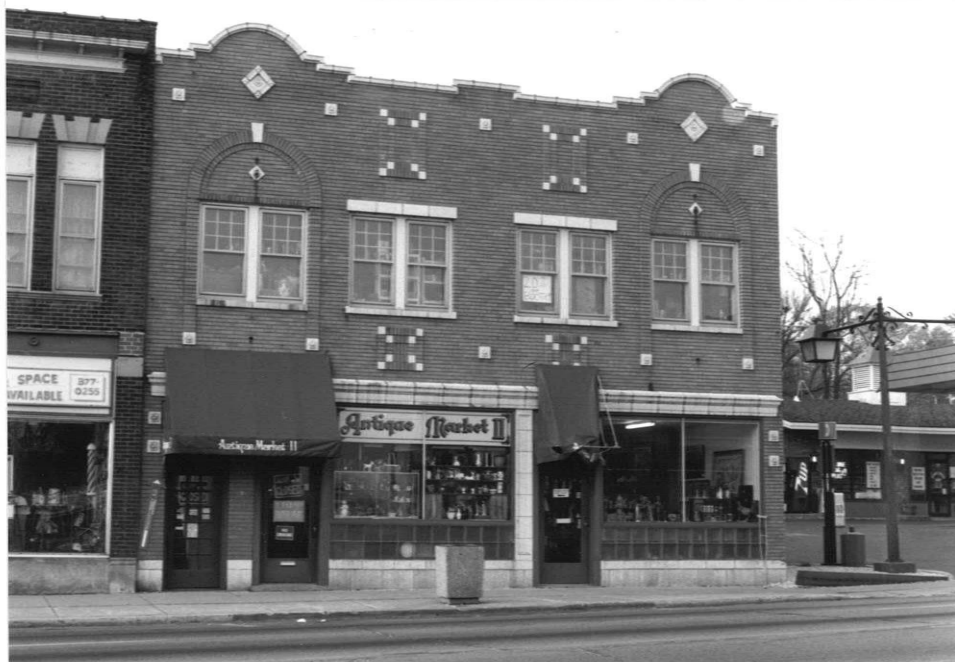
303 West Main Street

Beige terra cotta accents in tan brick facade. Paired double hung windows in upper level with 9 over 1 lites. Decorative terra cotta capped parapet with two curved top sections. Lower facade storefronts trimmed in terra cotta.

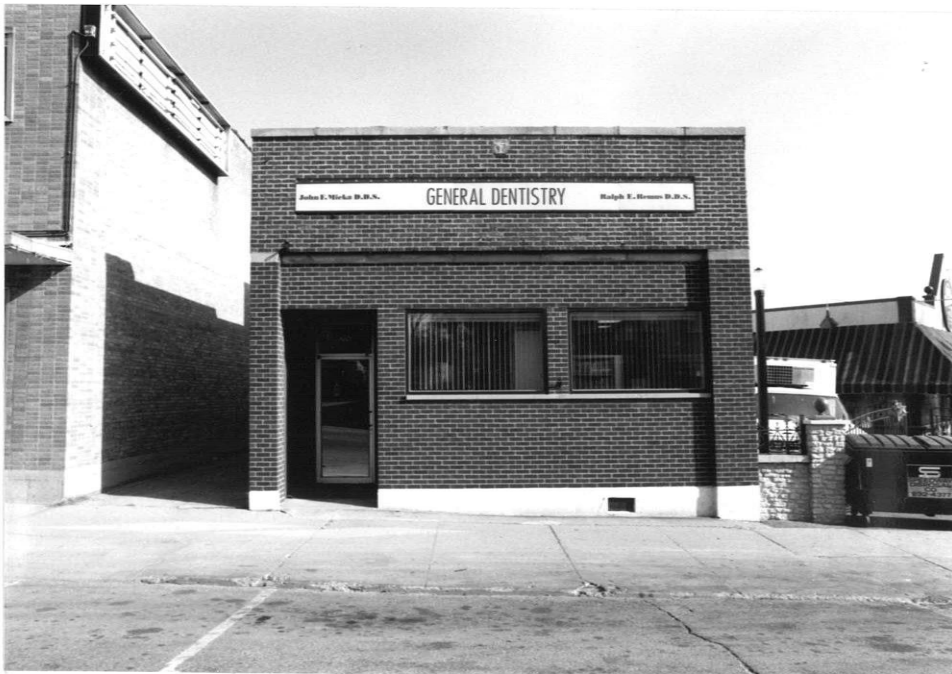
306 West Main Street

Brick facade on one story structure with stone parapet cap. Recessed entry with two high front picture windows. Recessed panel in brick at upper facade.

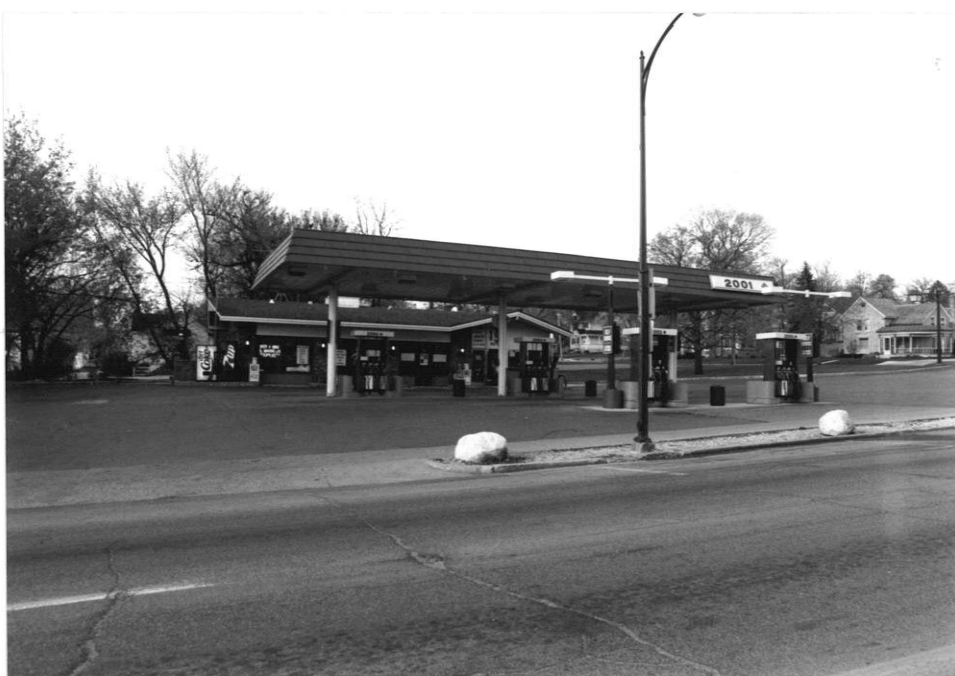
307 West Main Street

Low gabled ranch style building. Mansard canopy over gas pumps added in late 1980's.

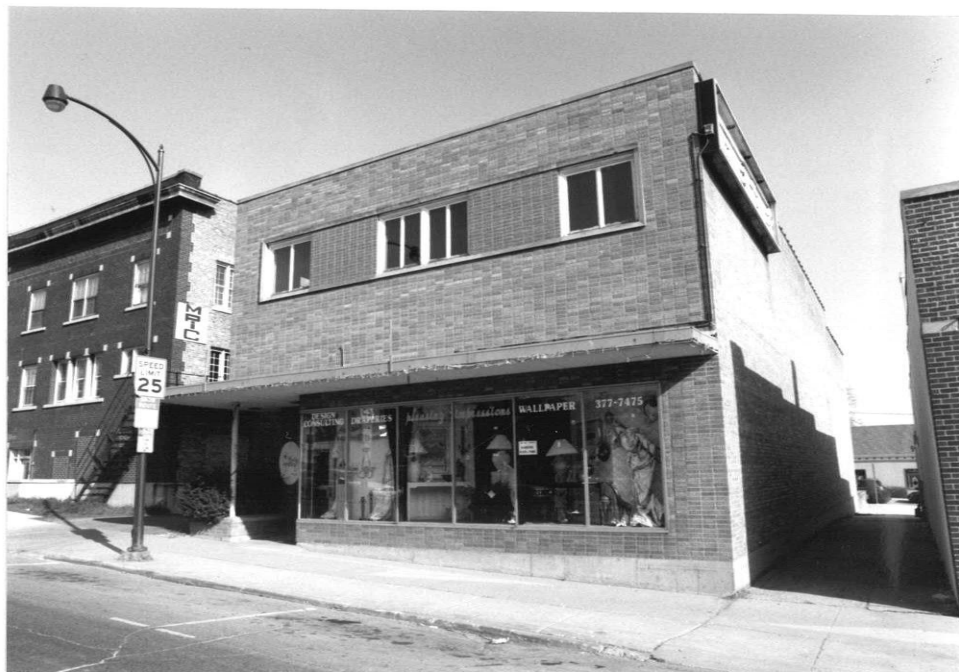
312 West Main Street

Stacked bond brick front, projecting canopy over large plate glass windows, entire width at first level. Second level windows are casement type set in stone surround.

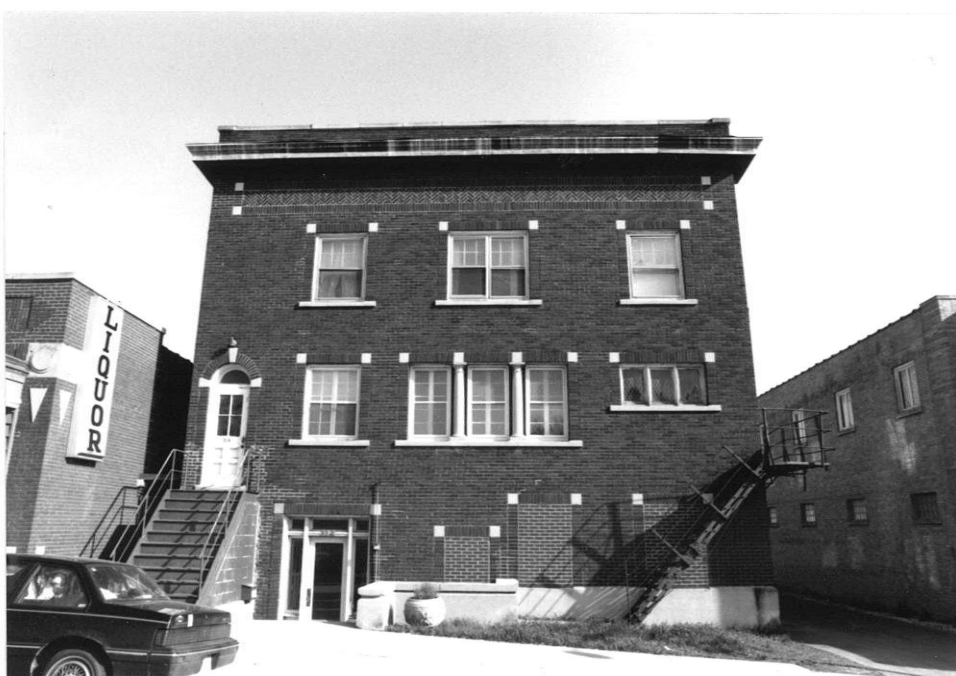
314/316 West Main Street

Built as the Lambert Convalescing Home, became a hospital in 1930. Brick masonry with square limestone accents. Herringbone brick pattern at upper facade panel. Parapet capped with stone. Projecting soffit at roof line. Lower level entry with transom and sidelights. Second level entry with circle top transom.

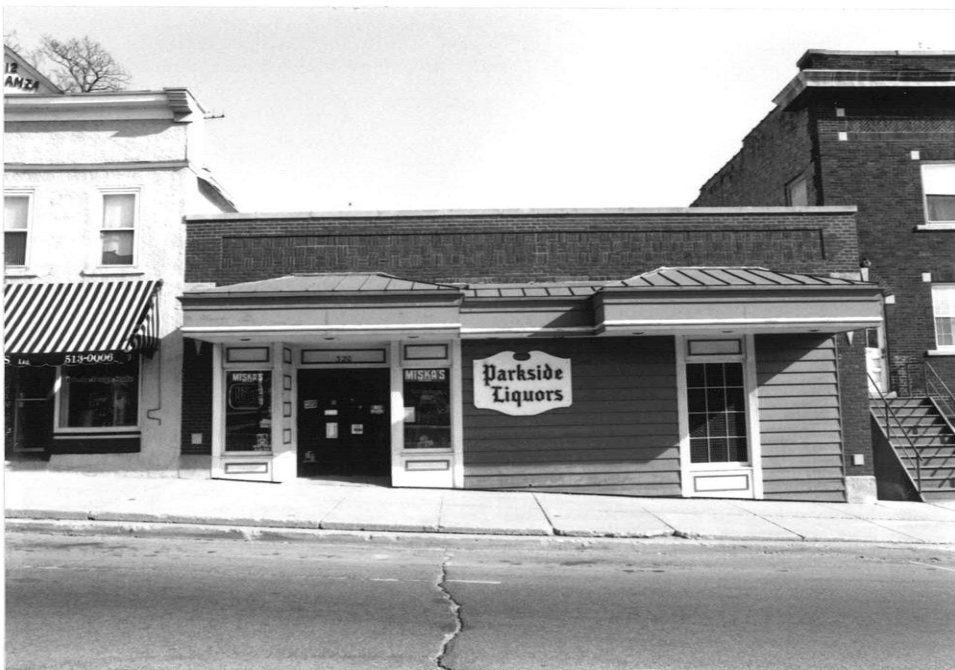
320 West Main Street

Masonry one story structure with stone parapet cap. Recessed panel in upper facade has herringbone brick pattern. Standing seam metal roof canopy over lower facade. Wood sided lower storefront added later. Decorative stone accents at corners.

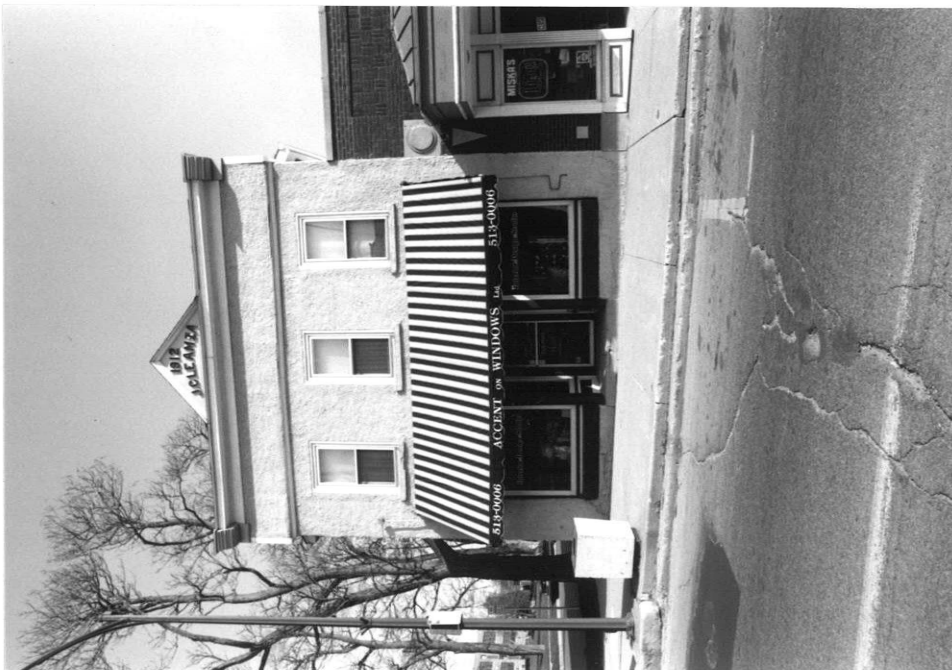
322 West Main Street

Two story gable roofed structure with front parapet. Simple vernacular commercial storefront which perpetrates Late Victorian design in sparer detail. Stucco facing may be over original masonry facade.
