ST. CHARLES HISTORIC PRESERVATION COMMISSION

**ARCHITECTURAL SURVEY**  
**ST. CHARLES CENTRAL DISTRICT**  
**ST. CHARLES, ILLINOIS**

DIXON ASSOCIATES / ARCHITECTS

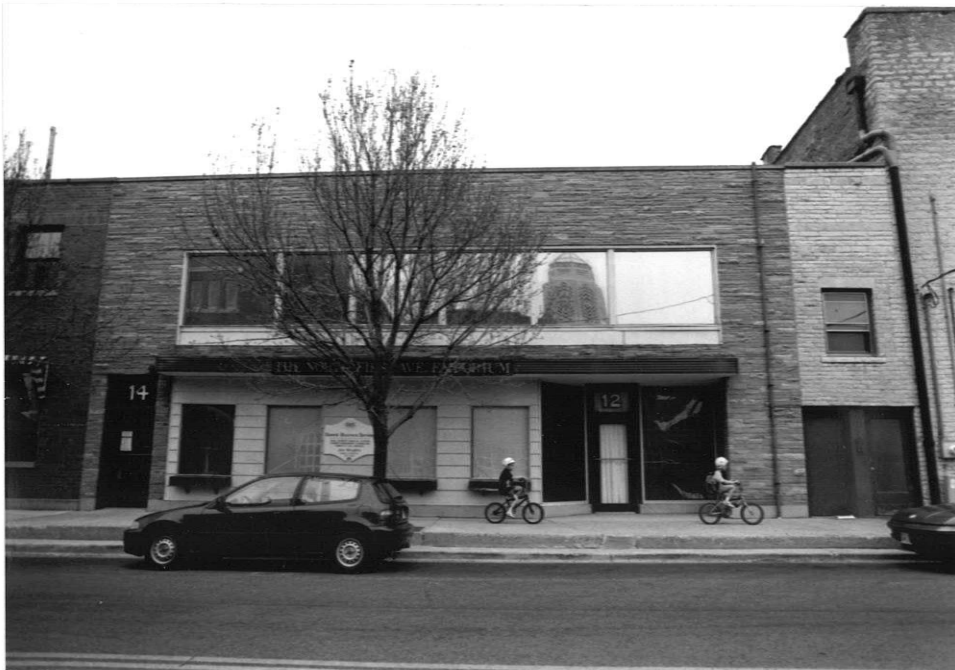
12-14 North 1st Avenue

Two story, greatly modified structure. Synthetic siding at first floor, lannon stone cladding at second floor. Large picture windows at second floor.

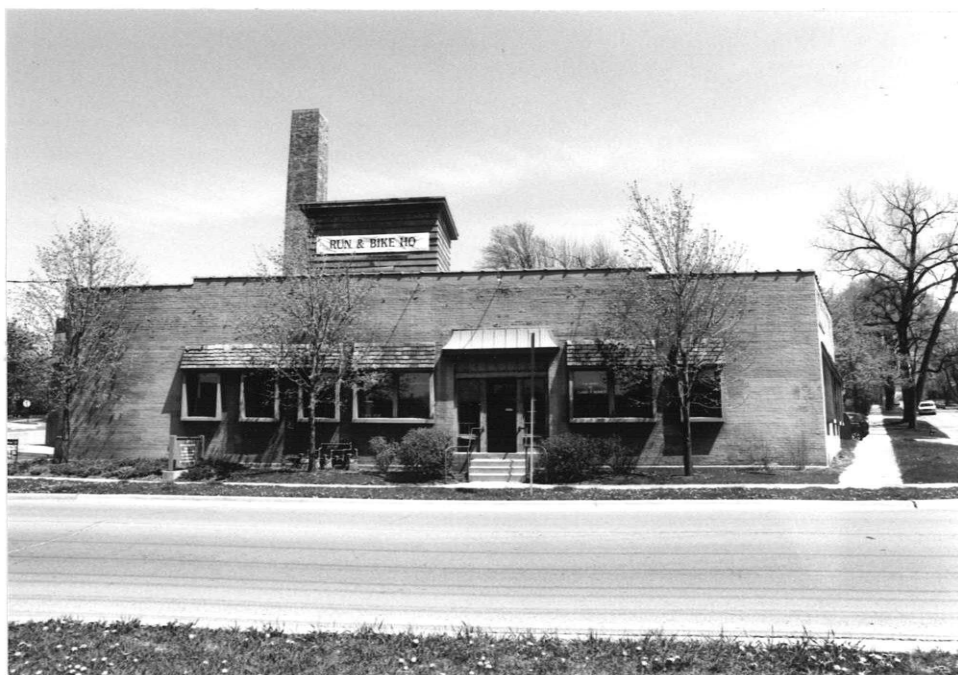
216-218 South 1st Avenue

Former ~~daily~~ building of brick, one story with wood tower and brick chimney.

The building is considered contributing based on its historical use, not architecture.

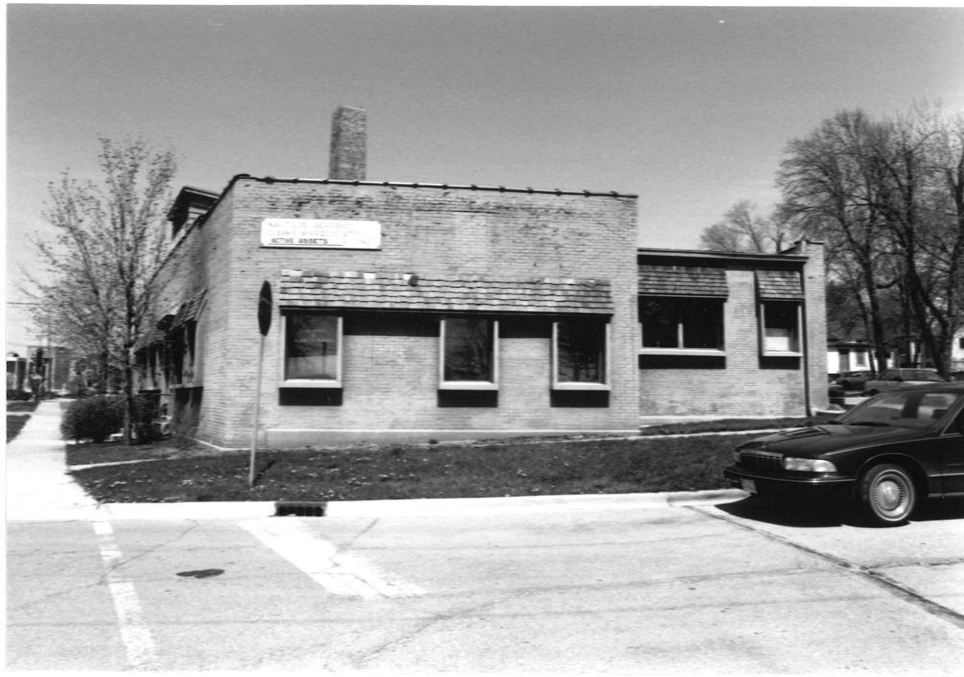
216-218 South 1st Avenue

South Elevation.

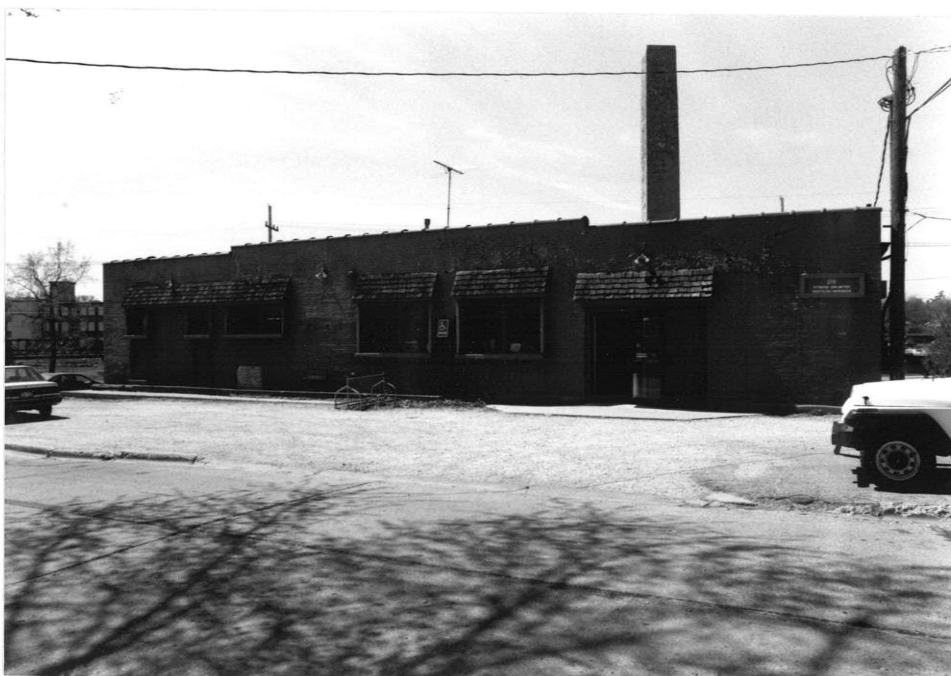
216-218 South 1st Avenue

East Elevation.

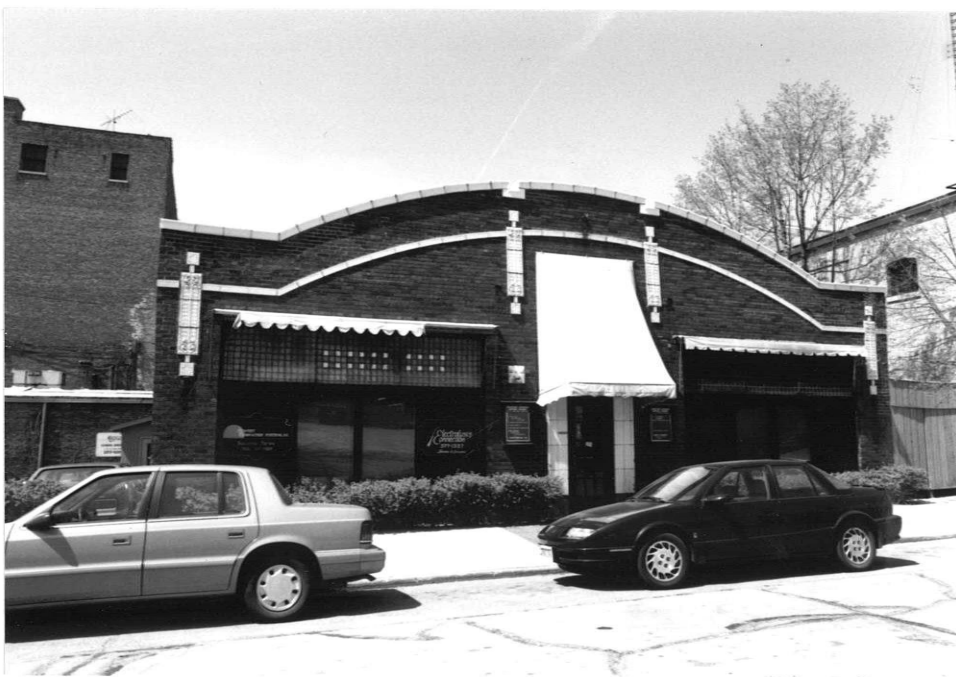
11 South 2nd Avenue

Brick one story building with terra cotta decorative accents and parapet cap. Prism glass transoms over front windows. Bow truss roof reflected in curved top front parapet.

2nd Avenue display windows are not original and do not contribute to the building. The unique architecture contributes to the neighborhood, but does stand out among other buildings.

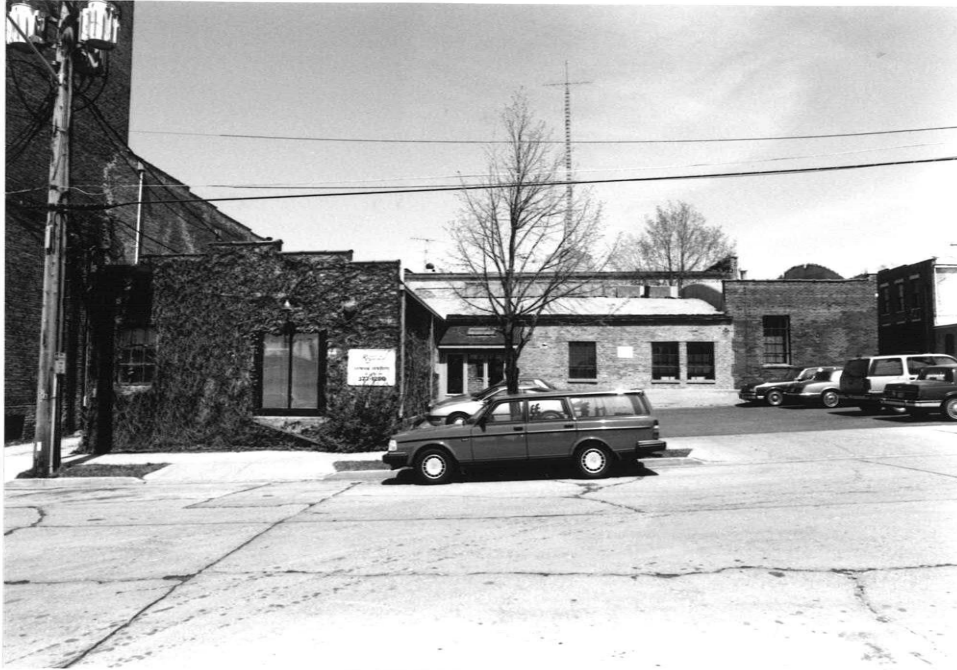
11 South 2nd Avenue

South Elevation.

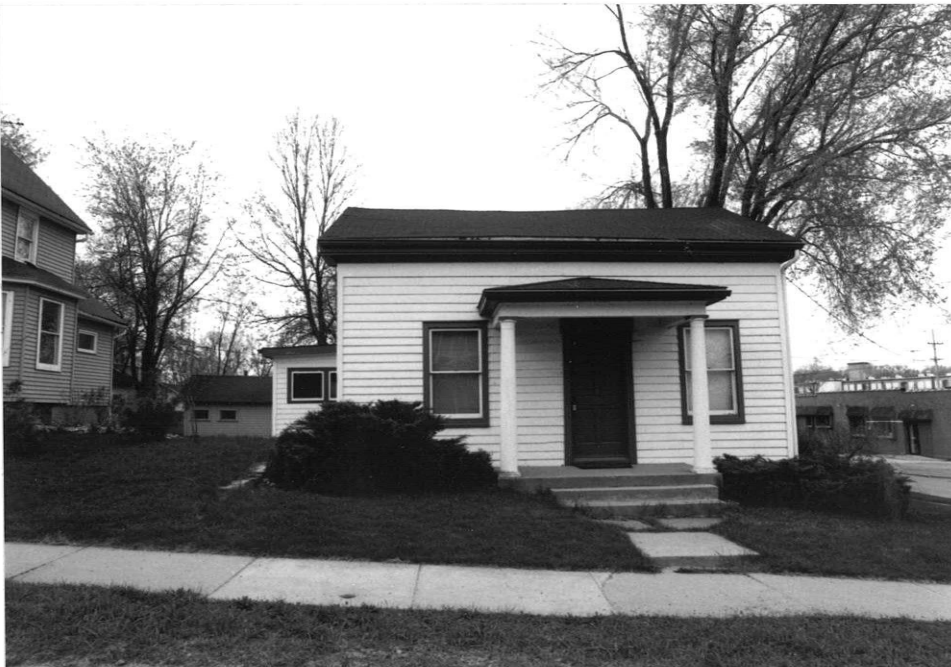
203 East Illinois Avenue

Side gable form. Classical entry porch. Porch details altered. Entry doors and windows have been replaced. Inappropriate shutters have been added.

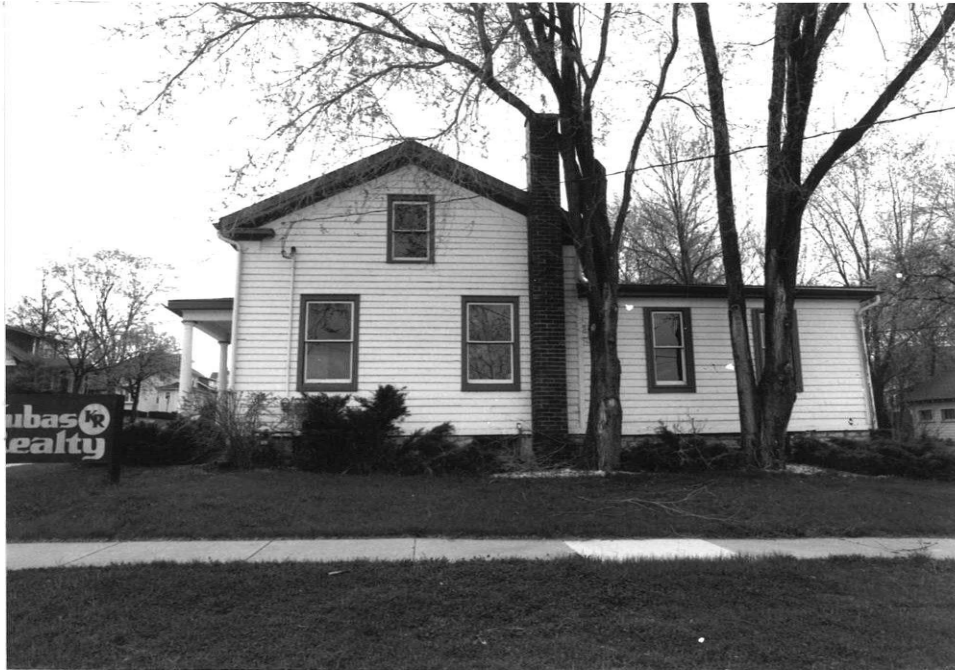
203 East Illinois Avenue

West Elevation

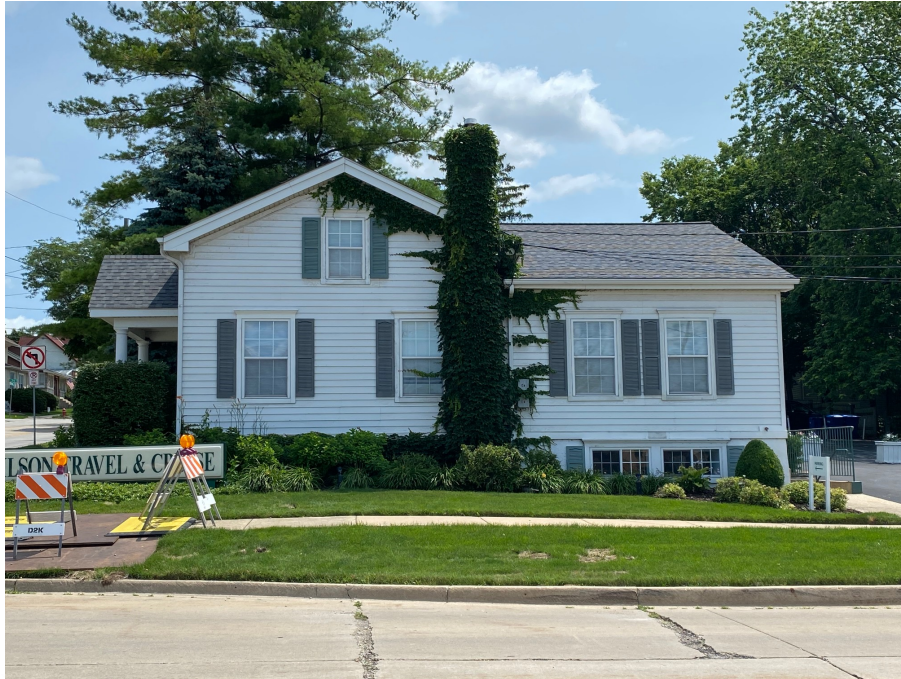
203 Illinois Ave.

West Elevation  
Photo taken 7/21

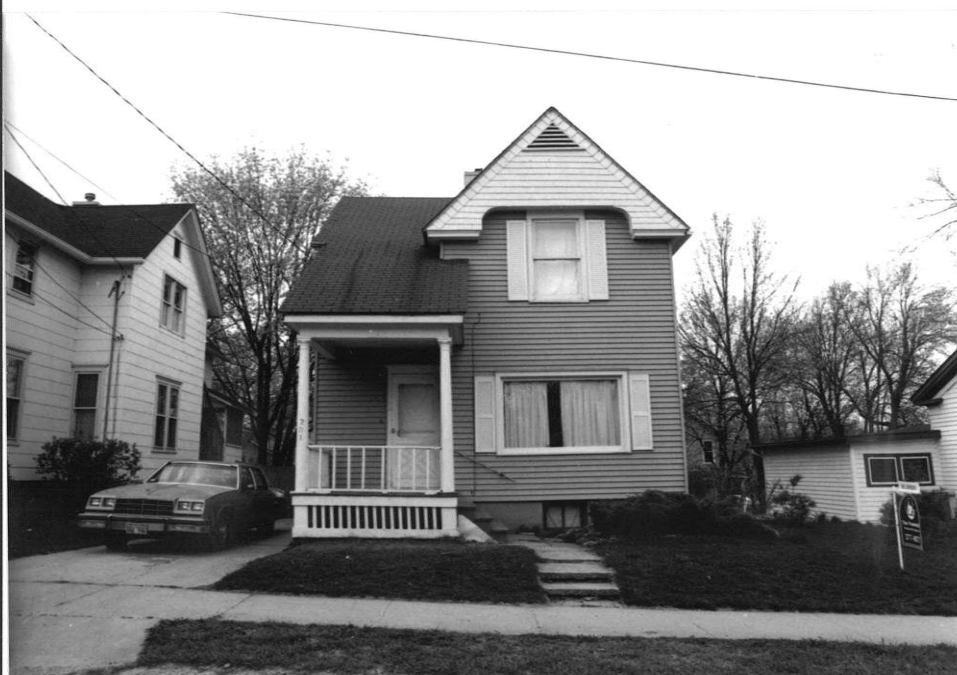
207 East Illinois Avenue

Two-story cross gable structure. Entry porch with shed roof. Projecting gable end with wood shingles.

Inappropriate picture window was removed and replaced with a more sympathetic size.

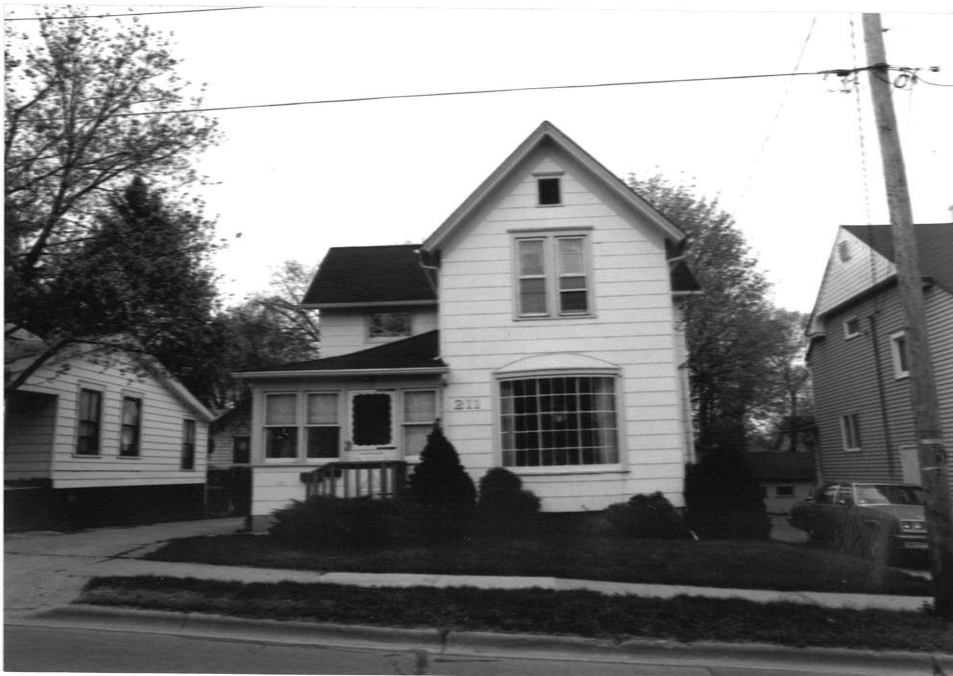
211 East Illinois Avenue

Two-story cross gable structure. Enclosed entry porch. Contributing picture window was added to the front of the house.

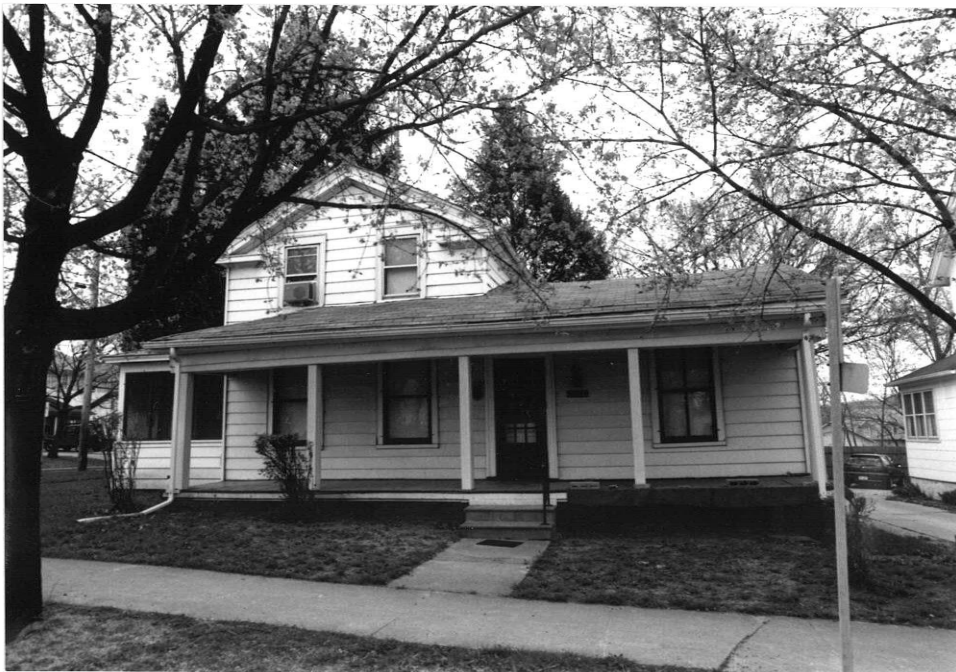
215 East Illinois Avenue

Gable front and wing form. Horizontal siding. Details have been removed or altered. Full width porch with shed roof. One story additions to side and rear. Horizontal synthetic siding.

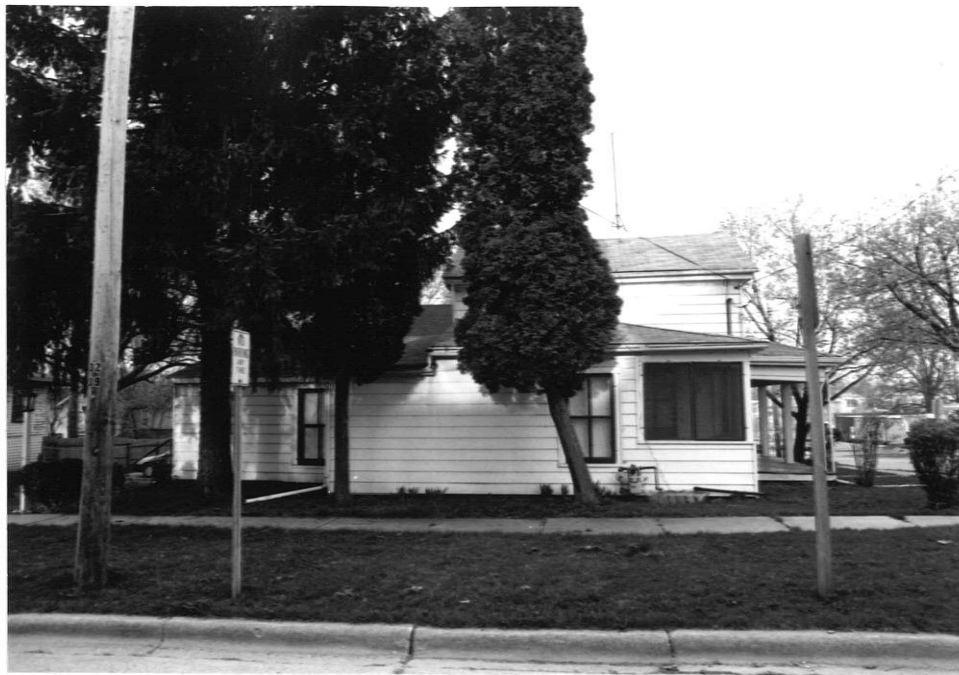
215 East Illinois Avenue

East Elevation
