ST. CHARLES HISTORIC PRESERVATION COMMISSION

ARCHITECTURAL SURVEY ST. CHARLES CENTRAL DISTRICT ST. CHARLES, ILLINOIS

DIXON ASSOCIATES / ARCHITECTS

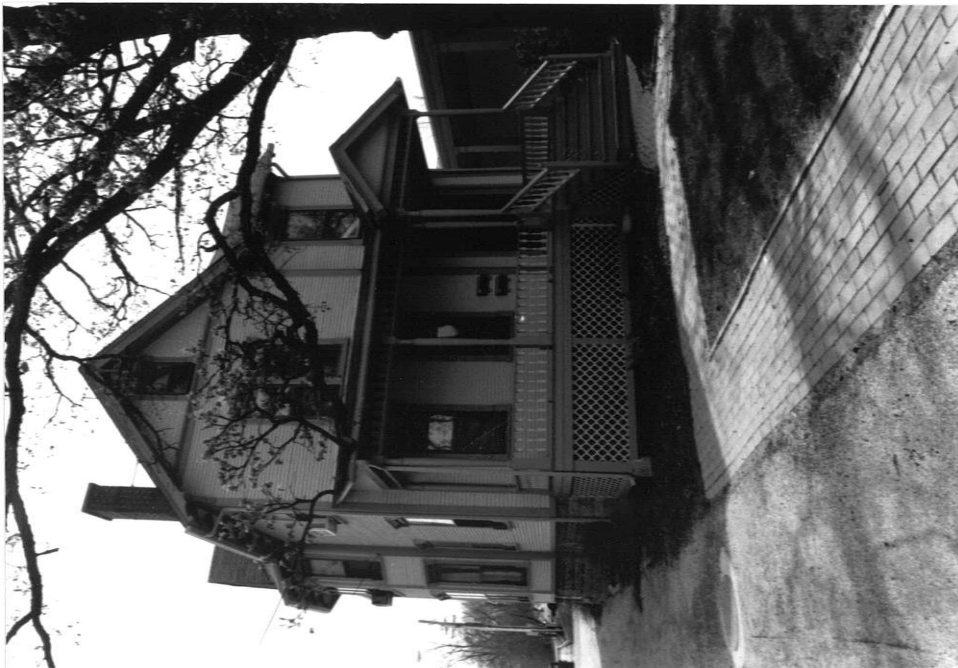
213 West Walnut Street

Style: Stick

Date of Construction: 1860-1890

Gabled roof, steeply pitched with cross gables. Decorative elements at apex of gables. Overhanging eaves. Shingles at gables, 4" exposure wood clapboard siding. Full width front porch with gable accent at entry stair.

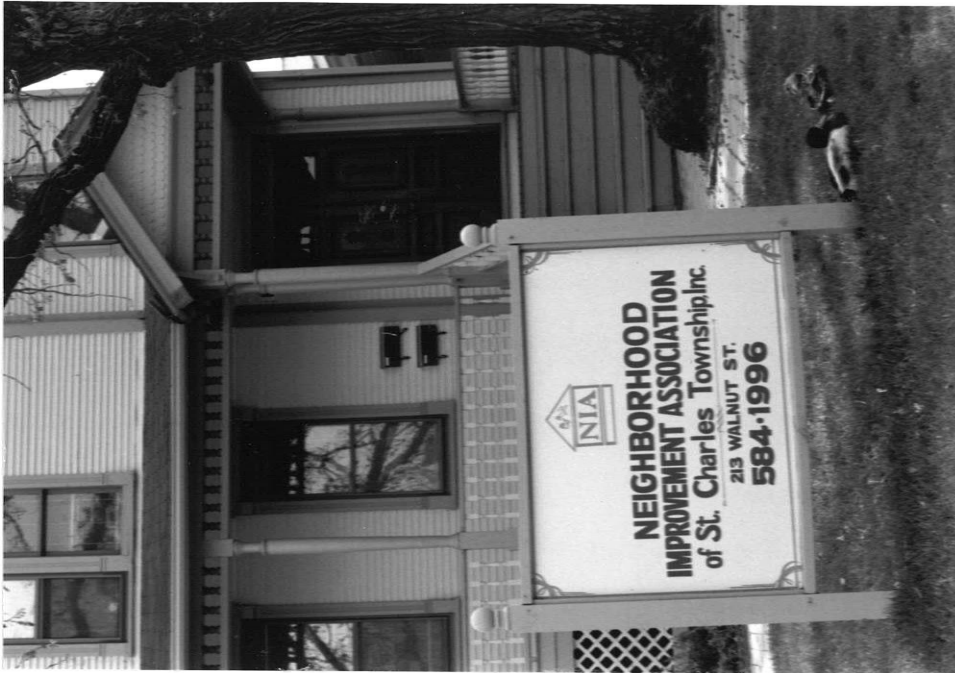
213 West Walnut Street

North Elevation

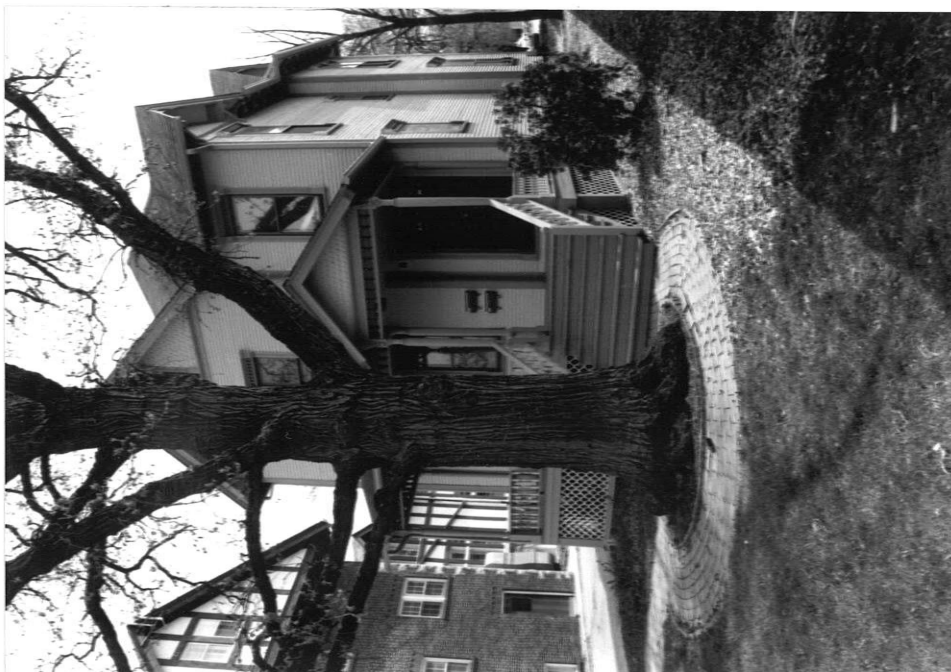
213 West Walnut Street

North Elevation

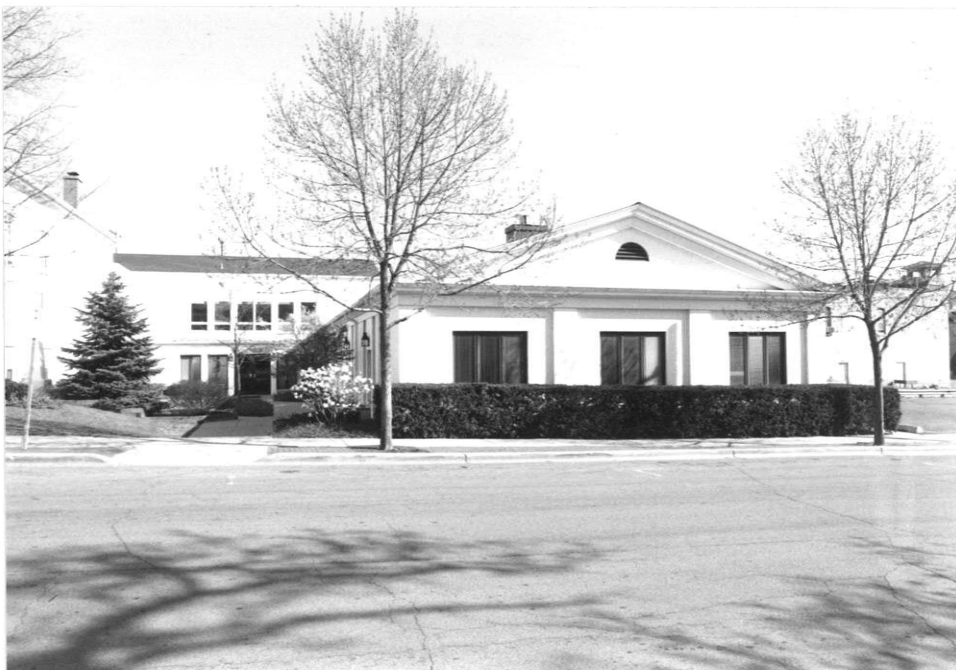
214 West Walnut Street

Style: Neocolonial

Date of Construction: 1960-1970's

Front gable roof, single story masonry structure built to be compatible with Greek Revival Congregational Church. Three pairs of triple casement windows. Semi-circular louver in gable.

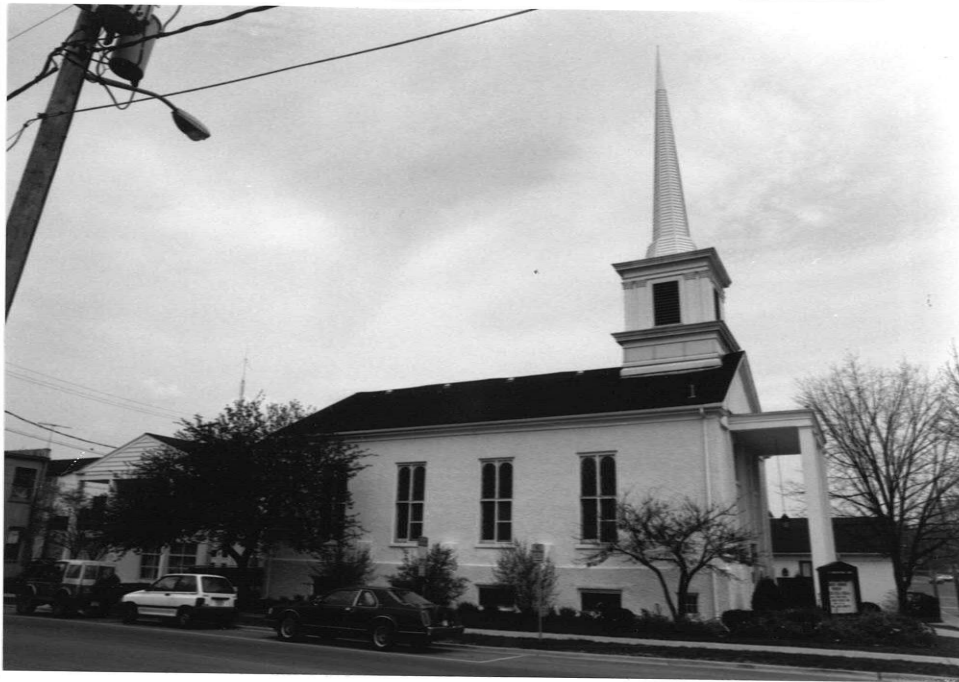
214 West Walnut Street

West Elevation

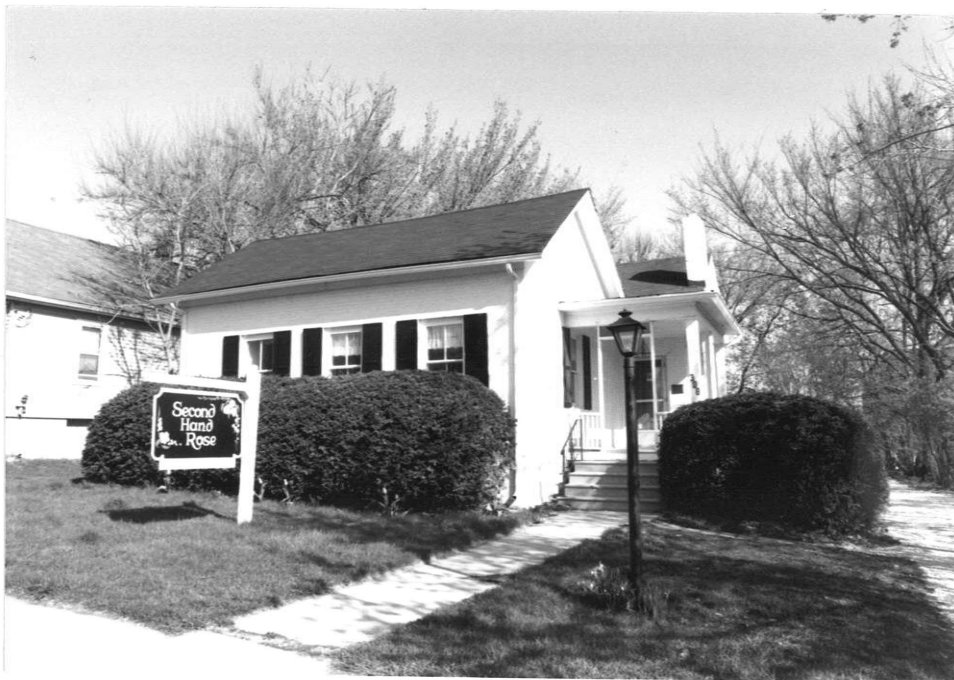
308 West Walnut Street

Style: Greek Revival

Date of Construction: 1845

Simple two over two windows in gable roofed, painted brick structure. Rear gable roofed structure apparently added later.

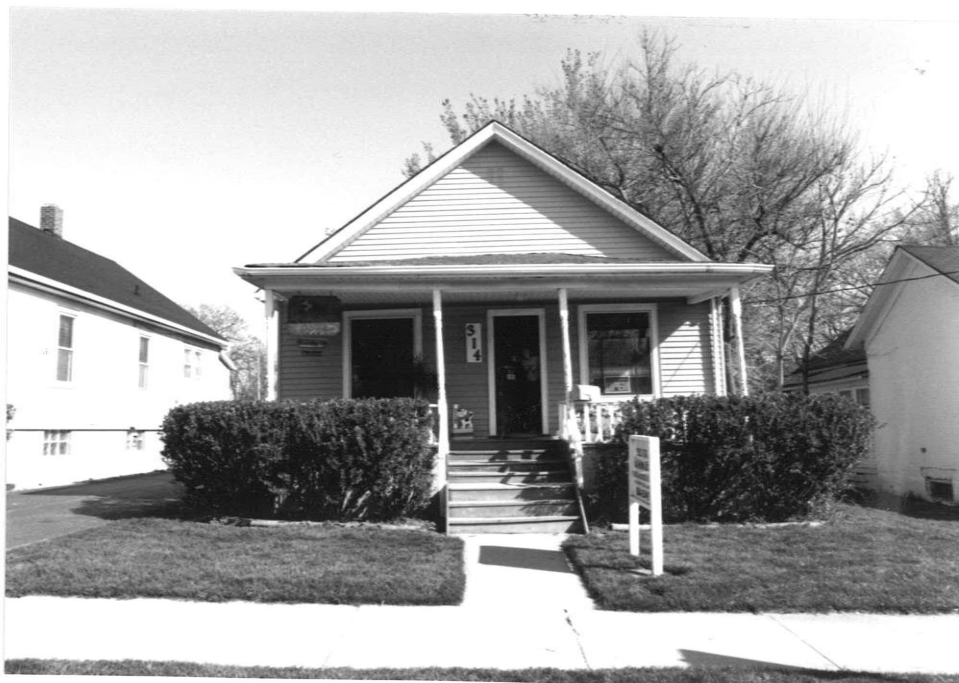
314 West Walnut Street

Style: Greek Revival

Date of Construction: 1850's-1870's

One story front gabled roof. Lean-to shed addition at rear. Two large front windows suggest Victorian influence. Full width front porch.

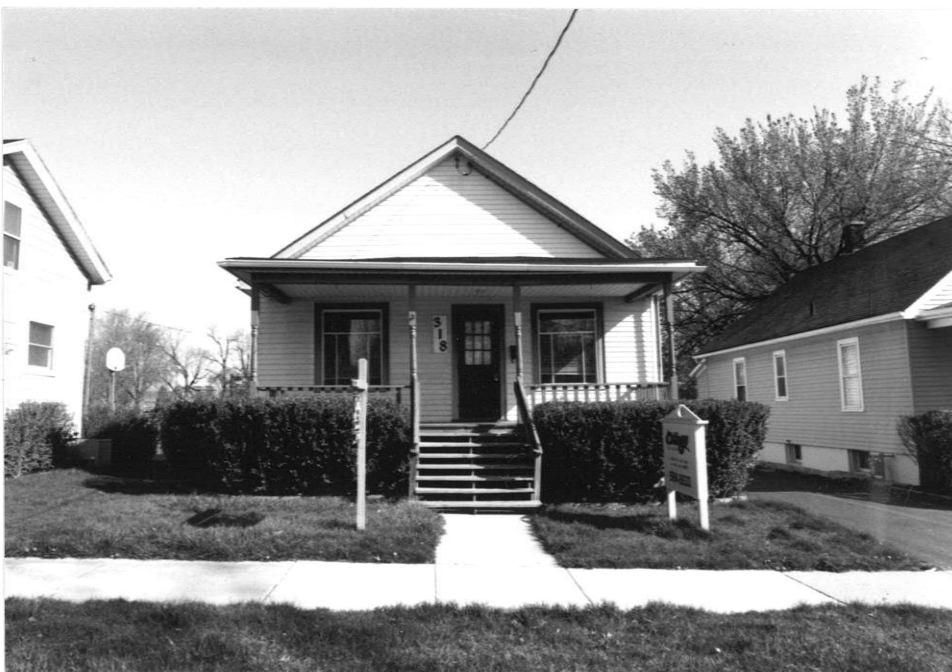
318 West Walnut Street

Style: Greek Revival

Date of Construction: 1850's-1870's

One story front gabled roof. Lean-to shed addition at rear. Two large front windows suggest Victorian influence. Full width front porch.

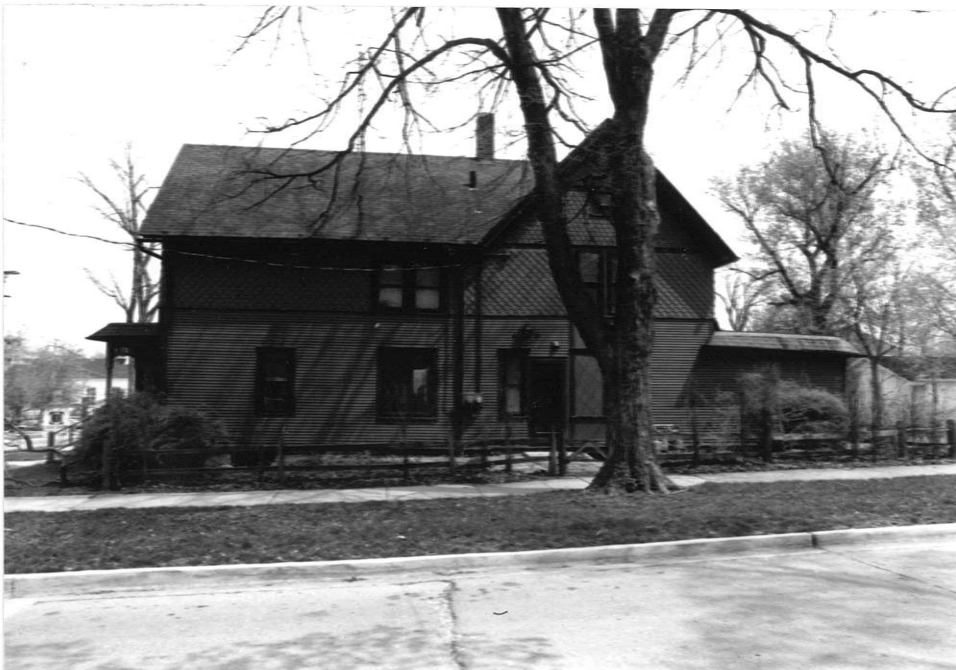
325 West Walnut Street

Style: Stick

Date of Construction: 1860-1890

Shingle texture at upper level. Cross gable roofs. 4" clapboard siding.

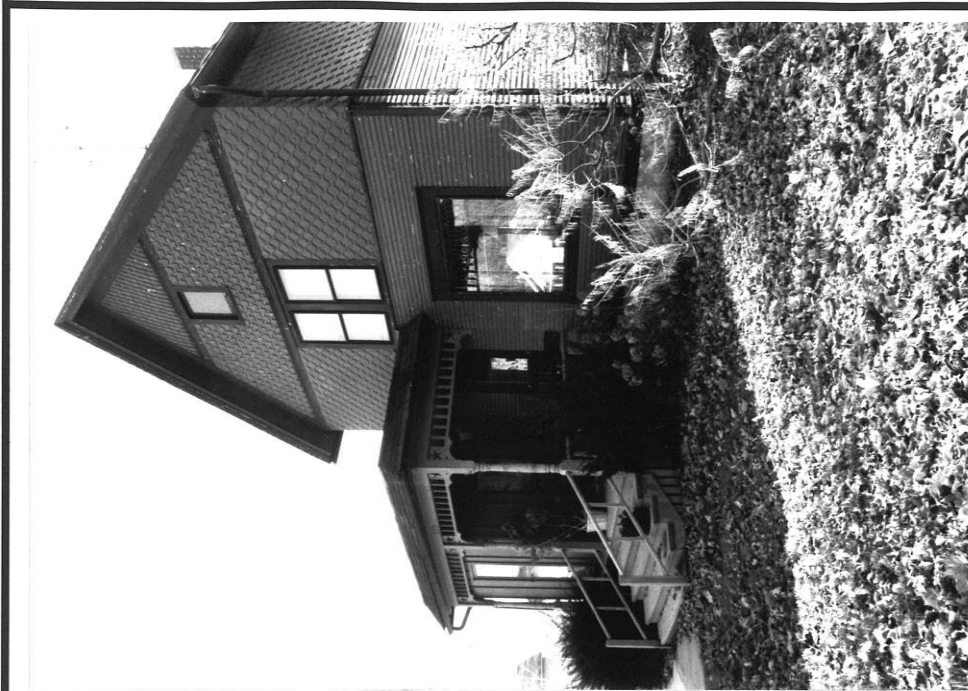
325 West Walnut Street

North Elevation

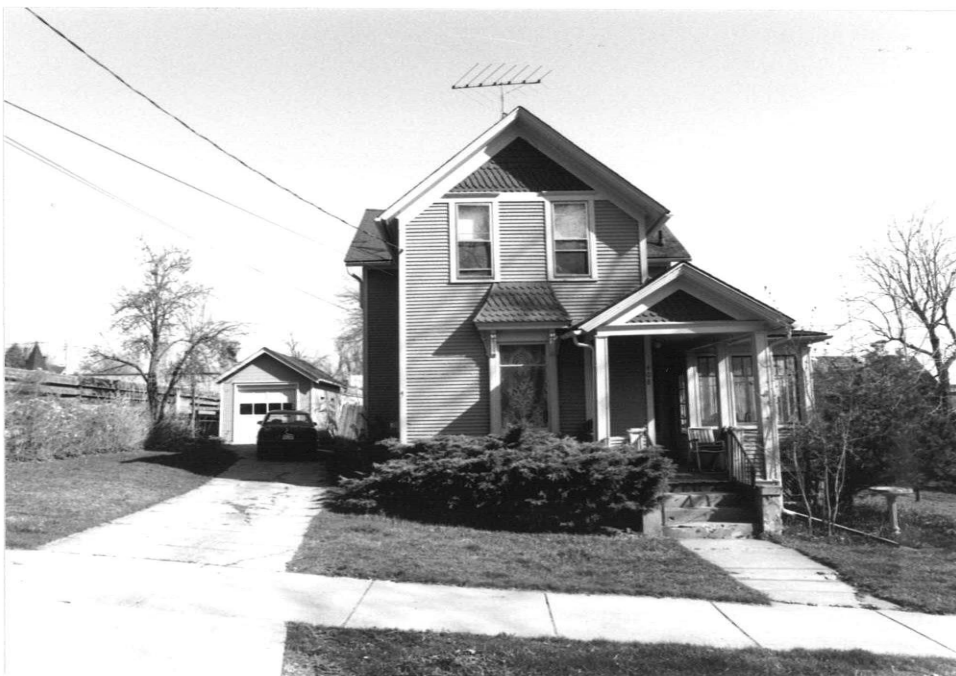
408 West Walnut Street

Style: Queen Anne

Date of Construction: 1890's

Steeply hipped gable roof with cross gable. Textured shingles in gable ends and over box bay window at front. 4" clapboard siding. Projecting gable porch.

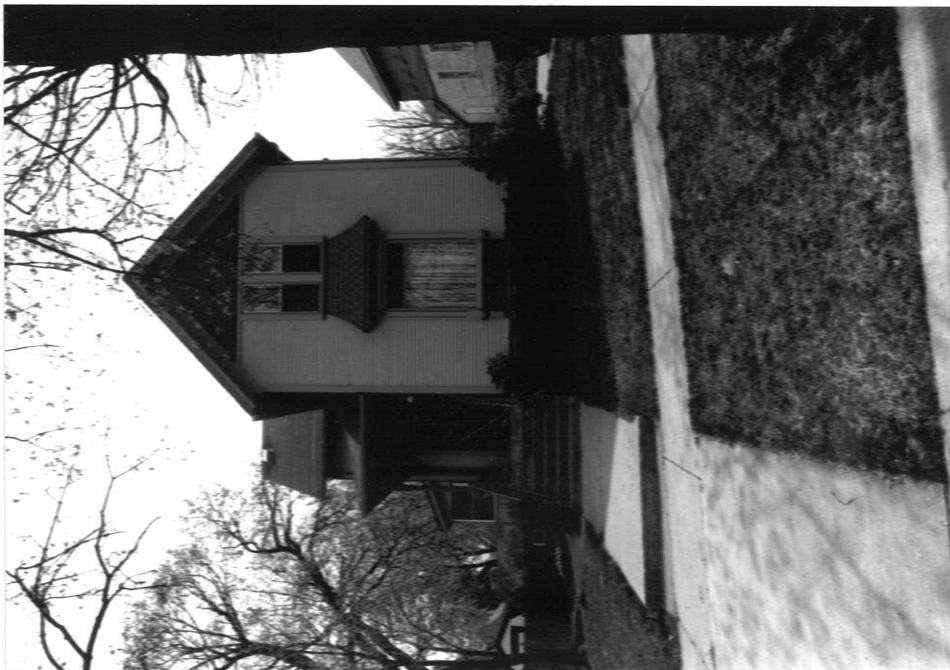
409 West Walnut Street

Style: Stick

Date of Construction: 1860-1890

Steeply pitched front gabled roof with double window at second floor and picture window with shingled hood on first floor. Shingle texture in gable.

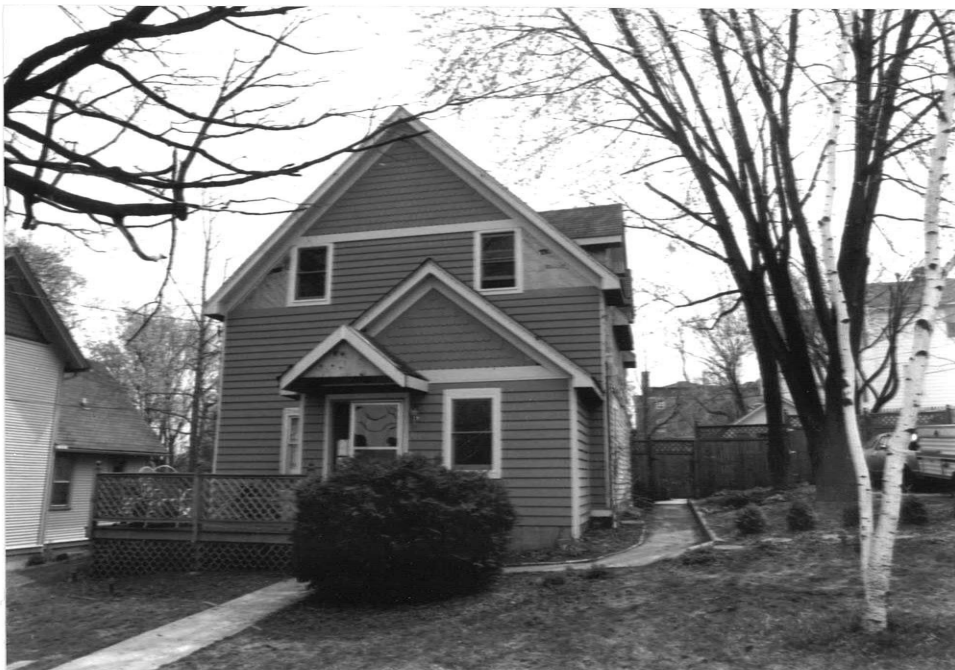
413 West Walnut Street

Style: Stick

Date of Construction: 1860-1890

Front gabled roof with shingle texture in gable.

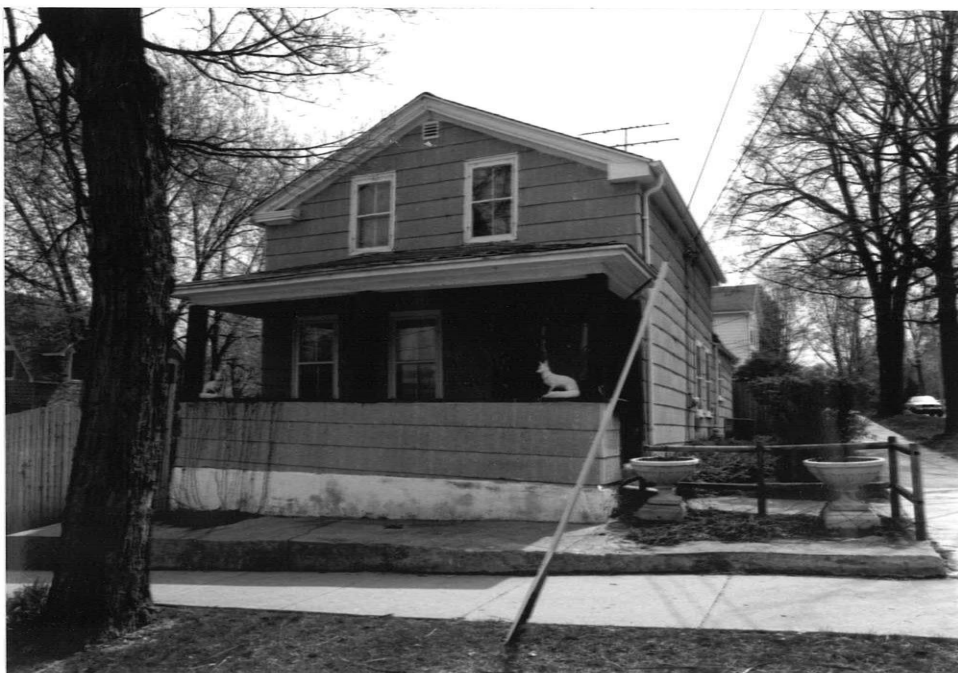
423 West Walnut Street

Style: Greek Revival

Date of Construction: 1825-1860

Front gabled roof on one and one-half story building.
Full width front porch. House clad with synthetic siding.

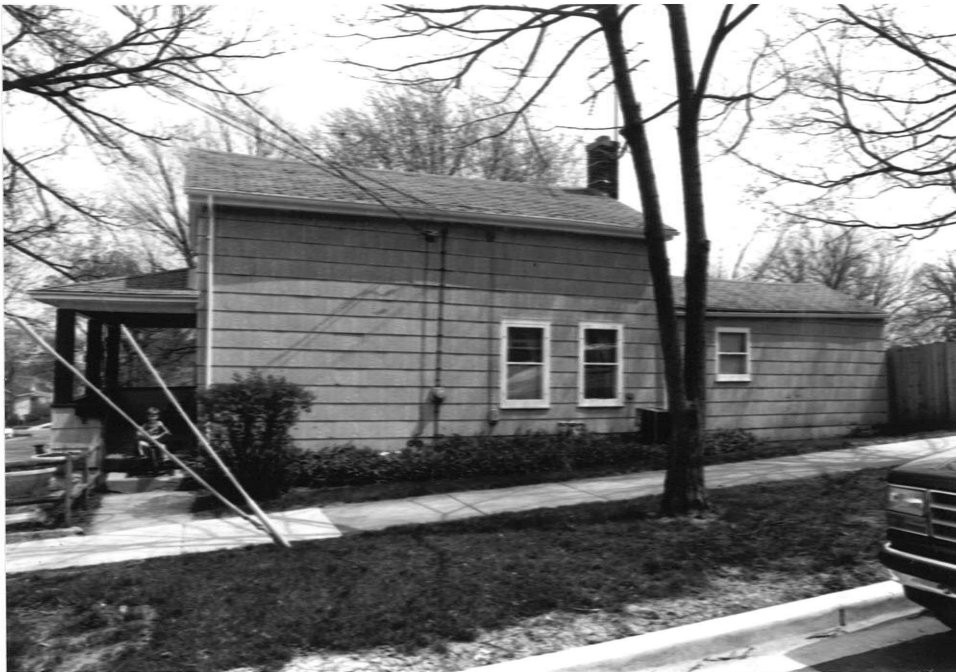
423 West Walnut Street

West Elevation.
