2.5 Wood Structure Exteriors

Siding, Trim and Architectural Elements

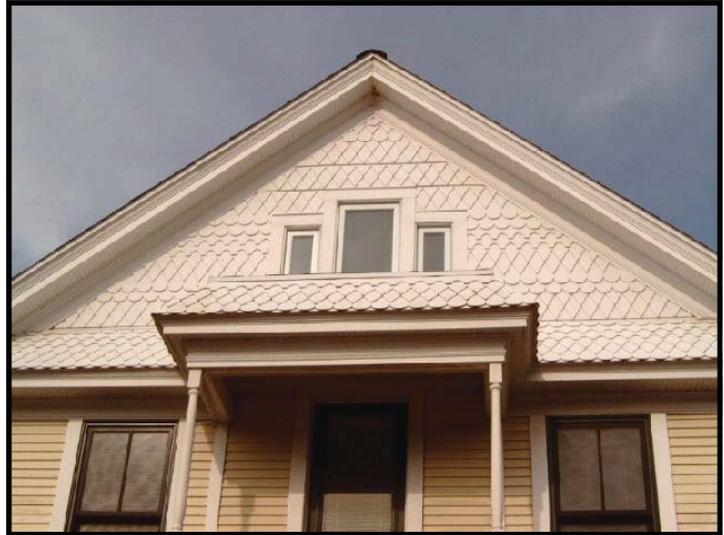
Common wood siding types

- Vertical Board and Batten
- Weatherboard: beveled clapboard, ship-lap, tongue-in-groove
- Shingles: beveled square end, beveled pattern end, split shake

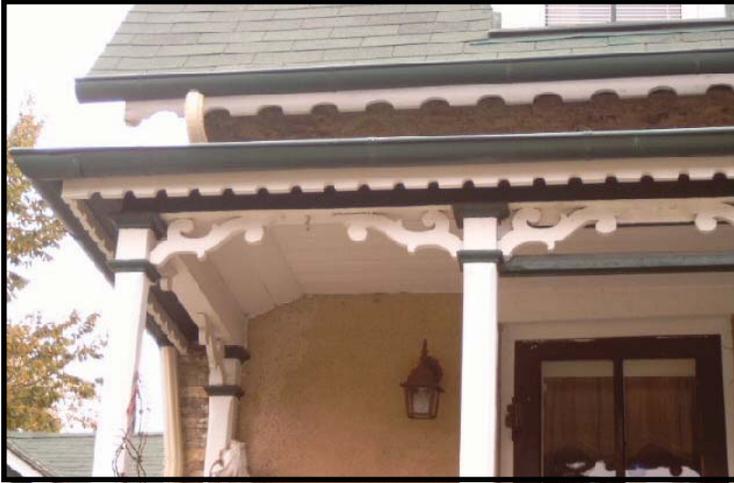
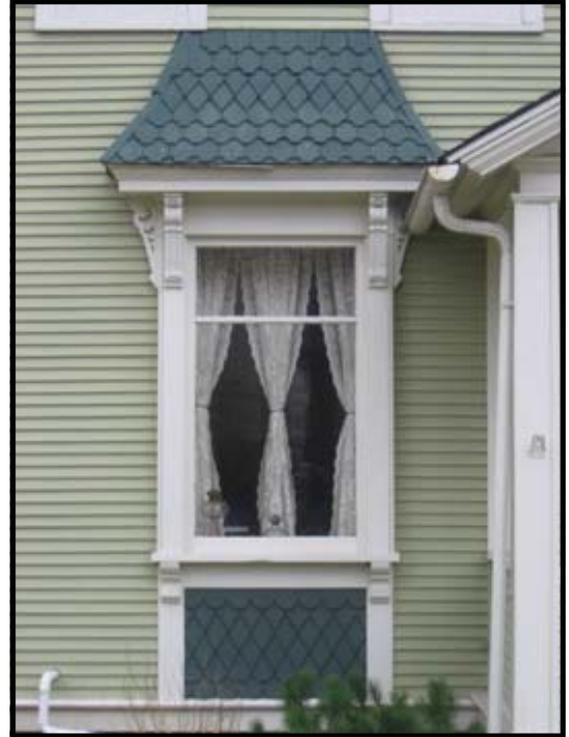
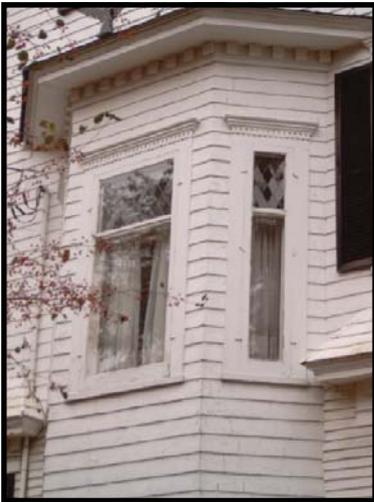
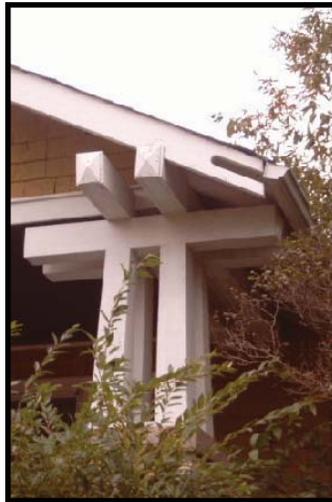
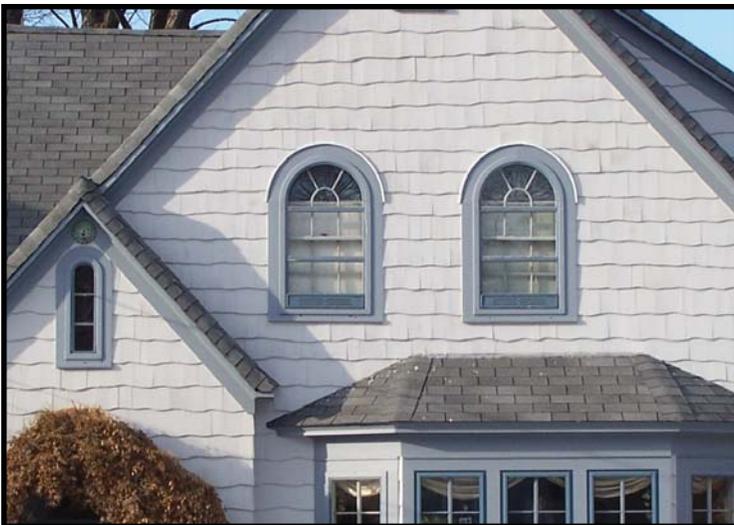
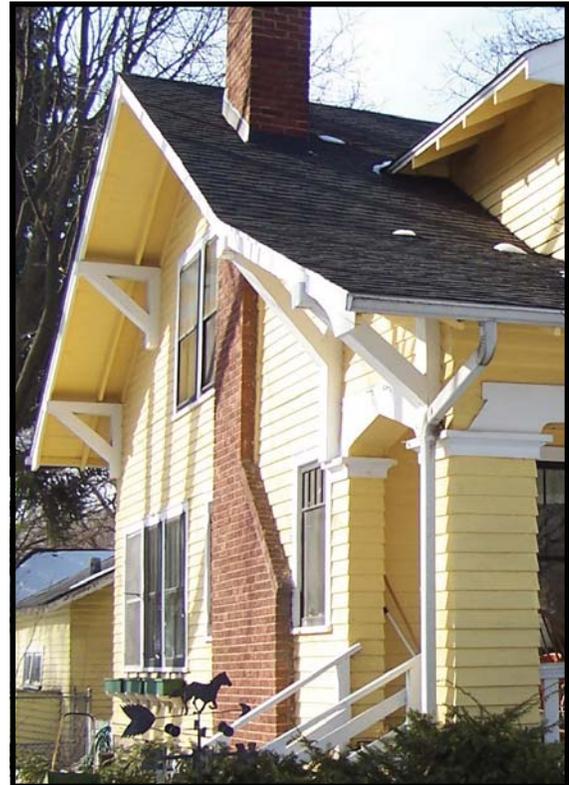
Wood Materials on Historic Buildings

Wood materials in an array shapes, textures and designs are used in historic buildings for both functional and decorative purposes. The unique designs and patterns found in wood exteriors greatly contribute to the historic or architectural character of a building.
