<b>HISTORIC PRESERVATION COMMISSION AGENDA ITEM EXECUTIVE SUMMARY</b>				
  <b>CITY OF ST. CHARLES</b> ILLINOIS • 1834	<b>Agenda Item Title/Address:</b>	COA: 217 Cedar Ave		
	<b>Significance:</b>	Contributing		
	<b>Petitioner:</b>	Baker Memorial Church		
	<b>Project Type:</b>	Doors		
	<b>PUBLIC HEARING</b>		<b>MEETING 2/15/23</b>	<b>X</b>
<b>Agenda Item Category:</b>				
	Preliminary Review		Grant	
X	Certificate of Appropriateness (COA)		Other Commission Business	
	Landmark/District Designation		Commission Business	
<b>Attached Documents:</b>		<b>Additional Requested Documents:</b>		
Application, door information, photo, architectural survey				
<b>Project Description:</b>				
<ul style="list-style-type: none"> <li>A man door was installed in the middle of the garage door.</li> </ul>				
<b>Staff Comments:</b>				
Work was done without a permit. Commission tabled the item at the last meeting until the applicant could be present. Commission discussed adding siding to the garage door to make the building look more like a shed.

Re: 217 Cedar Avenue, St. Charles, IL 60174  
To whom it may concern,

### SCOPE OF WORK

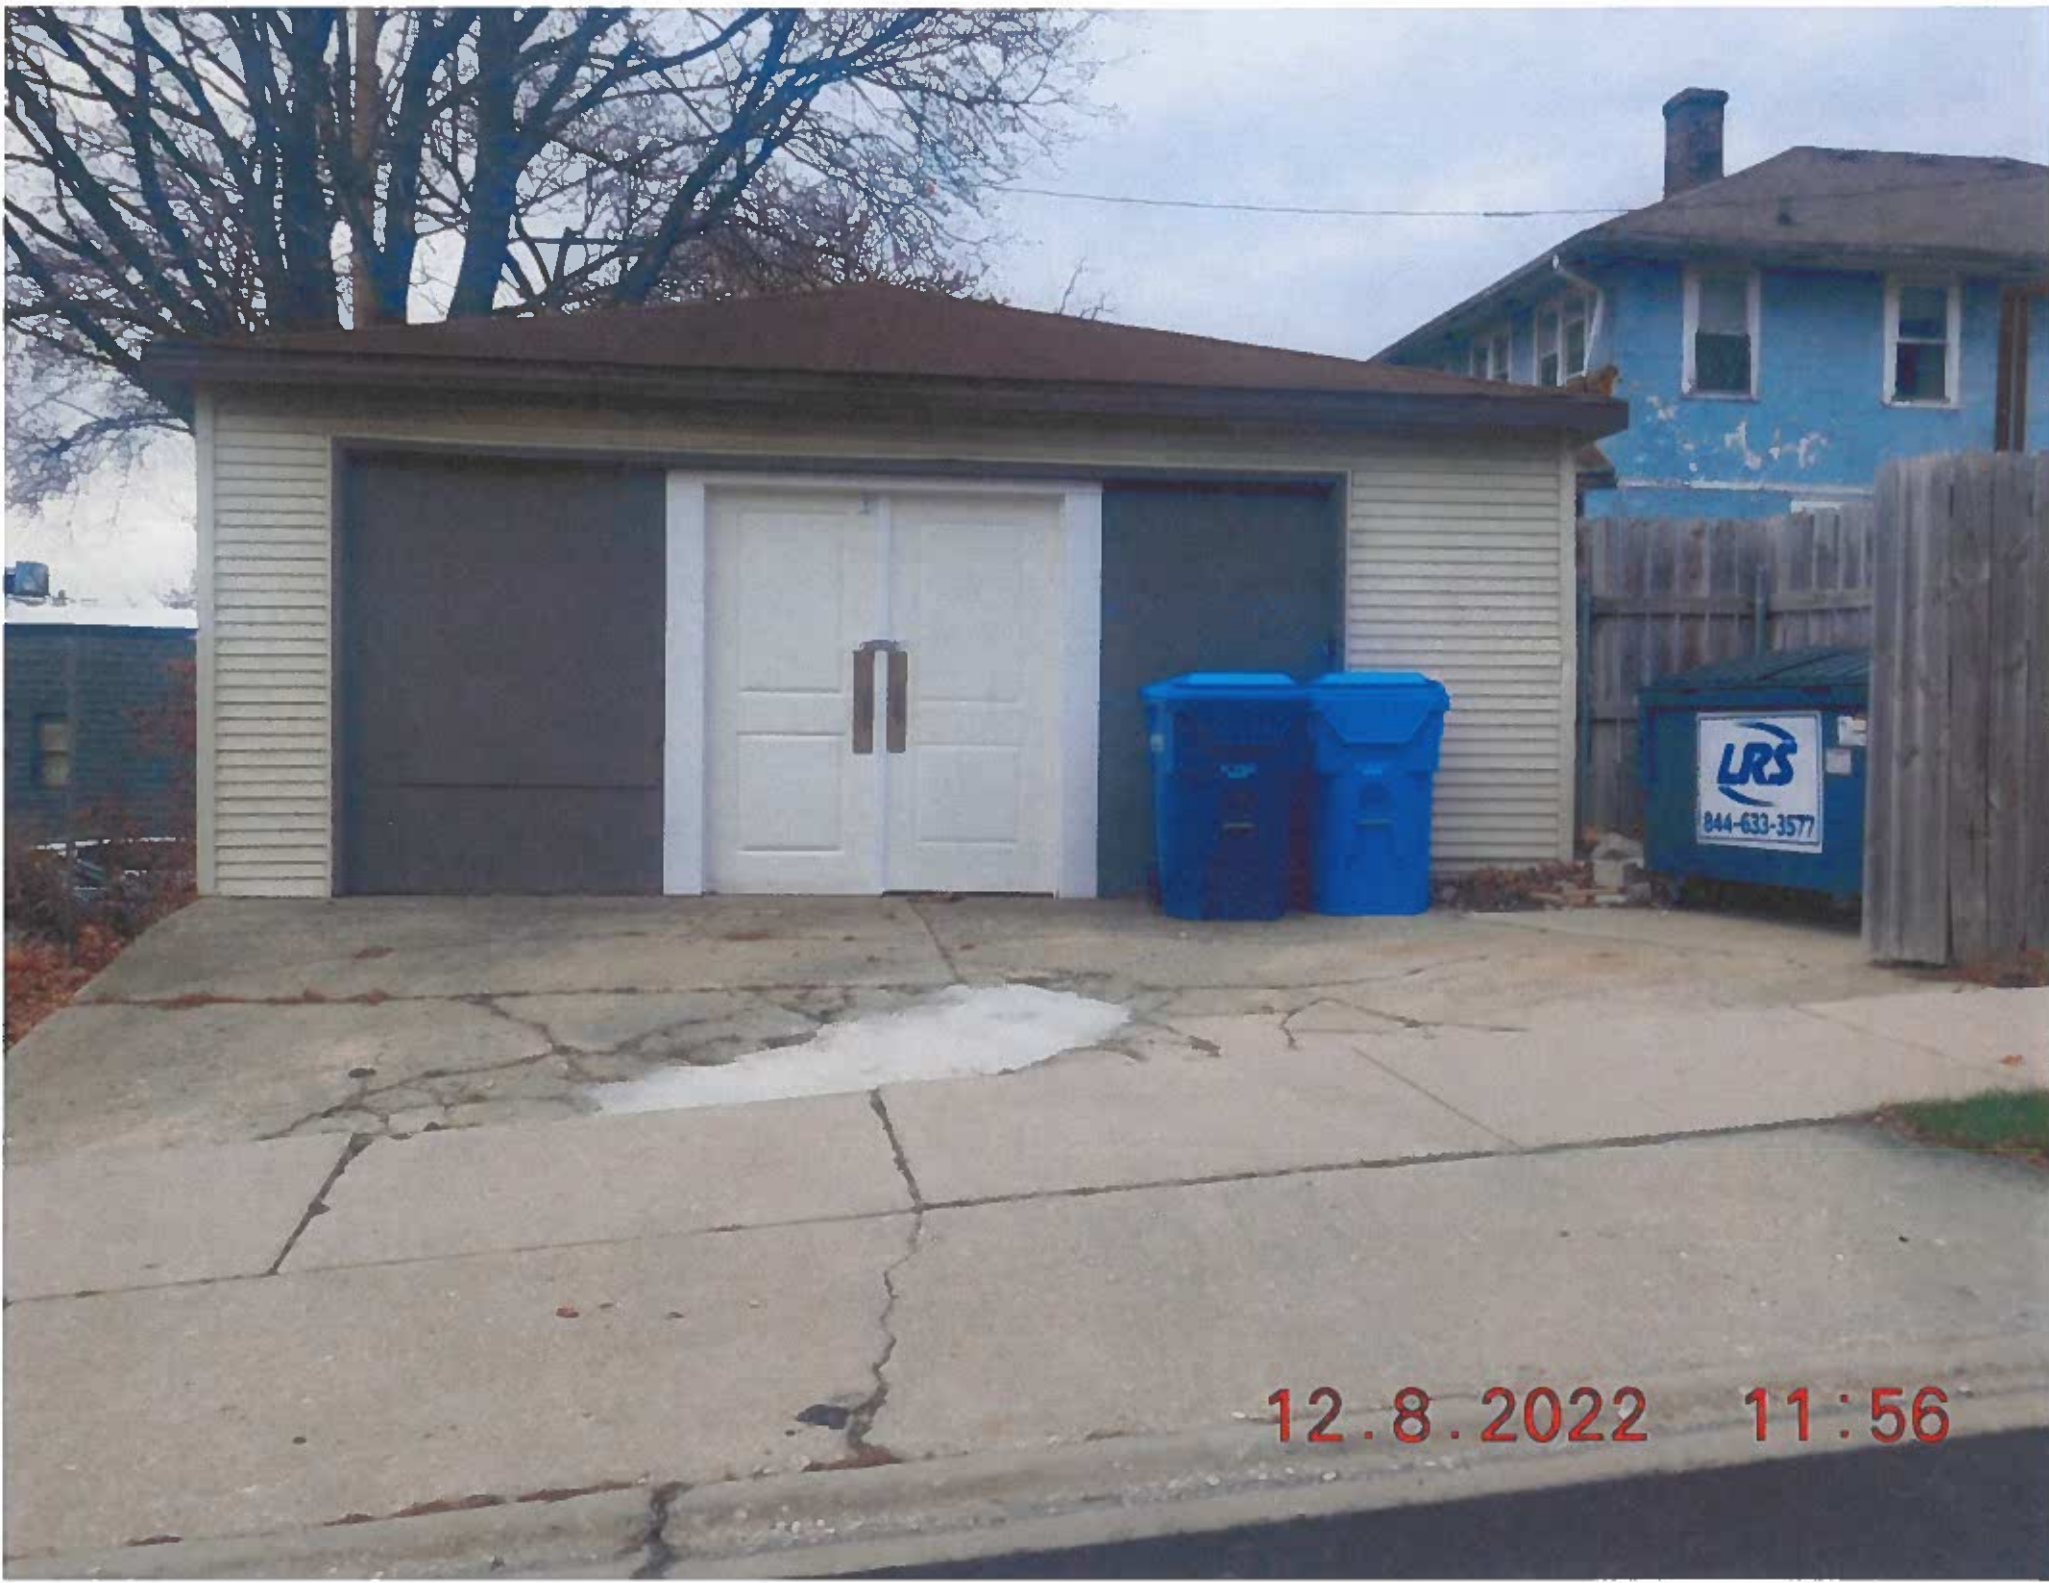
INTERIOR

- EXISTING GARAGE DOOR WAS HANGING BROKEN AT TOP AND NEEDED REPAIR IN ORDER TO CLOSE PROPERLY AND REDUCE FALL RISK. WORK PERFORMED INCLUDED REPLACING A BROKEN SPRING, REPLACING WHEEL GUIDES, BROKEN HINGES, AND DOOR JAM.
- EXISTING DOOR WAS IN EXCESS OF 200 LBS AND POSED A SAFETY RISK, NEEDING IMMEDIATE REPAIR.
- GARAGE IS NOT USED TO PARK CARS AND IT WAS DECIDED TO INSTALL A DOOR TO SERVE PEDESTRIANS AND SMALL YARD VEHICLES/EQUIPMENT.
- ALL WORK WAS PERFORMED BY VOLUNTEERS.
