# ARCHITECTURAL SURVEY ST. CHARLES CENTRAL DISTRICT ST. CHARLES, ILLINOIS

DIXON ASSOCIATES / ARCHITECTS

120 North Fifth Street

118 North Fifth Street

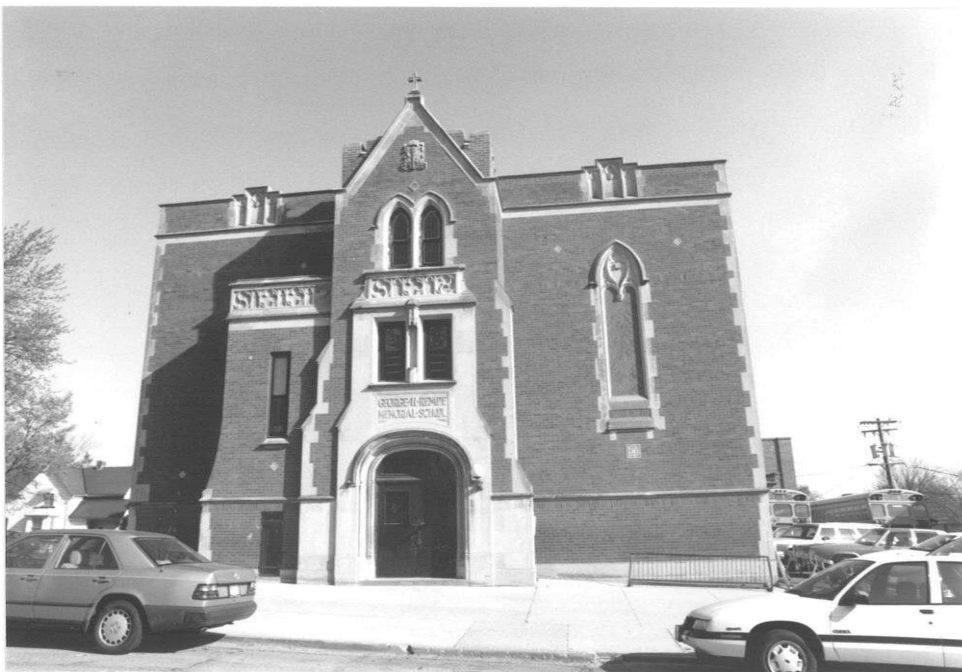
NEGATIVE NO. 23

Main facade at the south features stone trim in brick with Gothic arched windows. Arched entrance in stone projected out from face of building, capped with gable at parapet line. School building dedicated as George H. Rempe Memorial.

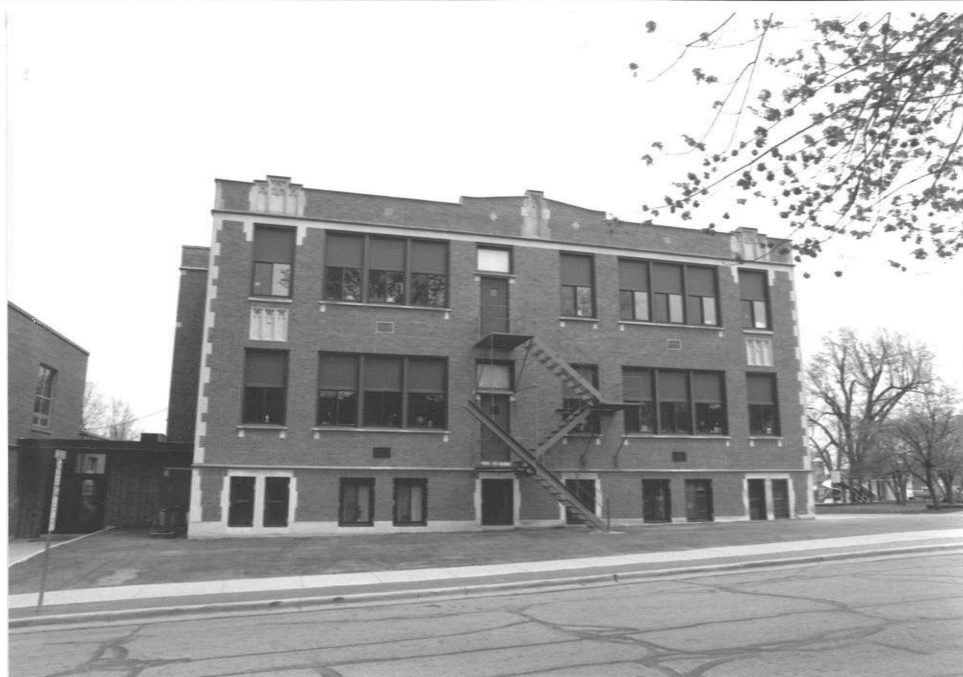
NEGATIVE NO. 34

West Elevation. Stone quoins on brick building. 2 1/2 stories plus decorative parapet with stone accents in brick.

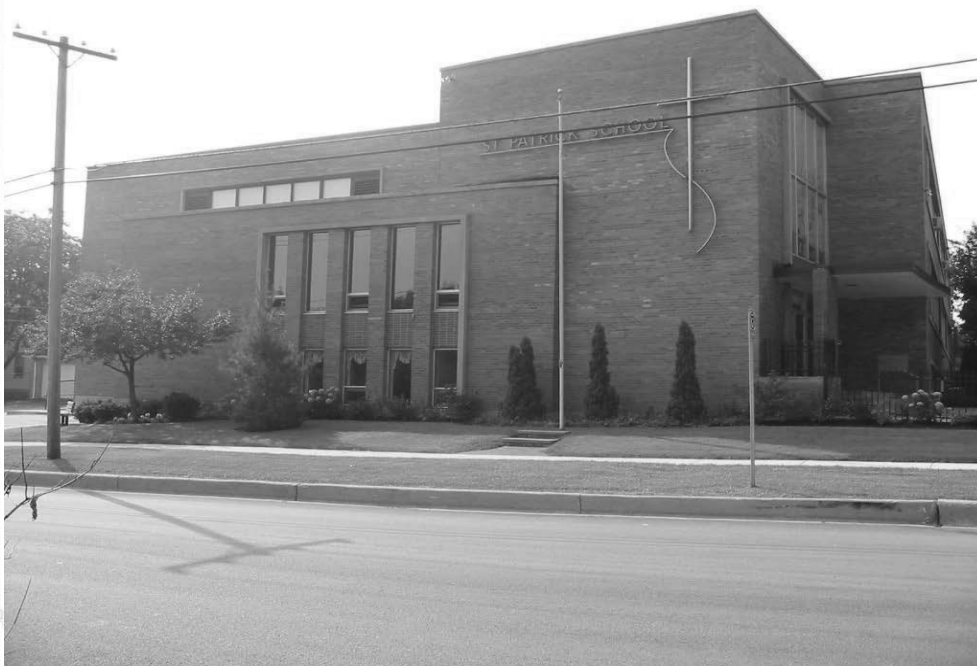
NEGATIVE NO. 33

Simple bands of windows on each floor with cut stone frame. Flat roof and simple box forms contribute to typical 1950's school building appearance.

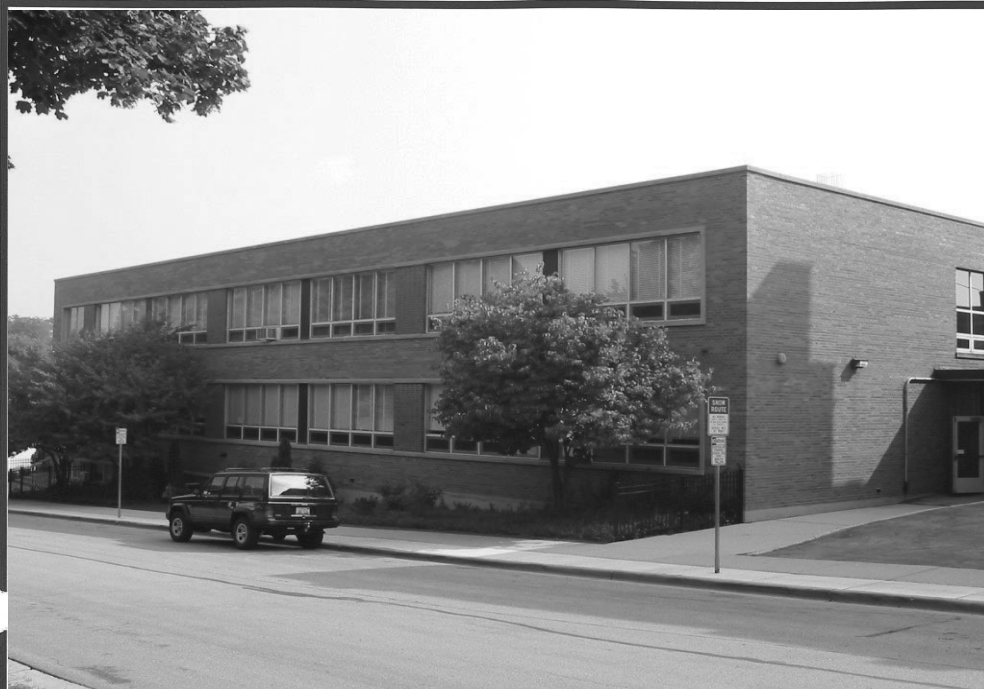
**NEGATIVE NO. 32**

North side facing State Street
