# POTTAWATOMIE NEIGHBORHOOD

## HISTORIC RESOURCES SURVEY

MCGUIRE IGLESKI & ASSOCIATES, INC.

JANUARY 2024

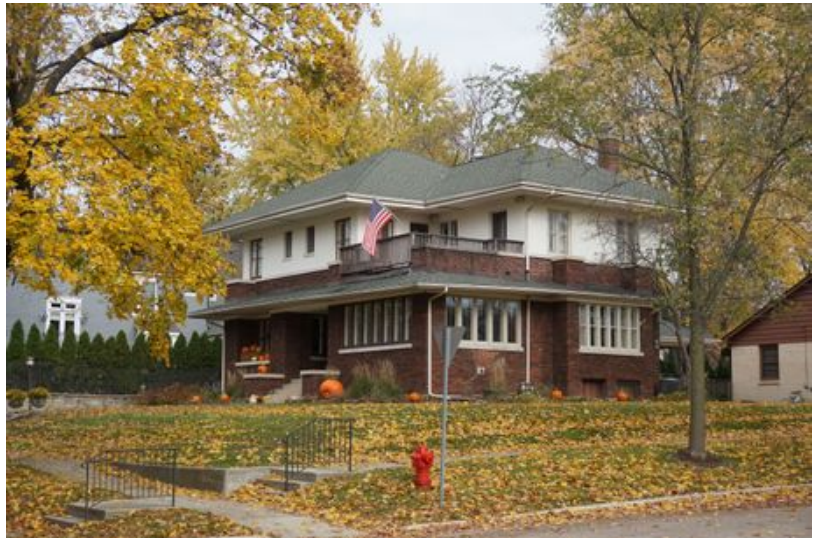
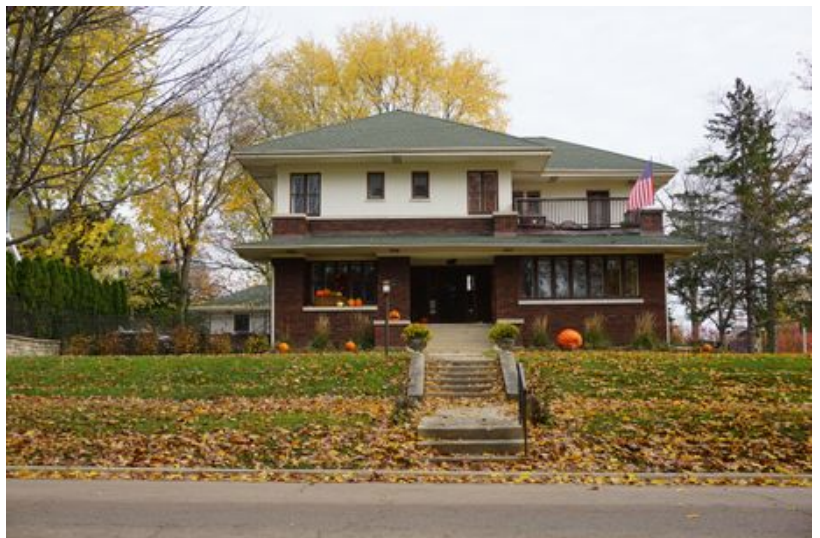
Hipped roof, symmetrical, with front entry (subtype)

Excellent

The low pitch of hipped roofs with wide overhangs.

Full-light casements; Three-light awning or hopper windows at basement.

Wide bands of casement windows at the primary facades of the first floor.

Predominately full-light wood door with a short, lower panel; The glazing is divided into six lights with a large center light flanked by two narrow lights and three small lights across the top.

Door is flanked by full-light sidelights with a matching lower panel.

Semi-enclosed front entry porch.

Overall form including the low pitch of hipped roofs with wide overhangs; Wide bands of casement windows at the primary facades of the first floor; Original/historic windows and doors; Mix of brick and stucco materials at the exterior.

Some windows may have been replaced.

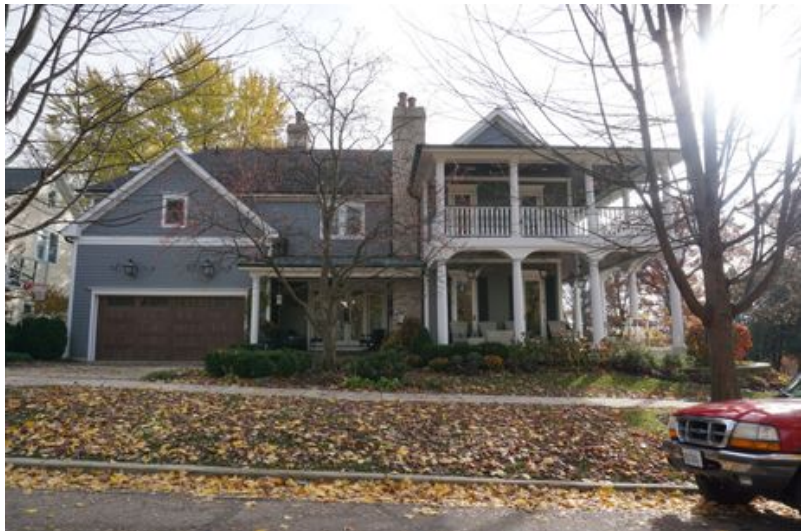
Main roof is a cross-gable with projecting gable ends at the north and west; Roof over the added two-story veranda is hipped; Eyebrow dormer at the west face of the roof.

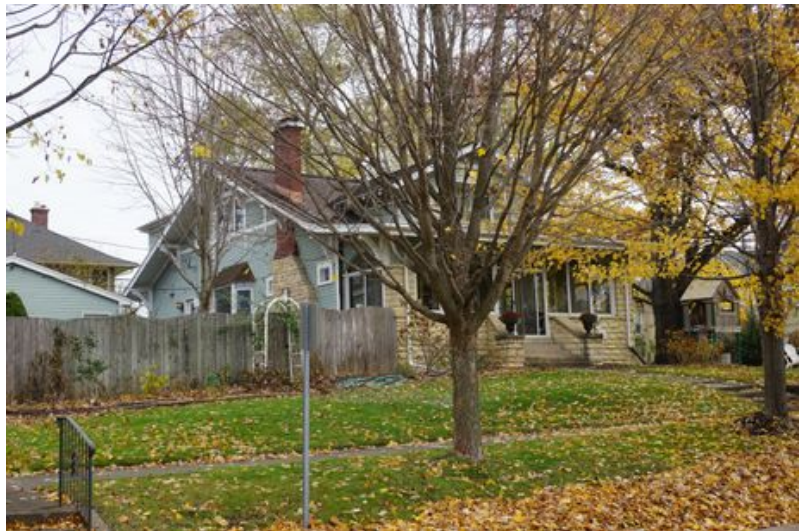
A prominent side gable roof with bracketed wide overhangs; Front-facing gabled wall dormer at the west facade with wide eave overhangs with exposed rafters; Gabled wall dormer addition at the rear (east) facade.

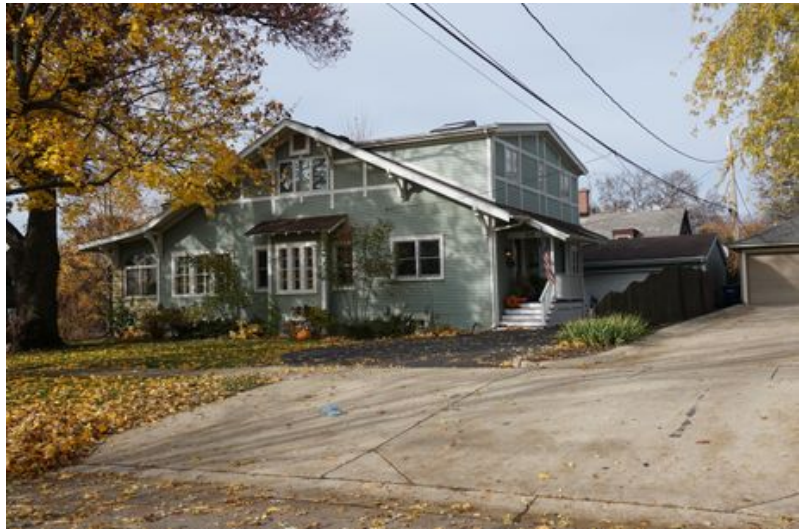
Oriel window at the north facade (difficult to see due to fencing).

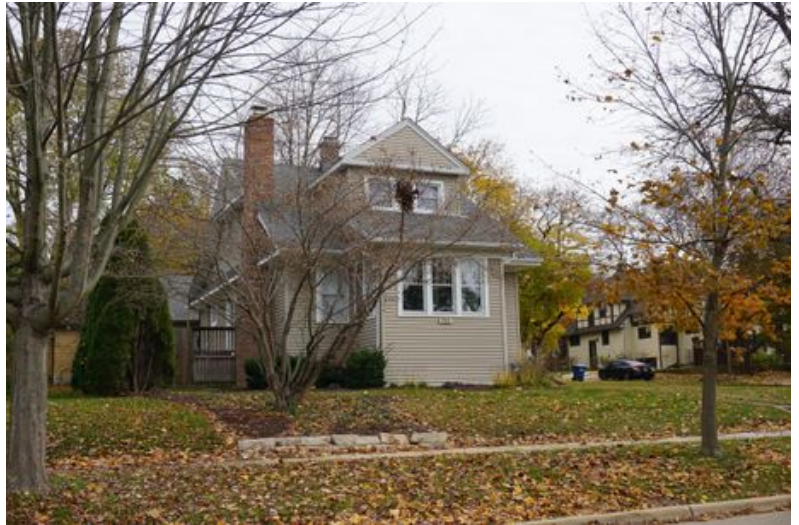
Main side gable roof form with a prominent front-facing gabled wall dormer at the front (west) facade, a shed roof extends from the base of the wall dormer for the projecting living room alcove, Smaller gabled wall dormer at the rear (east) facade.

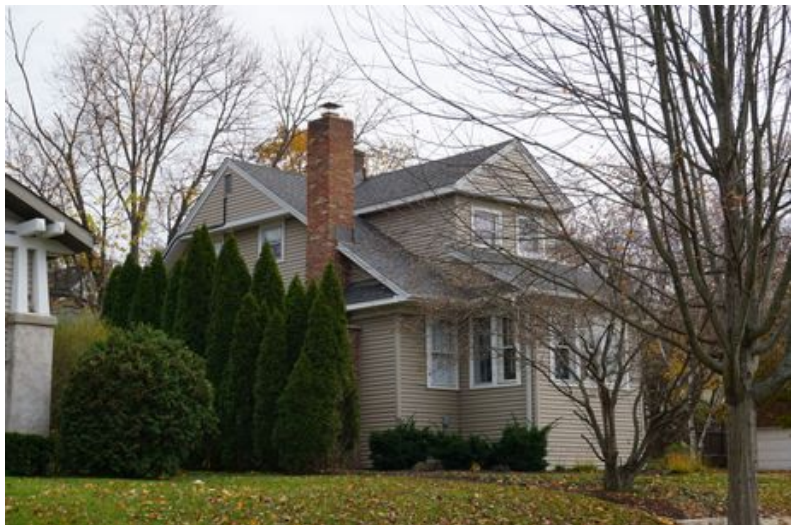
One-over-one double-hung; Full-light casements; Three-over-one double-hung (historic, wood); Two-light awning or hopper at basement (historic, wood).

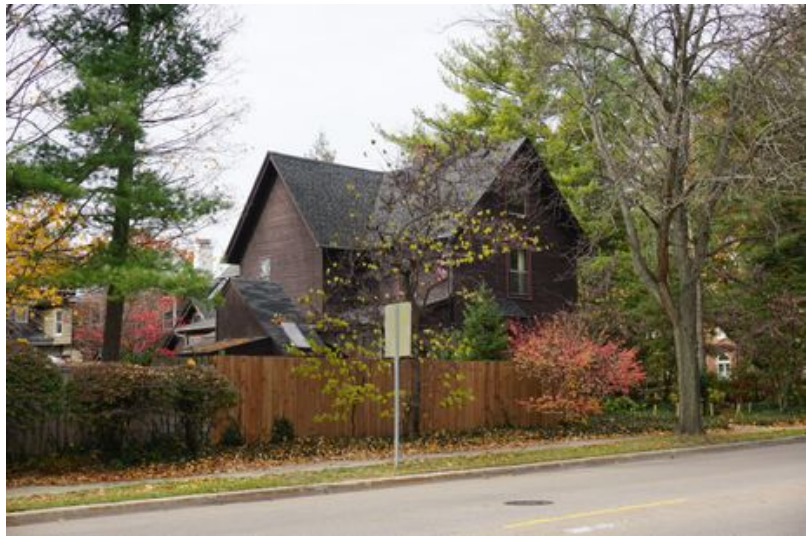
Main cross-gable roof form with a projecting gable end at the center of the side (north) facade.

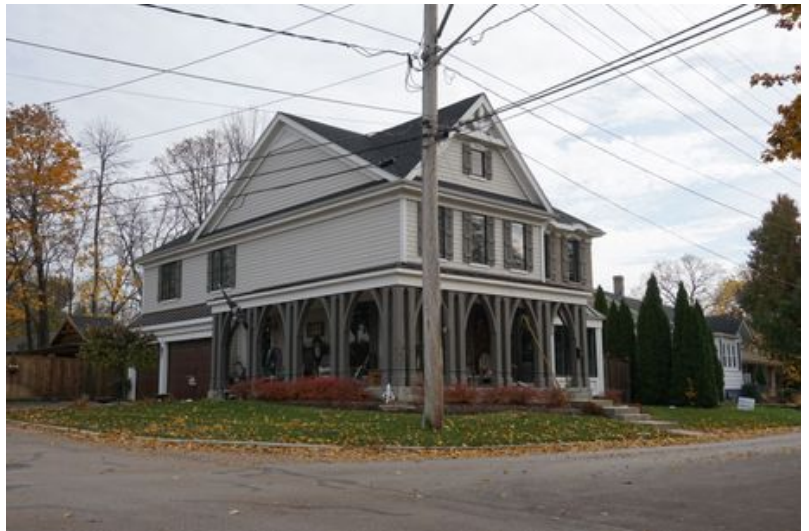
The main roof is a pair of side-gable roofs with a front-facing gable roof wing projecting from the west face of the main roof and a cross-gable roof over the attached garage section at the rear of the residence; The face of the front-facing gable wing is ornamented with vergeboard.

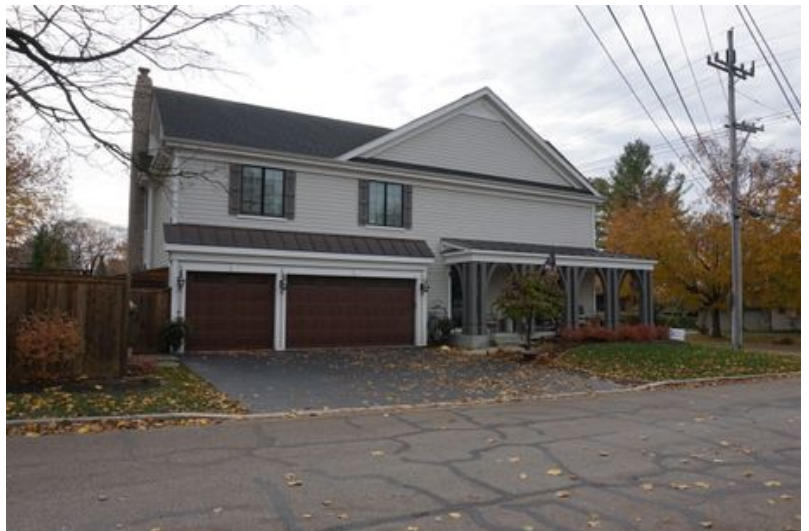
Plank shutters; At the front (west) facade the window at the attic and the two windows at the south end of the second floor are crowned by faux arched headers; Oriel window with a Mansard roof at the south end of the front (west) facade at the first floor.

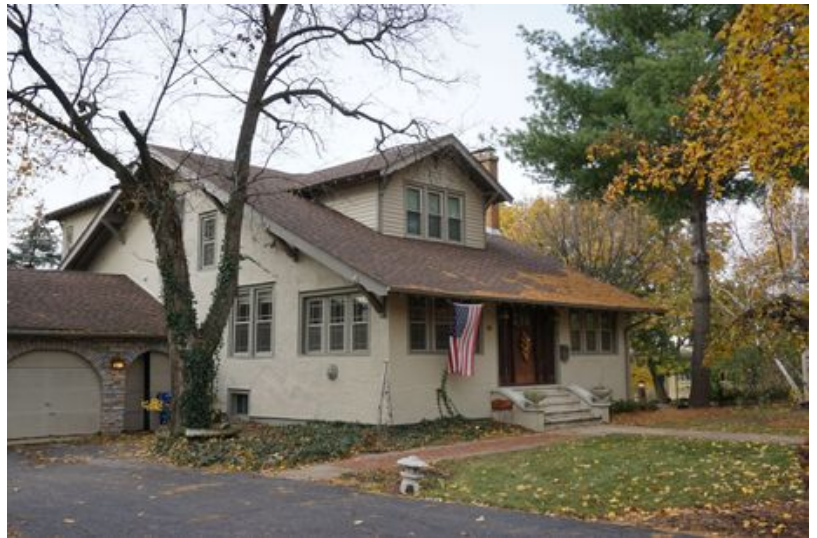
Low-pitched side-gabled roof with wide eave overhangs and triangular knee braces; Front-facing gable roof dormer with wide eave overhangs, triangular knee braces, and exposed rafter tails.

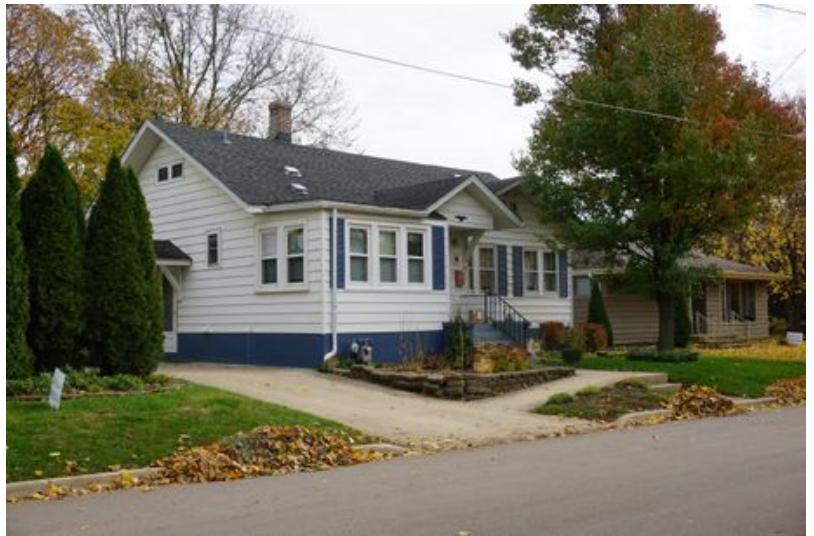
Main side-gabled roof with a projecting front-facing gable at the south end of the front (west) facade.

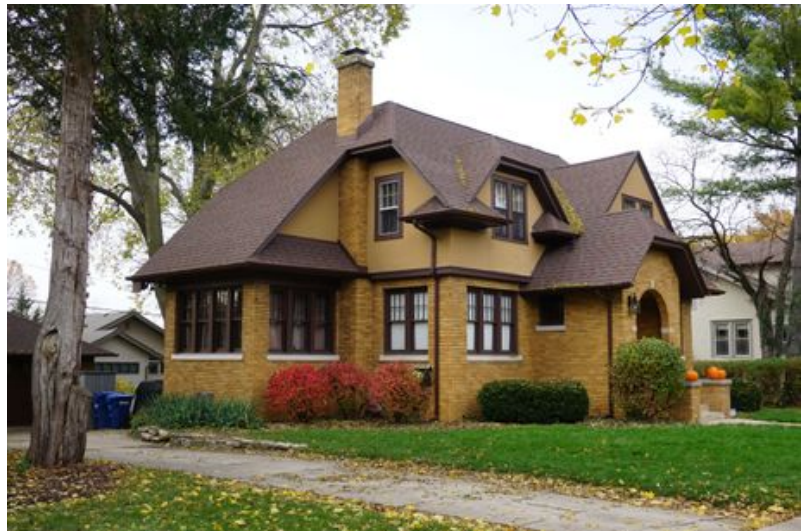
Overall hip-on-gable roof with wide eave overhangs; Jerkinhead and gabled wall dormers.

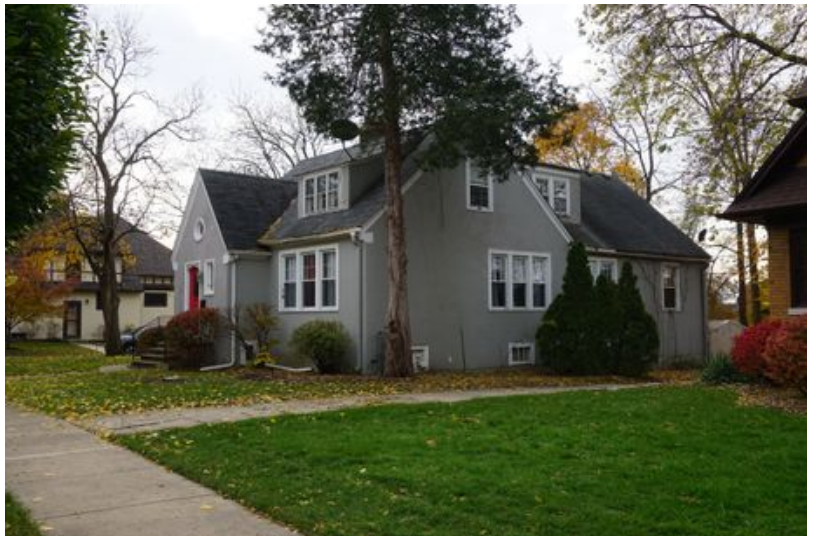
Primary side-gabled roof form with a lower front-facing gabled projecting; Shed roof dormer at the north end of the front (east) face of the main roof.

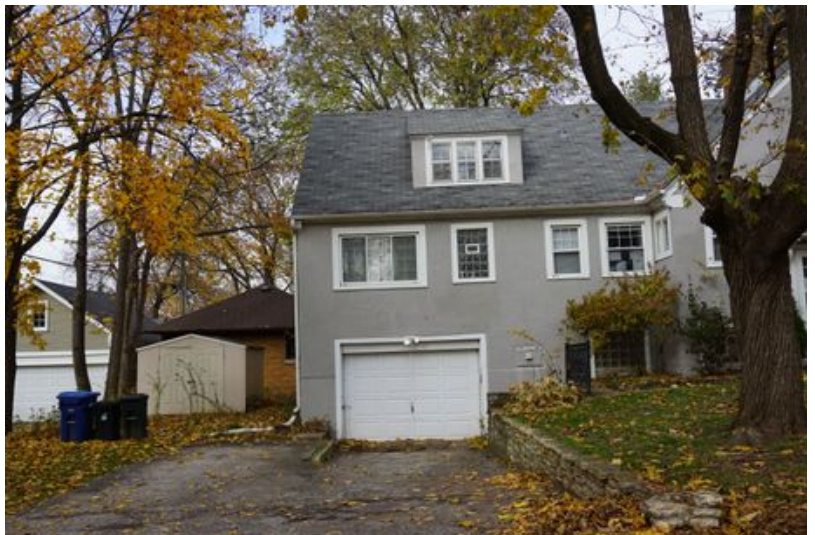
A majority of historic windows remain intact.

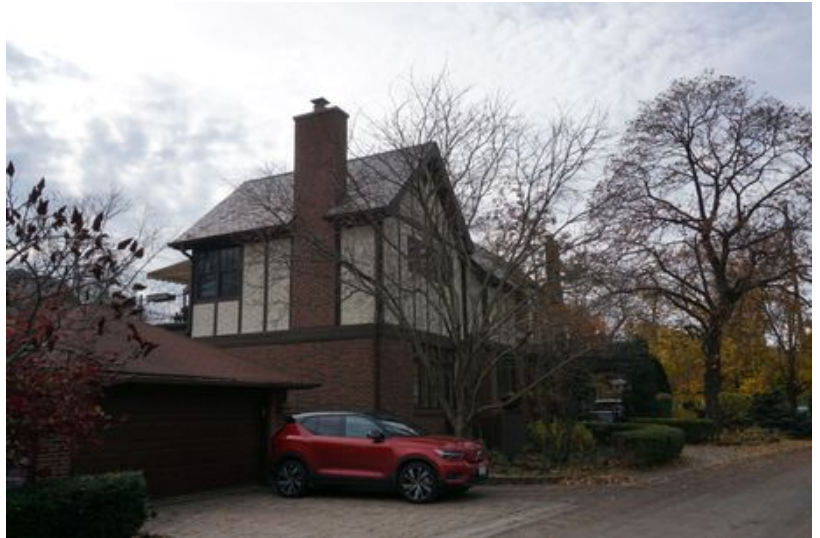
The main roof is a "T" shaped cross gable with a pair of projecting gabled wings along the south face of the roof.

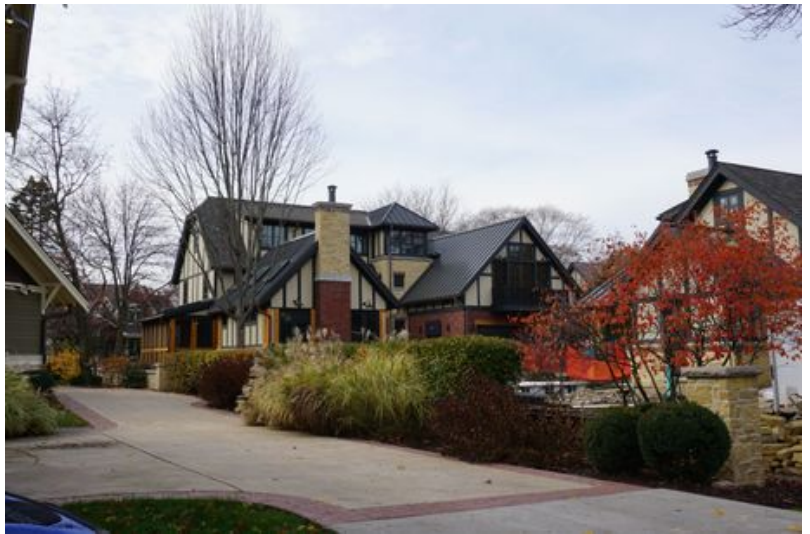
The main roof is a Jerkinhead (clipped gable) with projecting front-facing gabled wings at the center of the front (west) facade and at either end of the rear (east) facade; Two gabled oriel windows break the eave of the main roof at either end of the front (west) facade.

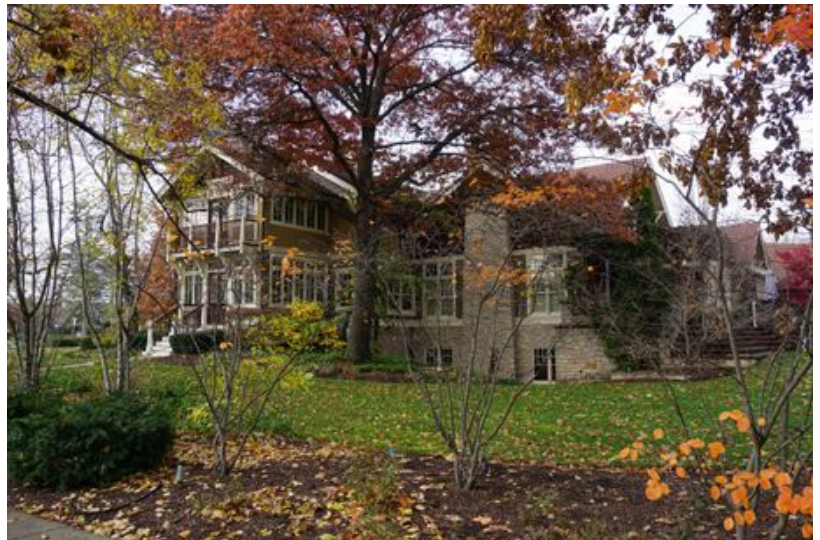
The original main roof is composed of several side-gabled roofs with wide eave overhangs and exposed rafter tails with triangular knee braces at the gabled ends, the center original roof is accentuated by a gabled dormer with a low-pitched front-gabled roof with triangular knee braces, the secondary main roof to the north features a shed roof dormer with wide eave overhangs and exposed rafter tails.

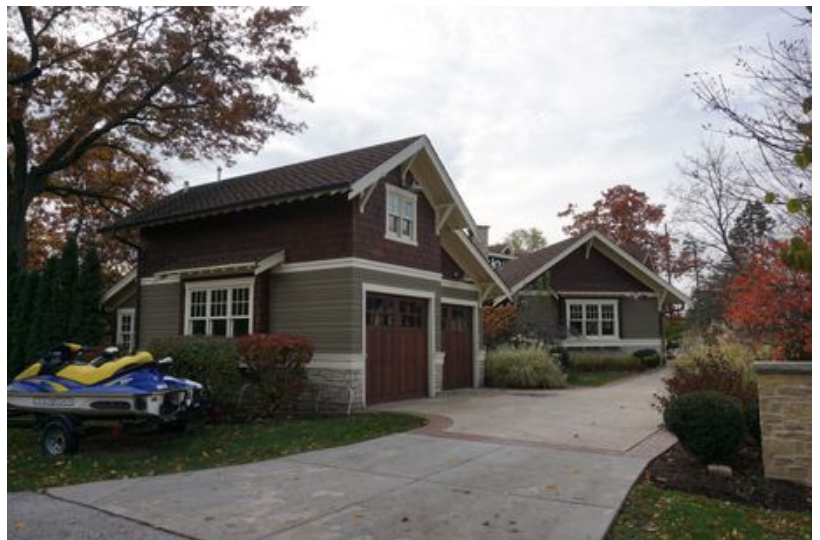
Six-over-one wood double-hung windows (non-historic); Four-over-one wood double-hung windows (non-historic); Four-light wood casements (non-historic); Four-light wood awning or hopper windows (non-historic).

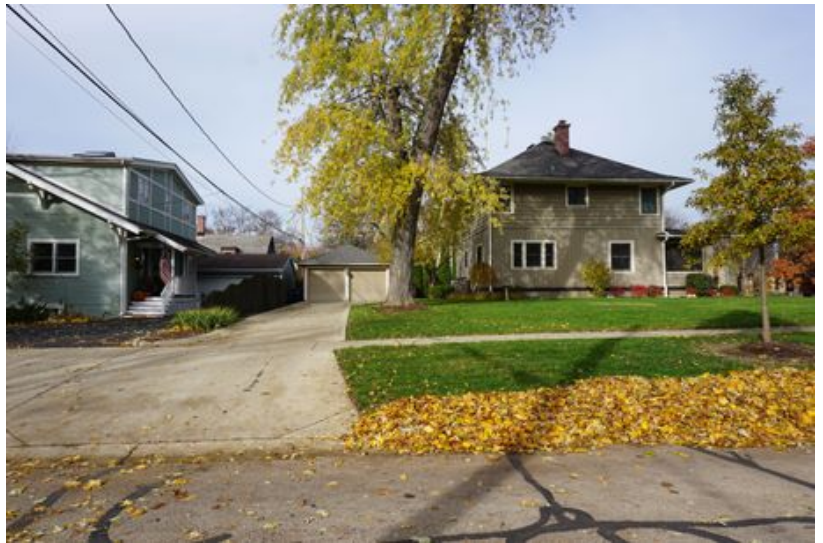
Steeply-pitched hipped roof form with wide eave overhangs.

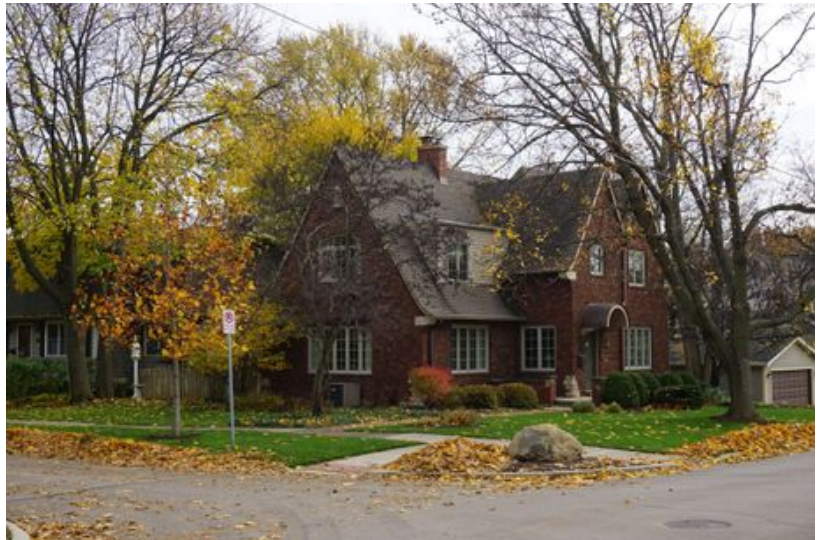
Steeply-pitched side-gabled form with a pair of cross gables at the front (west), south, and east facades; Flared eaves at all roofs; Below the pick of each gable is a diamond-shaped opening infilled with a terra cotta grille featuring nine circular openings which help vent the attic.

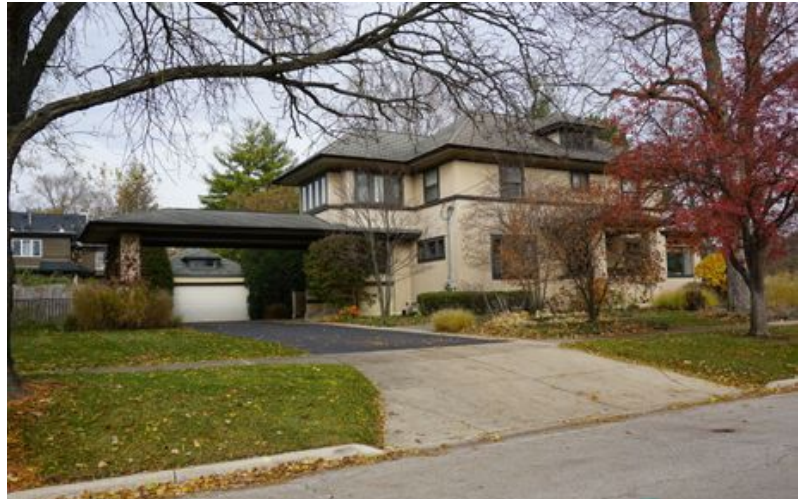
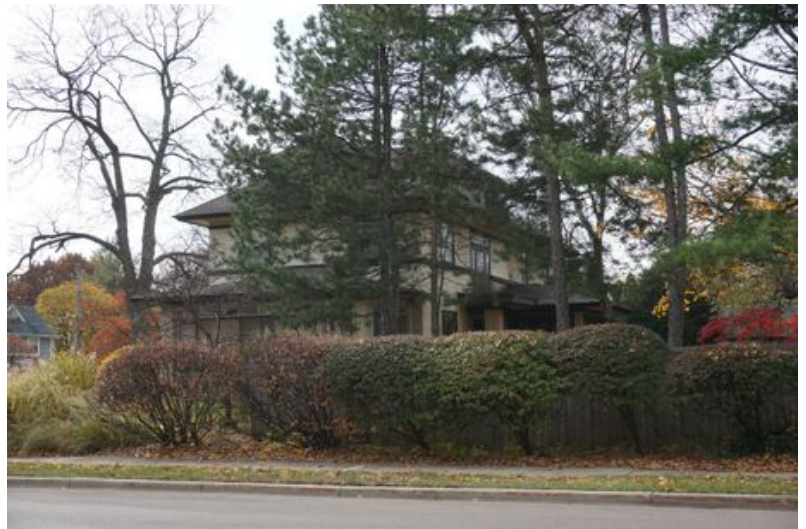
Wide, rectilinear window trim; Continuous wall trim below and above the second floor windows.

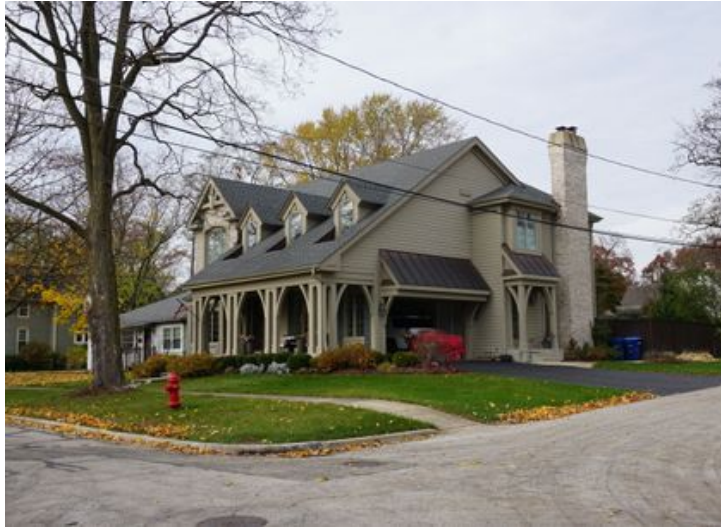
The residence features a complex roof form with a main roof that is a side gable with a projecting full-height wing at the rear (northeast corner) with a cascading hipped roof and a full-height projecting wing at the front (southwest corner) with a cross gable roof that is ornamented with a raking cornice, decorative vergeboard, and cornice returns; Gabled dormers at the front (south) face of the main roof.

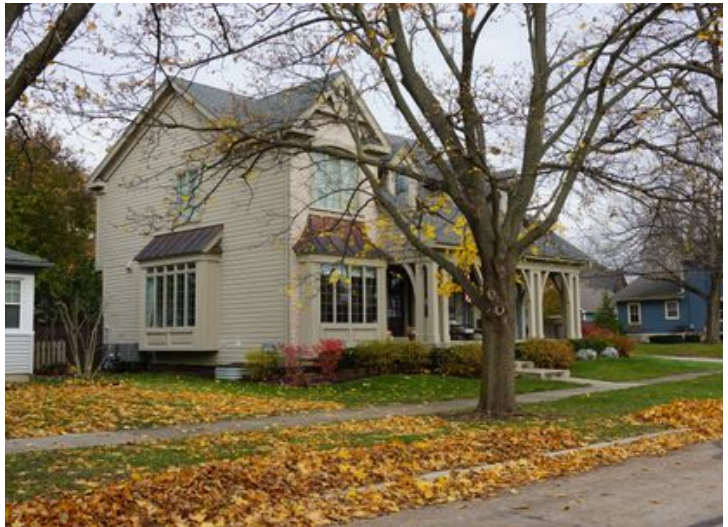
Some windows are ornamented with a wood surround which mimics a historic arched window header; Oriel window with a faux-Mansard roof at the first floor of the west end of the front (south) facade; Oriel window with a shed roof at the first floor of the side (west) facade; Square bay window at the second floor of the side (east) facade.

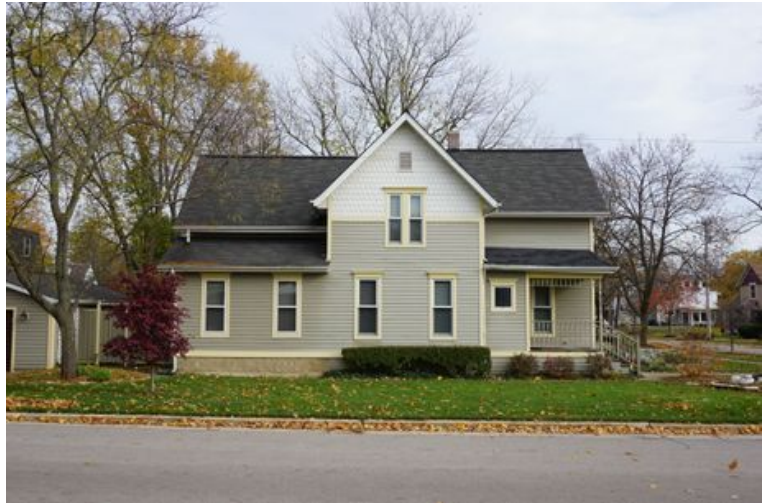
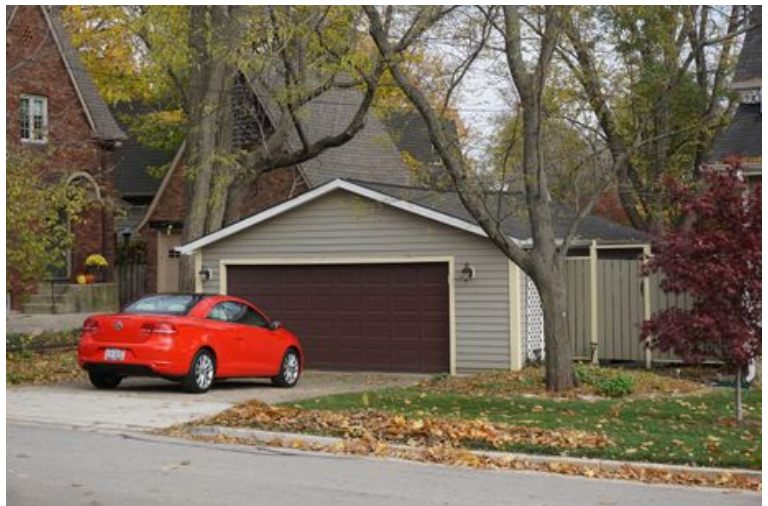
Covered open-air entrance porch at the southwest corner of the residence.

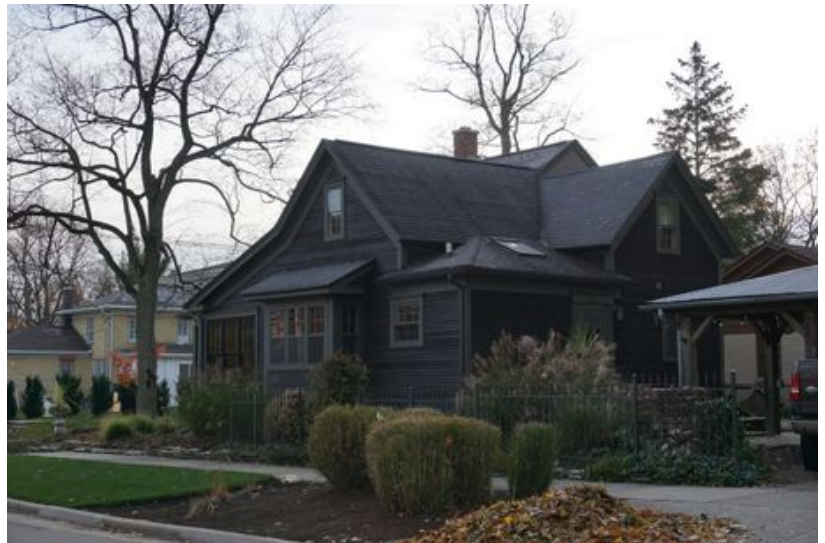
Gabled roofs with wide eave overhangs; Raking cornice at the gable face of the side-gabled wing.

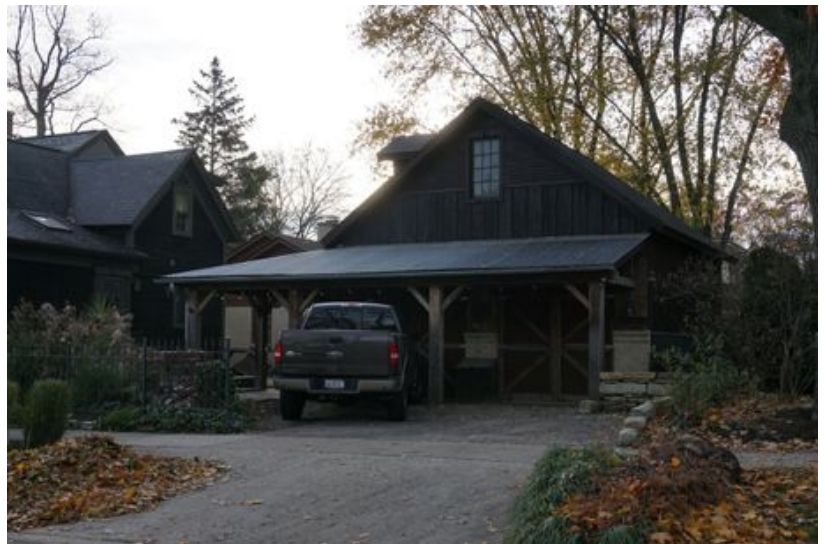
Wide, rectilinear wood trim and window hoods which mimic a classical entablature at the windows at the wing section of the residence.

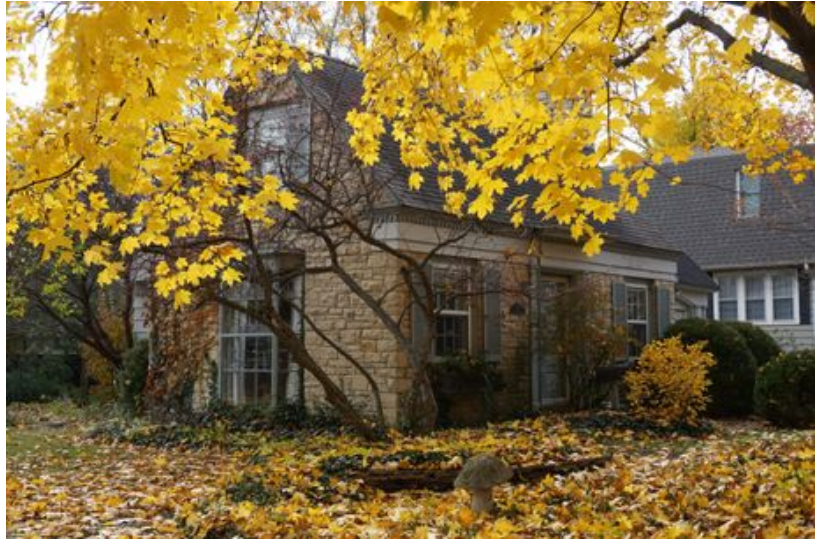
Side-gabled main roof form with a projecting cross-gable bay at the rear (south) face of the main roof; The main roof is accentuated by a wide, dentillated fascia board.

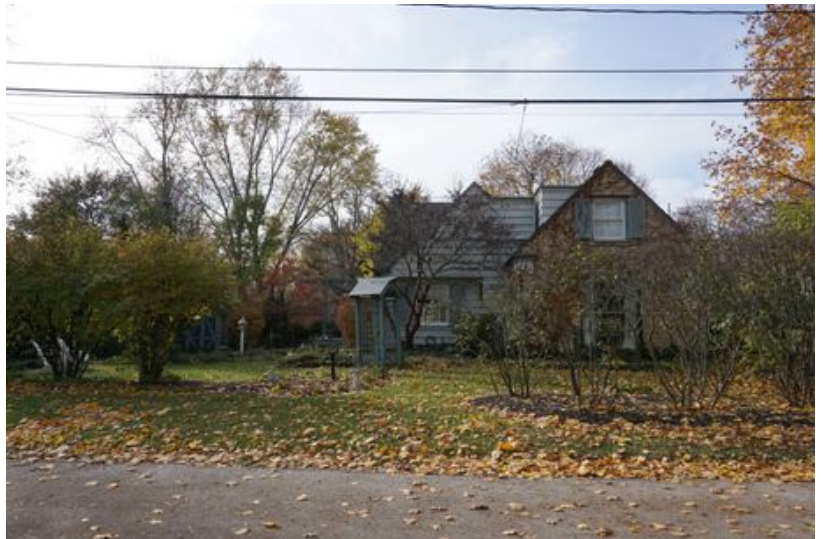
Hexagonal bay window at the side (east) facade; Original windows; Shutters.
