# ARCHITECTURAL SURVEY

NEAR WEST HISTORIC DISTRICT  
ST. CHARLES, ILLINOIS

ST. CHARLES HISTORIC PRESERVATION COMMISSION

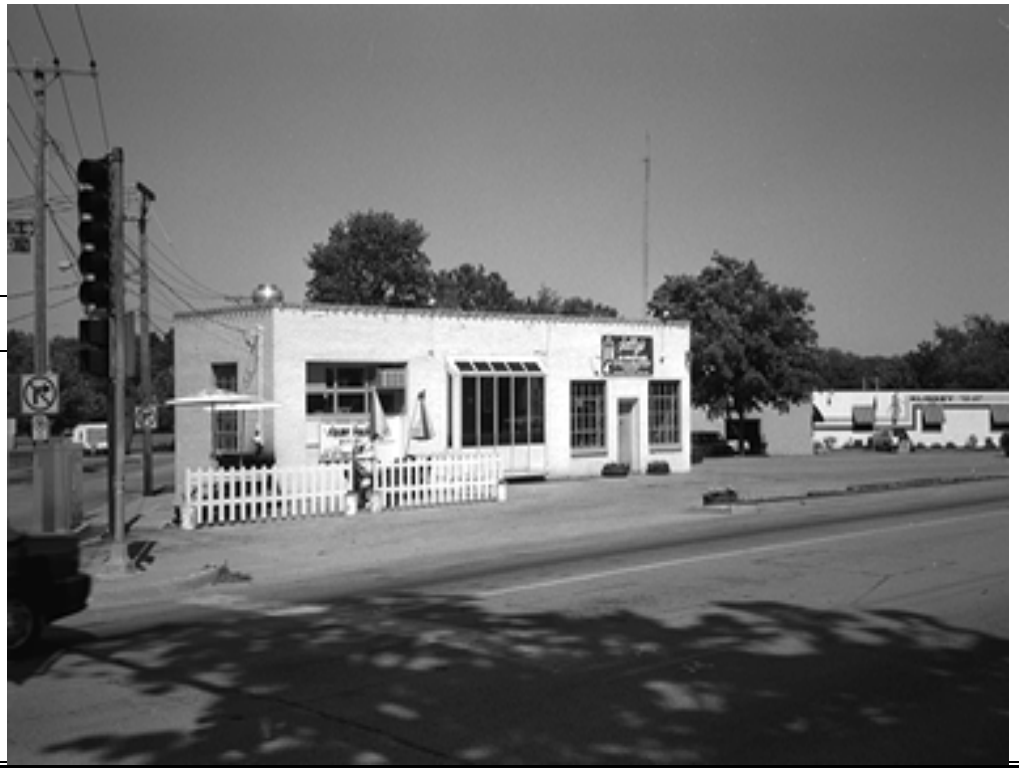
ADDRESS 602 Geneva Rd.

Architectural Style/Type: Commercial/modern

Exterior Walls (Current): Painted Brick

Architectural Features: Large windows

**ALTERATIONS:** Adaptive reuse of a gas station. This building is located at the edge of a residential area. It is sited on a lot that was formerly a house. The house was moved to Prairie Street.

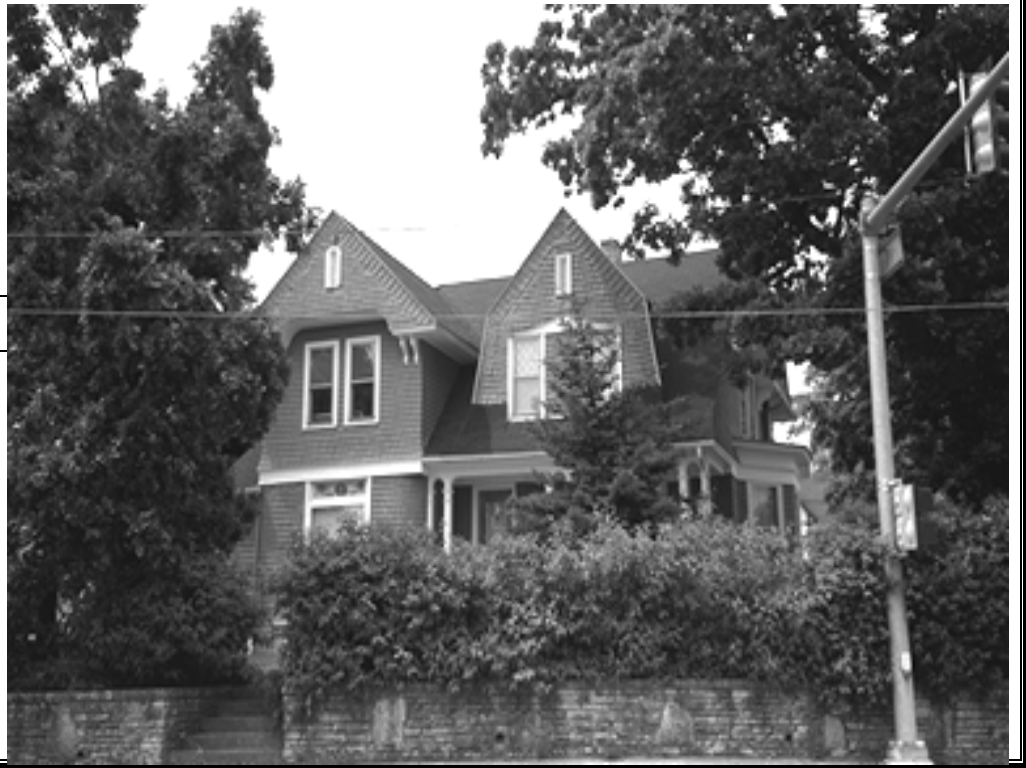
ADDRESS 603 Geneva Rd.

Architectural Style/Type: <u>Victorian/Shingle Style</u>	Exterior Walls (Current): <u>Wood Shingles on wood frame</u>
Architectural Features: _____	Exterior Walls (Original): <u>Wood Shingles on wood frame</u>
Date of Construction: <u>1864</u>	Foundation: <u>Stone (orig), Conc. (addition)</u>
Source: <u>Township Assessor's Office</u>	Roof Type/Material: <u>Cross gable w/ gambrel front &amp; gable front</u>
Overall Plan Configuration: <u>Compound</u>	Window Material/Type: <u>Alum/Wd/double hung</u>

**ARCHITECTURAL FEATURES:** This house is sited on a site that is elevated from the street level which adds to the impression of size and stateliness. The front façade is dominated by both a large gable and gambrel. The ends of the crossing gables are sheathed with shingled surfaces. The gables at the front and the side overhang the windows on the second floor and are supported by ornately detailed wood brackets. The shingled surfaces unify the eclectic montage of forms around the façade.

**ARCHITECTURAL FEATURES contd.:** The main entrance is accessed through the front porch which is covered with a sloping roof that is a continuation of the main cross gable. Simply detailed square columns support the porch roof. All of the window surrounds are simply detailed. Some of the ground floor windows have leaded glass transoms. There is a single story bay window located on the north elevation that is supported by wood brackets.

**ALTERATIONS:** There have been 2 significant additions to this house. The one to the rear has a flat roof and is not sympathetic to the original design. The other addition is located on the south side of the house. It serves as a side entrance/means of egress for the second floor. This addition is somewhat sensitive to the original design.

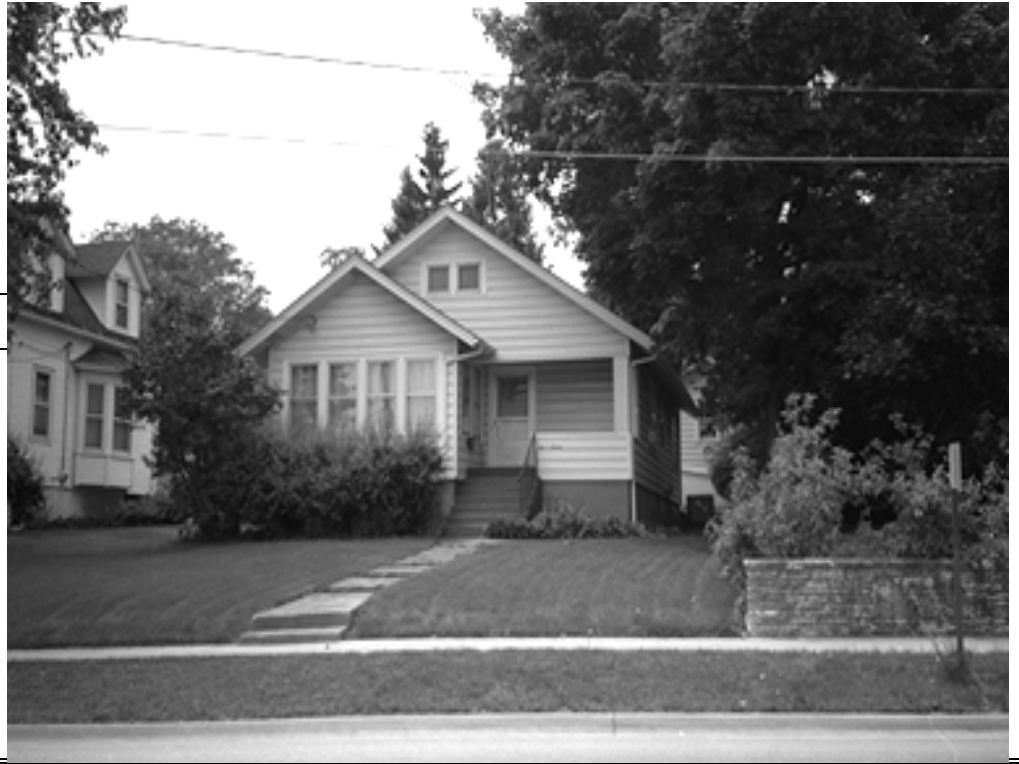
ADDRESS 607 Geneva Rd.

Architectural Style/Type: Craftsman bungalow

Exterior Walls (Current): Aluminum siding

**ARCHITECTURAL FEATURES:** This is a variation of the Craftsman bungalow. The scale and massing is typical of the style. The entrance was usually located in the smaller front gable here it is placed off center of the main gable.

**ALTERATIONS:** There is a small addition at the rear that has a hipped roof. All of the soffits are aluminum as are all of the windows.

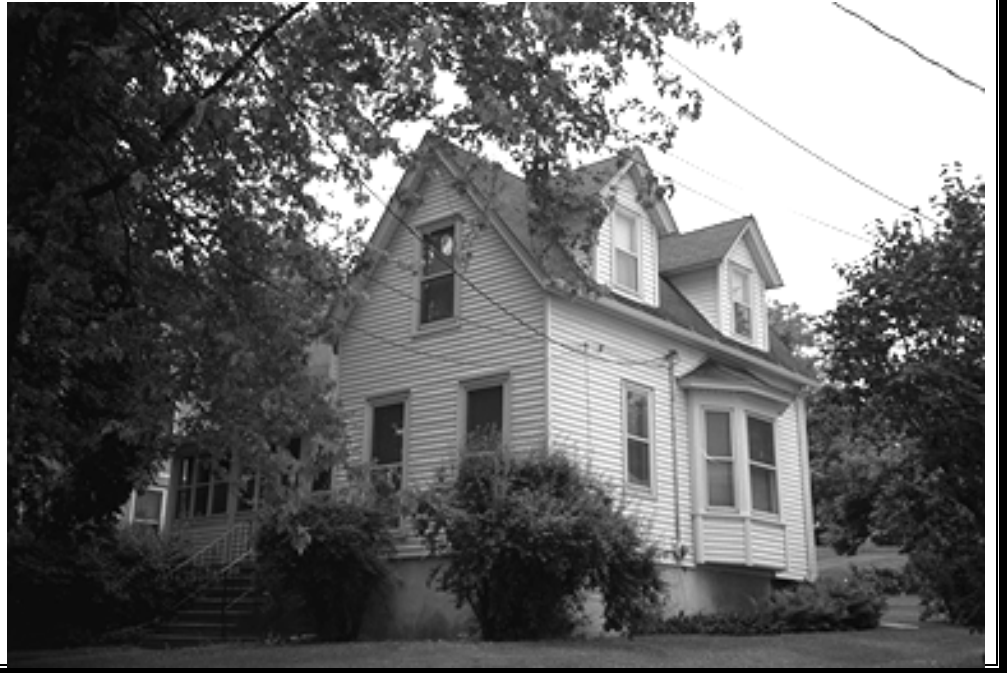
ADDRESS 611 Geneva Rd.

**ARCHITECTURAL FEATURES:** A gabled wall dormer provides some interest to the front façade while gabled roof dormers articulate the north side façade.

**ALTERATIONS:** The closed in front porch appears to have been added. It is poorly constructed and is in need of repair. There is an addition at the rear of the house that has a gabled roof and that does not fit the original house.

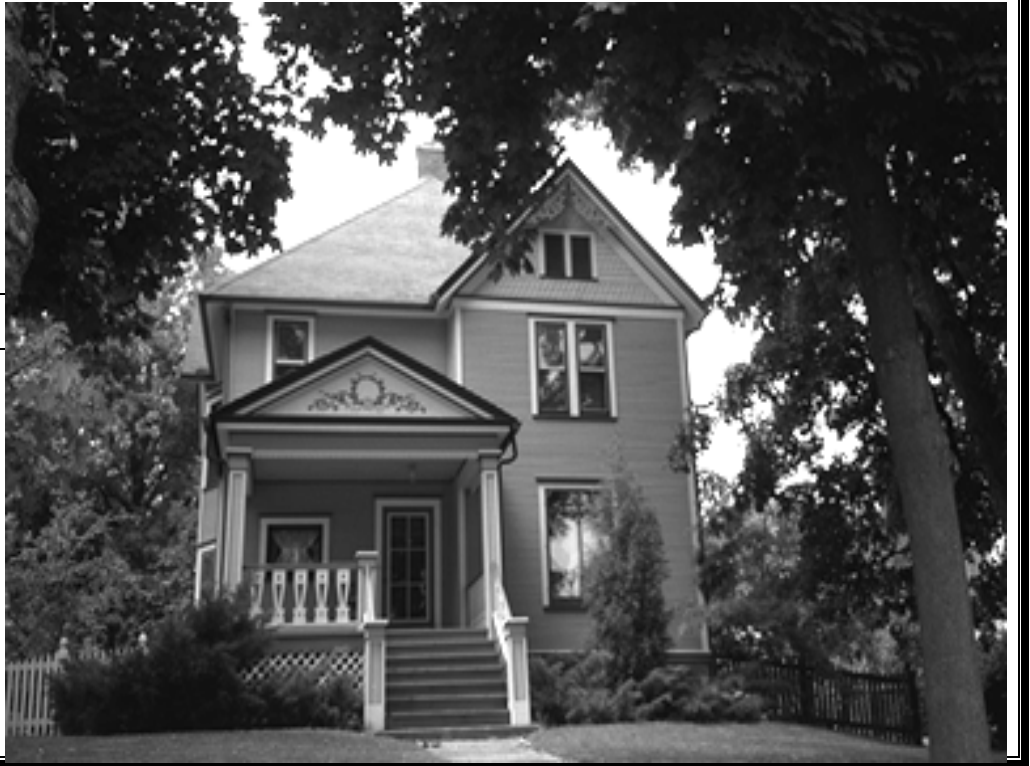
ADDRESS 617 Geneva Rd.

Architectural Style/Type: <u>Victorian/Queen Anne</u>	Exterior Walls (Current): <u>Clapboard</u>
Architectural Features: _____	Exterior Walls (Original): <u>Clapboard</u>
Date of Construction: <u>1900</u>	Foundation: <u>Stone</u>
Source: <u>Township Assessor's Office</u>	Roof Type/Material: <u>Hipped w/ lower cross gables</u>
Overall Plan Configuration: <u>Simple with irregularities</u>	Window Material/Type: <u>Wood/Dbf hung</u>

**ARCHITECTURAL FEATURES:** The front entry is covered with a gables lower roof that is supported by square wood columns. The columns feature some nice detailing and the rake and eaves are detailed with classic molding profiles. Unusually shaped balusters support the guardrail and the newels recall the detailing from the columns. The ornament in the gable of the porch adds interest but appears to have been added as does the fretwork in the main front gable. There are fish scale shingles in

the main front gable that is separated from the siding by a heavier accent band of painted wood trim. The south side elevation features a 2 story bay with fish scale shingles. The upper roof eaves are open, not boxed.

**ALTERATIONS:** The front porch appears to have been redone in character with the style. There is an addition to the rear of the house that appears to be somewhat in character with the original design.

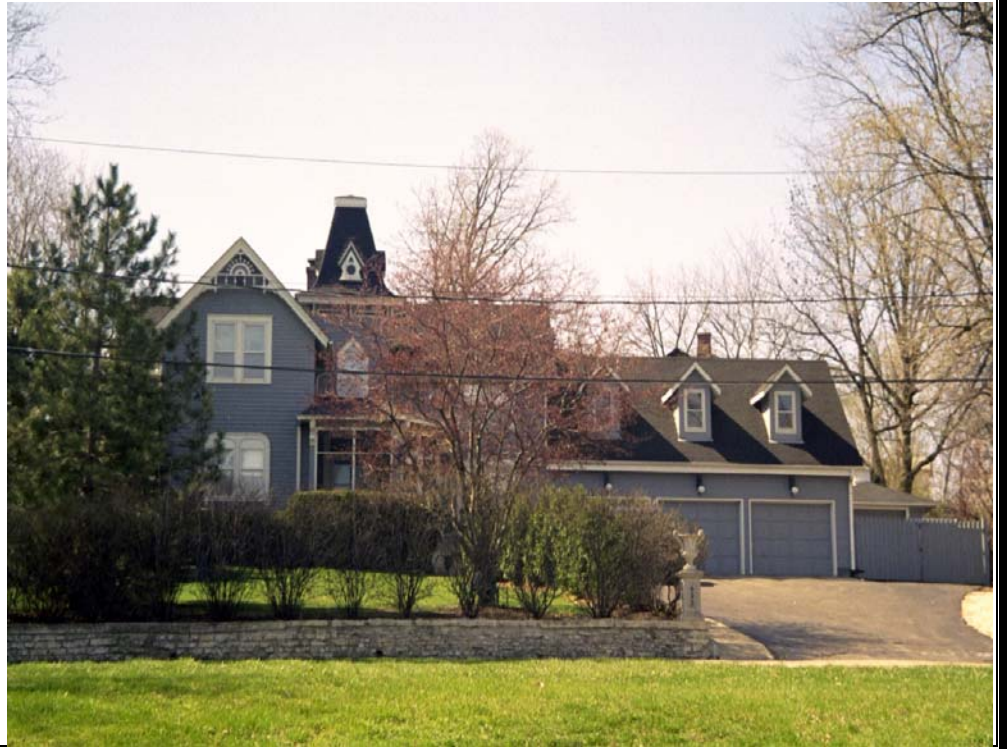
ADDRESS 625 Geneva Rd.

**ARCHITECTURAL FEATURES:** The original house was most probably a much simpler Cross gabled house. A Second Empire turret crowns the house from the front. The front gable features a decorative truss and unusual curved wood trim over the ground floor window. Some of the upper windows have an angled head seen in some Gothic revival examples. All of the original roofs of the main body of the house are steep (greater than 45°).

**ARCHITECTURAL FEATURES contd.:** There is a 1 story bay window located on the south side elevation of the house. It has a flat roof with an angled roof edge.

**ALTERATIONS:** This is an eclectic assemblage of a variety of architectural styles. There have been three possibly four significant additions to the house over its life. The 3 car garage is the most obvious of these. It is somewhat respectful of the original style in the use of materials, roof slope, and colors. The roof dormers are out of place and the proportions relate to a Cape Cod style than to the original gothic revival style. Heavy, out of scale wooden brackets support the roof overhang of a front porch that has been screened in and added a later date. A large 2 story addition with a shed roof was constructed to the rear of the house. The French tower appears so out of character that it was also probably added to the original house. All of the soffits are boxed in with aluminum.

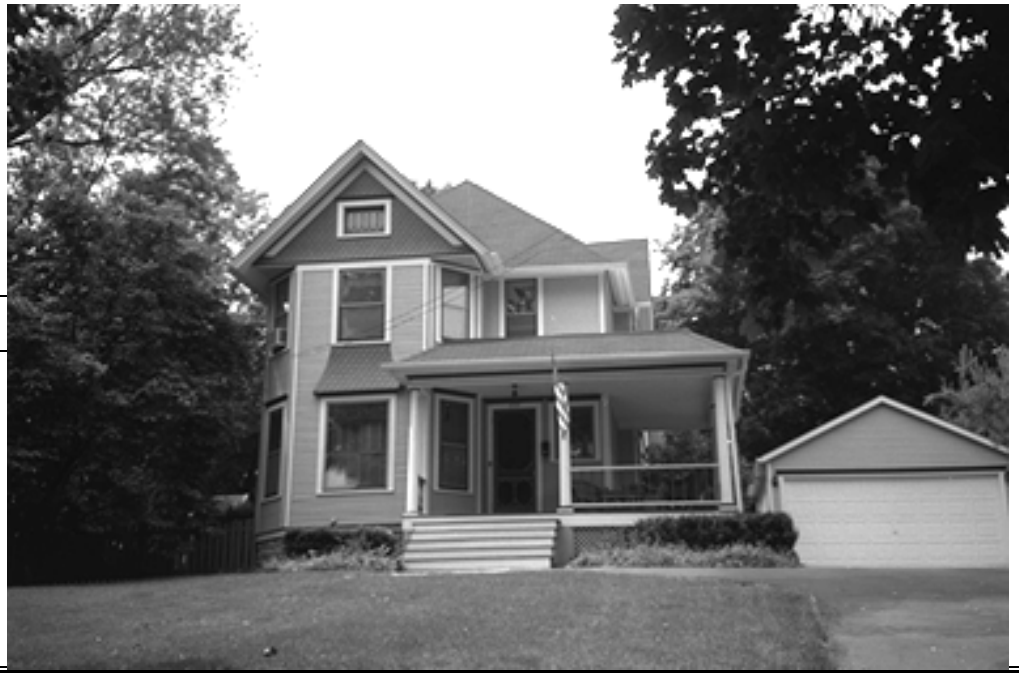
ADDRESS 633 Geneva Rd.

Architectural Style/Type: <u>Victorian/Queen Anne</u>	Exterior Walls (Current): <u>Clapboard</u>
Architectural Features: _____	Exterior Walls (Original): <u>Clapboard</u>
Date of Construction: <u>1896</u>	Foundation: <u>Stone w/ beaded joints</u>
Source: <u>Township Assessor's Office</u>	Roof Type/Material: <u>Hipped w/ lower cross gables</u> <u>Asphalt</u>
Overall Plan Configuration: <u>Compound w/irregularities</u>	Window Material/Type: <u>Wd/Alum/Dbl hung</u>

**ARCHITECTURAL FEATURES:** Front gable roof is placed over a 2-story bay and thereby creates triangular soffits at the eave. The gable end is sheathed in fish scale shingles and has a small window divided into hexagonal shaped panes of glass. There is a leaded glass transom over the lower window of the bay that in turn is crowned by a fish scale shingled roof. A flat roof wrapped with a hipped shingled roof at the edge covers a wrap around front porch. Simply detailed round Doric columns with entasis support the roof.

**ALTERATIONS:** A nicely detailed front screen door is prominent and appears to have been redone. Turned wooden balusters support the porch handrail do not appear to have been original. They are, however, nicely done and are somewhat sympathetic with the original design. Porches to the south and rear sides of the house are pleasant later additions to the original house. These exhibit lots of detailing such as spindle work and turned columns.
