ST. CHARLES HISTORIC PRESERVATION COMMISSION

ARCHITECTURAL SURVEY
ST. CHARLES CENTRAL DISTRICT
ST. CHARLES, ILLINOIS

DIXON ASSOCIATES / ARCHITECTS

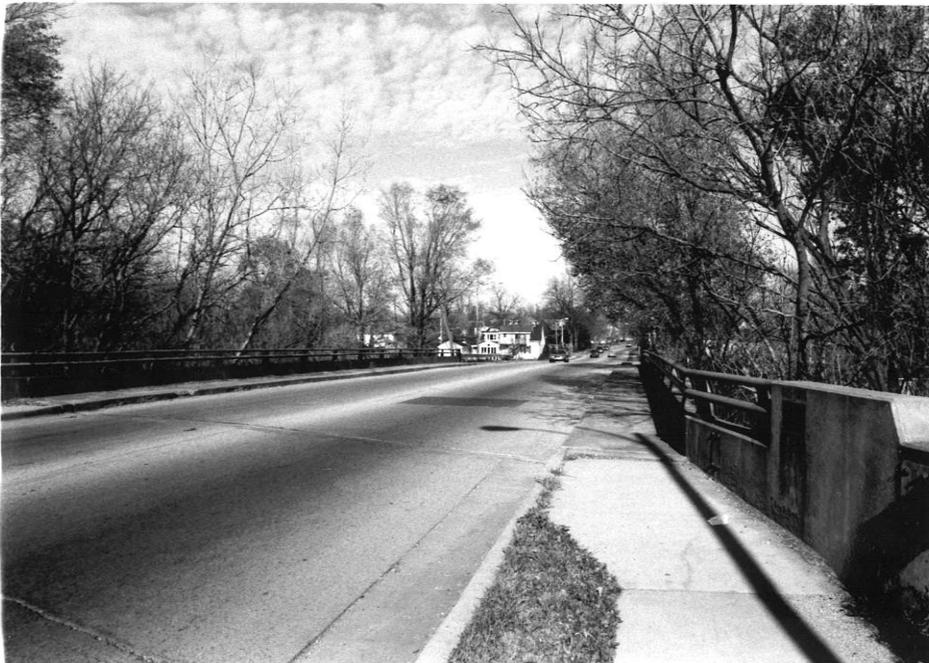
Route 25 (5th Avenue)
 Bridge

Style: Art Moderne

Date of Construction: 1969

Concrete abutments with steel guardrails.

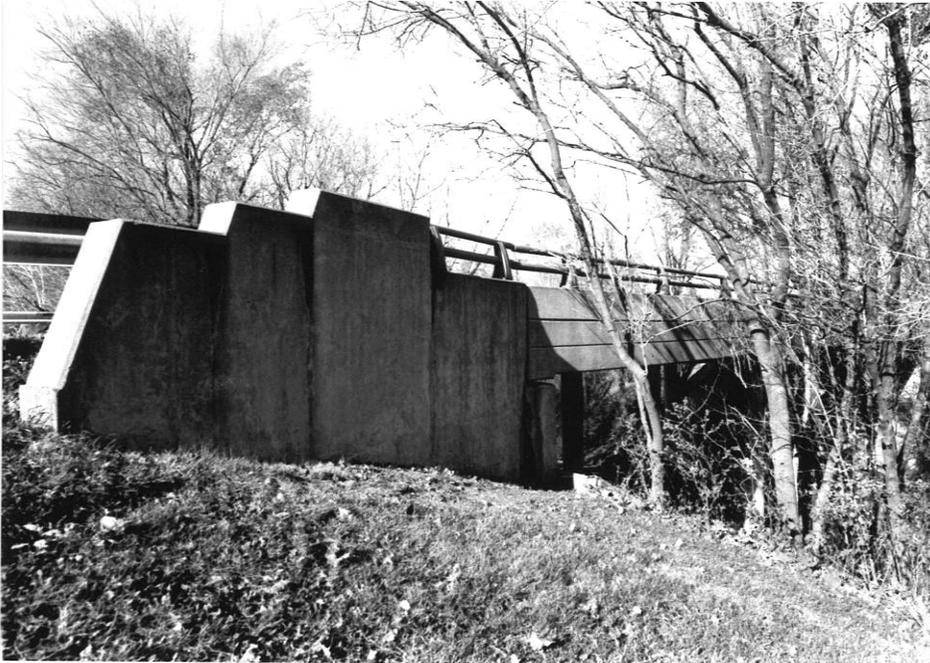
Route 25 (5th Avenue)
Bridge

Detail of Bridge.

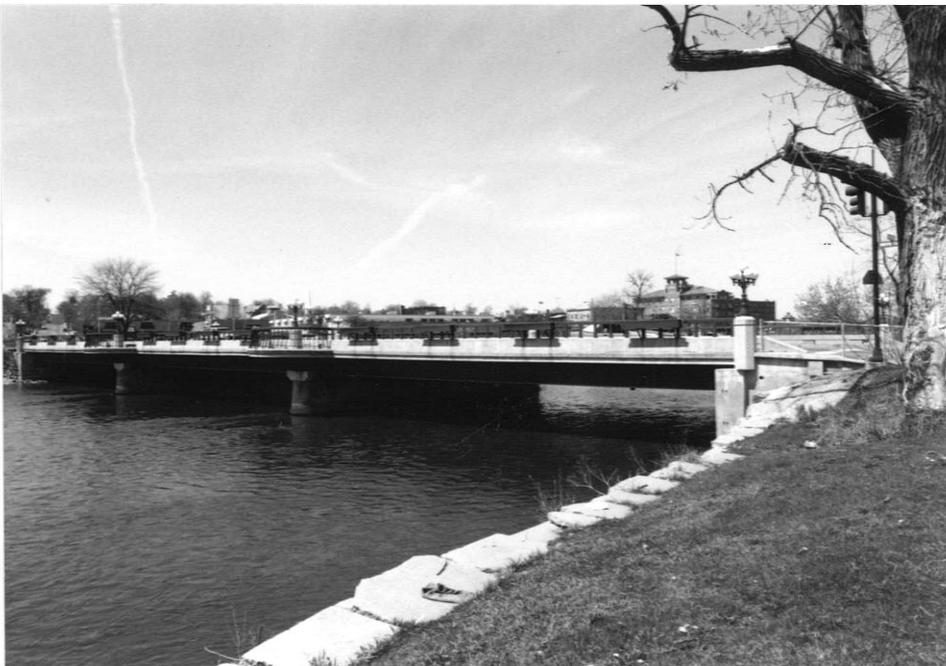
Illinois Street Bridge

Date of Construction: 1957

A gift of the Norris family and Colonel Edward Baker.
Renovated in the late 1980's.

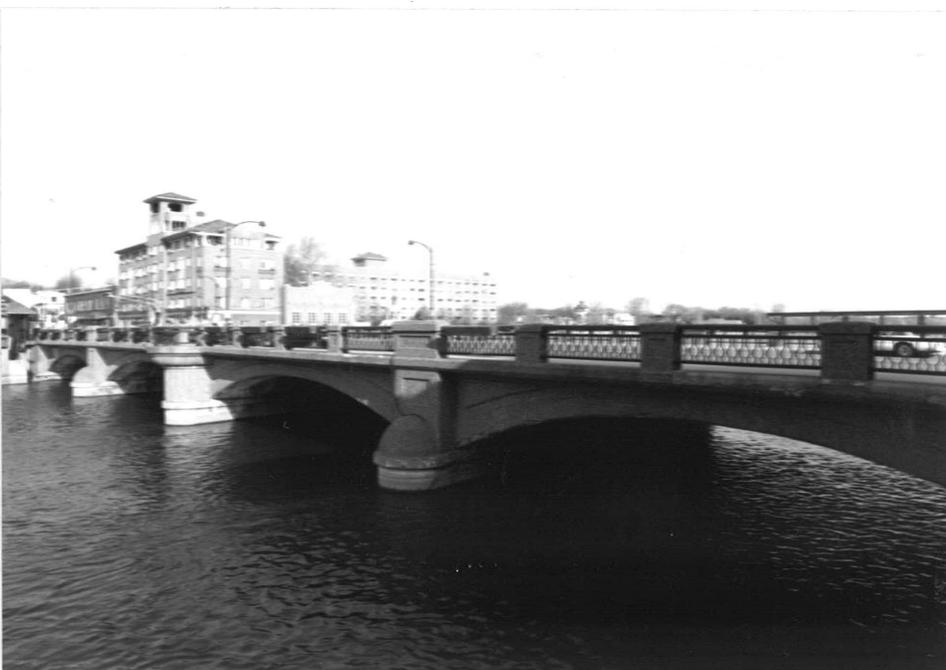
Main Street Bridge

Style: Neoclassical

Date of Construction: 1928

Railings and balusters designed by Lester Norris, inspired by a Roman bridge which he admired during travels abroad. Four bronze foxes placed by Herbert Crane. Concrete balusters replaced with Cor-Ten steel shaped to reflect in 1973. The solid railing sections were refinished in merrimac gravel.

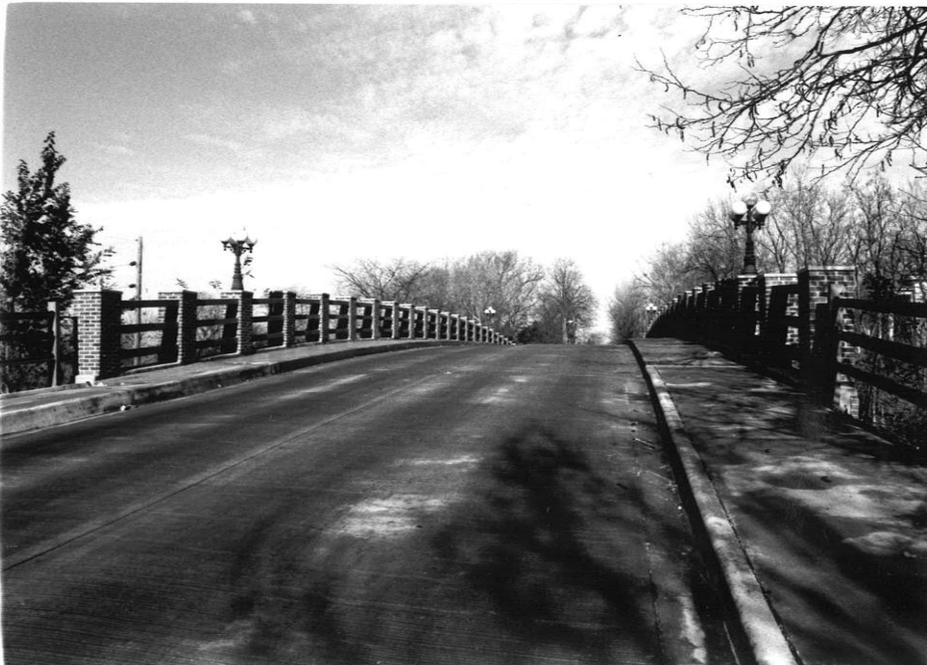
2nd Avenue Bridge

Date of Construction: 1985

Closely spaced brick piers. Four, five globe light fixtures on elaborate metal base. Heavy timber rails.

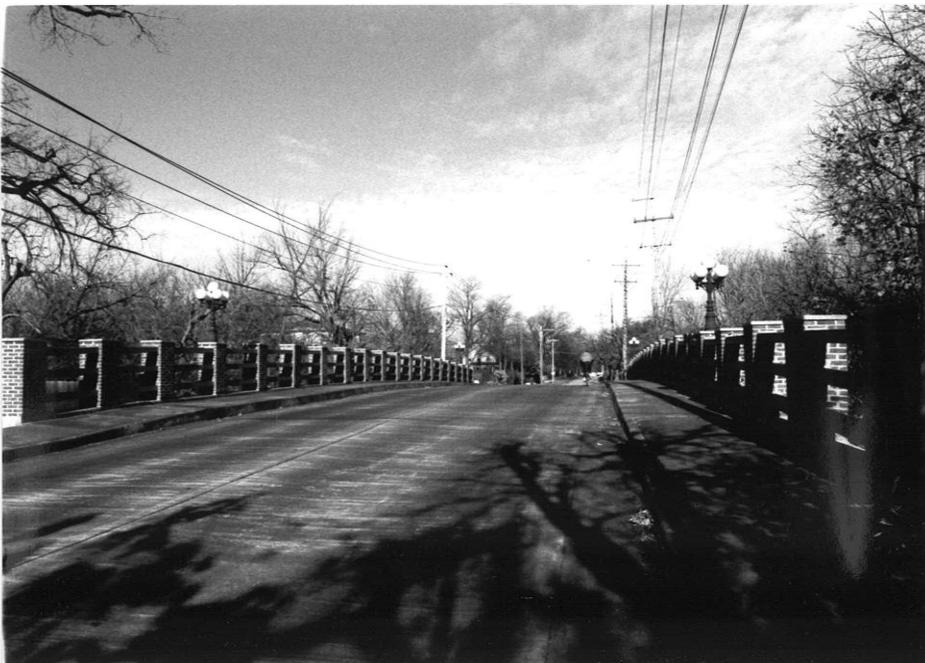
Third Avenue Bridge

Date of Construction: 1985

Closely spaced brick piers. Four, five globe light fixtures on elaborate metal base. Heavy timber rails.
