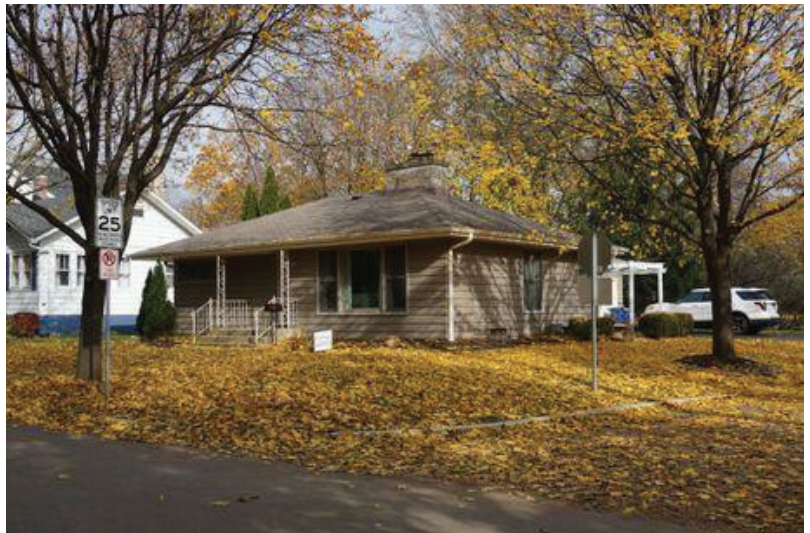
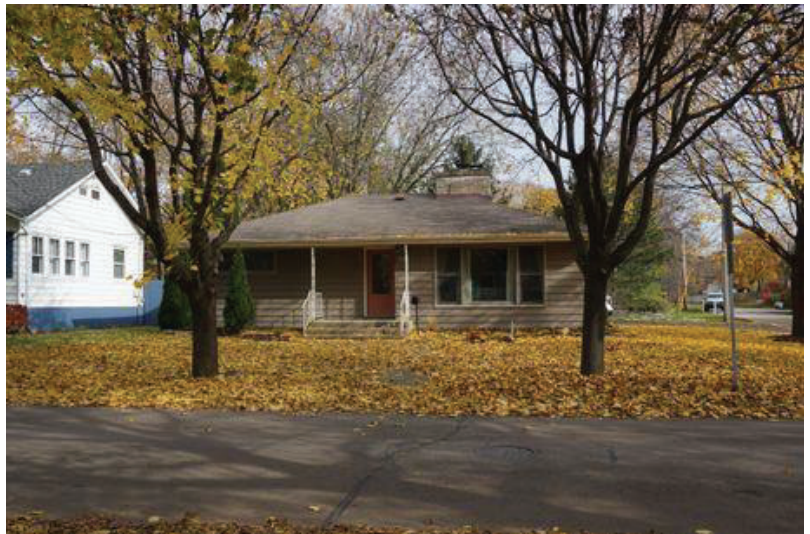
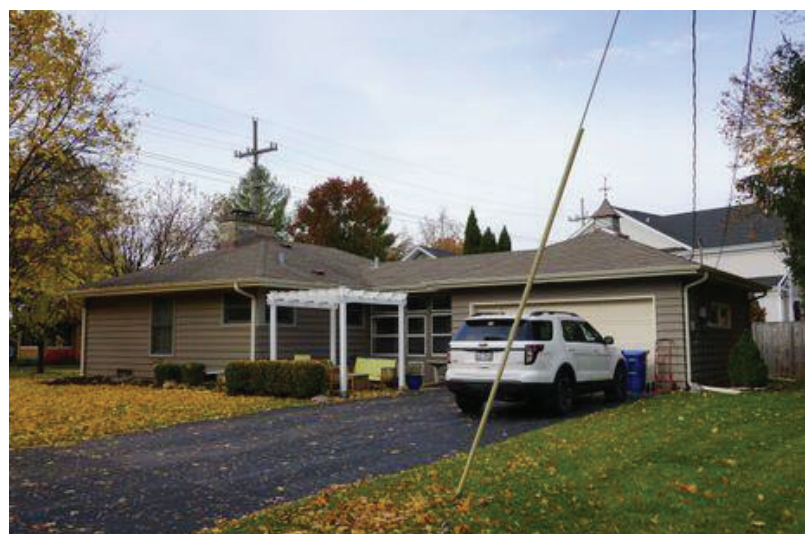
Harold E. Philips Residence

Low-pitched hipped roof with wide eave overhangs.

One-over-one wood double-hung windows (historic); Fixed wood picture window (historic).

The porch is covered by the deep eaves of the main roof, the outer edge of the roof over the porch is supported by open metal columns embellished with scrolling metalwork, the railing for the porch is simple metal railing with twisted spindles.

A hyphen has been added at the rear of the residence to connect the residence with the formerly detached garage.

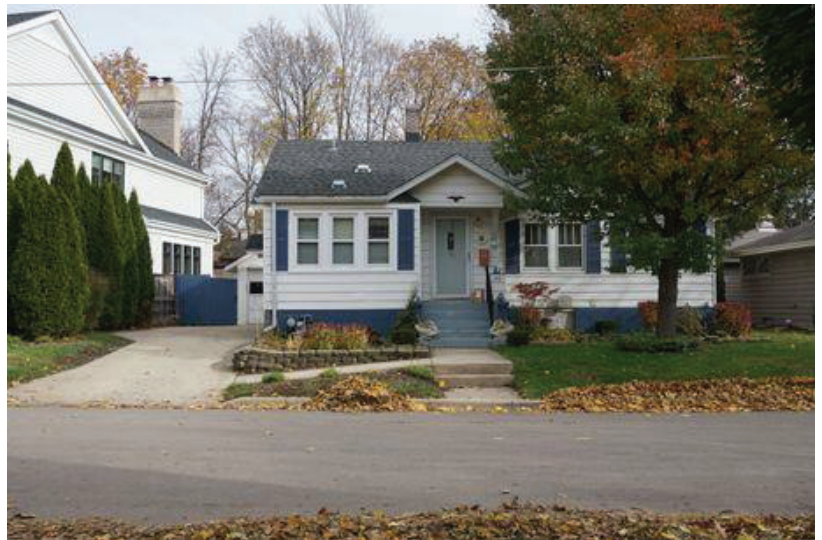
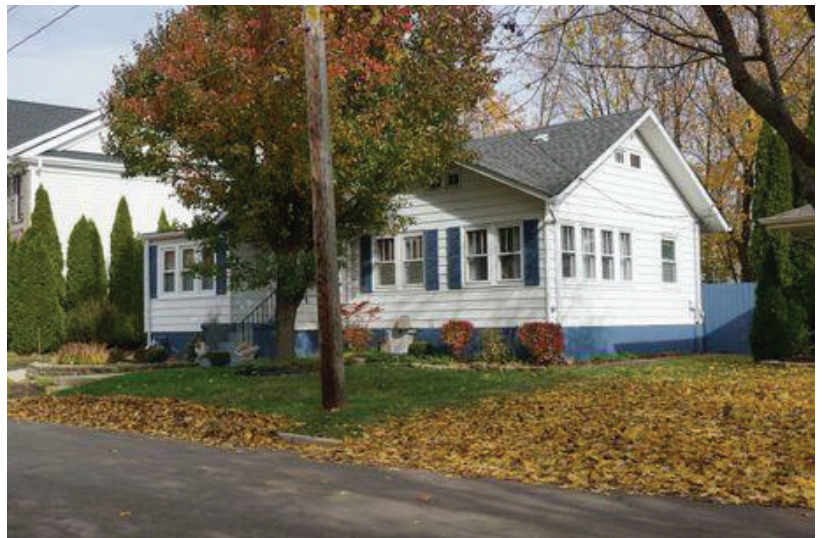
Erick and Hilma Schuberg Residence

Main side-gabled roof with a projecting front-facing gable at the south end of the front (west) facade.

The exterior has been re-sided; A porch at the north end of the front (west) facade appears to have been enclosed based on the difference in windows and window frame construction.

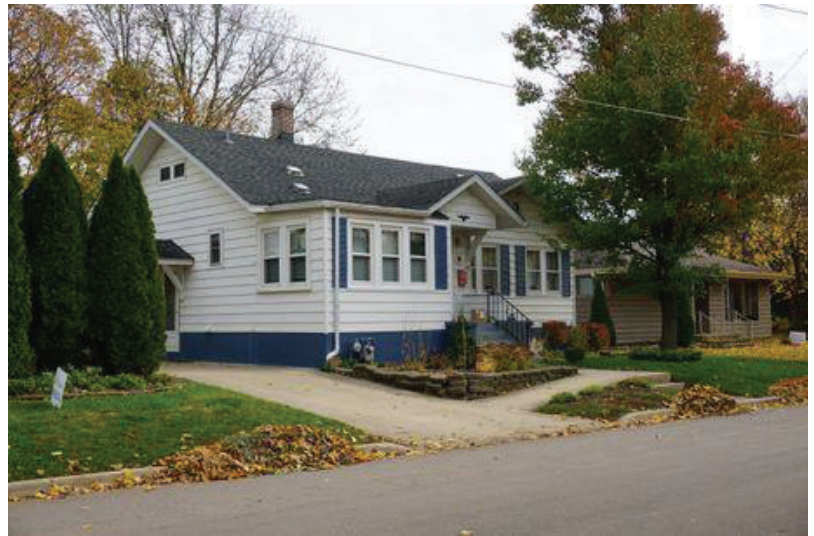
Three-over-one wood double-hung window (historic); One-over-one vinyl double-hung window (non-historic); Two-light wood hopper or casement window at attic (historic).

Original/historic windows; Shutters.

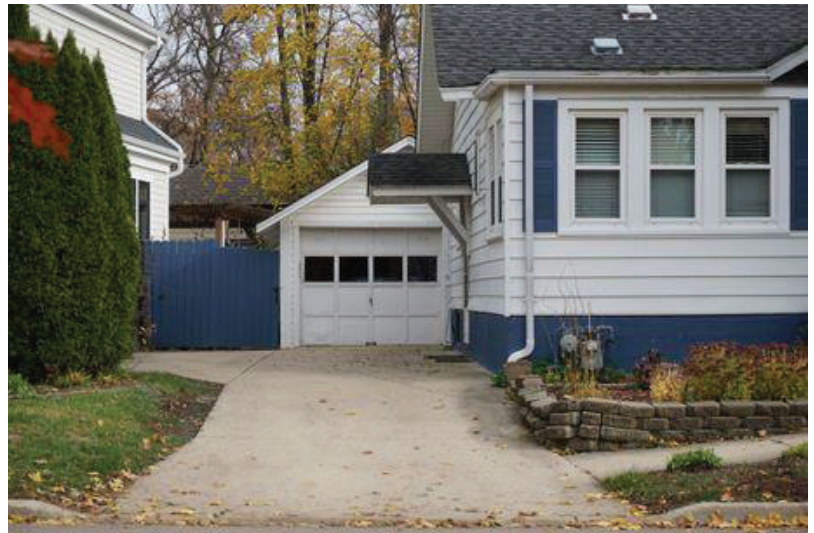
Aluminum paneled door with a central rectilinear light (non-historic) at the main (west) entrance, the door at the side (north) entrance is not clearly visible from the public right-of-way.

The main (west) entrance is protected by a projecting front-facing gable canopy, supported by a large triangular bracket, a similar gabled canopy with triangular brackets is located at the side (north) entrance.

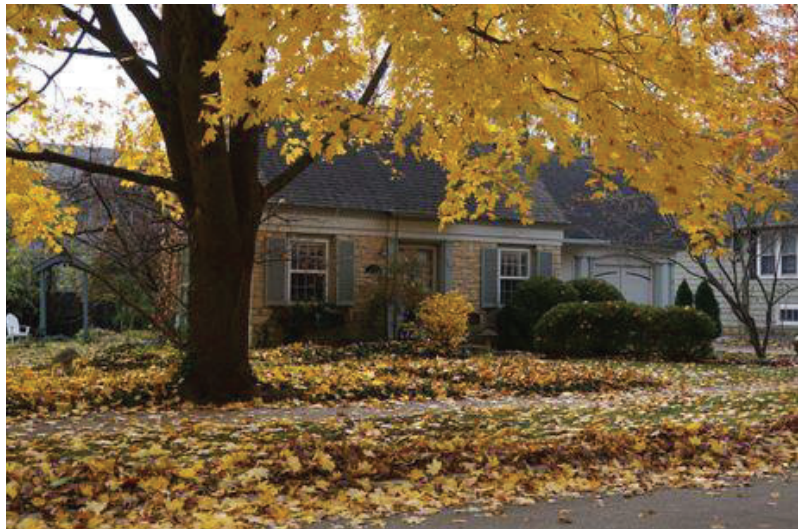
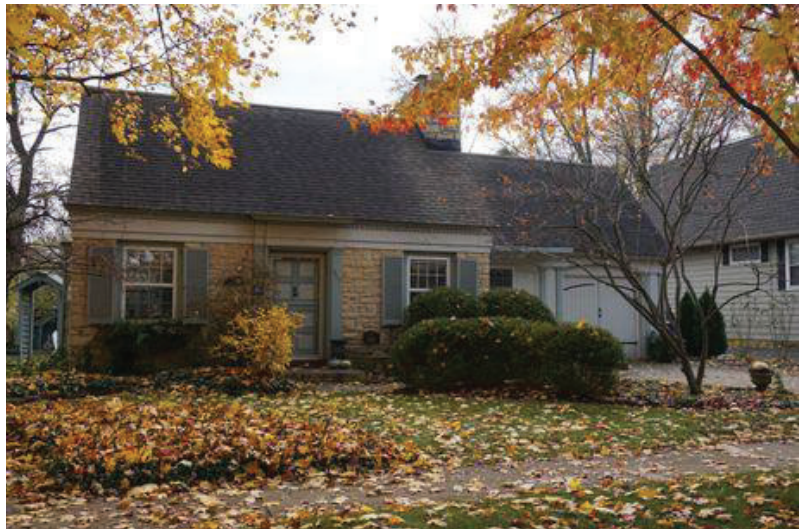
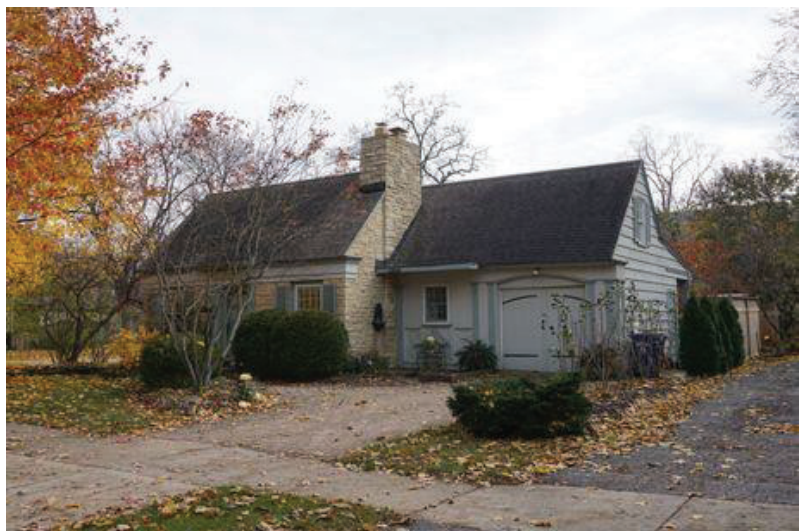
Zook House

Side-gabled main roof form with a projecting cross-gable bay at the rear (south) face of the main roof; The main roof is accentuated by a wide, dentillated fascia board.

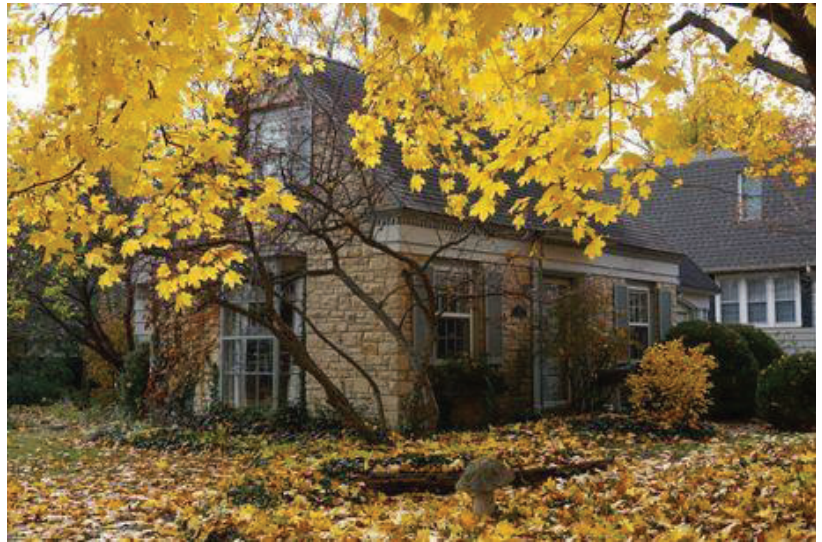
Six-over-six wood double-hung windows (historic); Eight-over-eight wood double-hung windows (historic); Multi-light fixed steel window at the bay window at the side (east) facade (historic).

Hexagonal bay window at the side (east) facade; Original windows; Shutters.

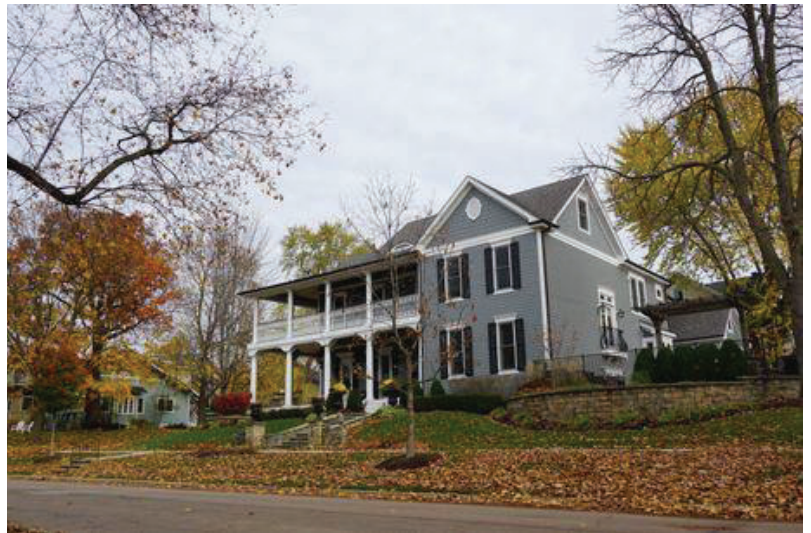
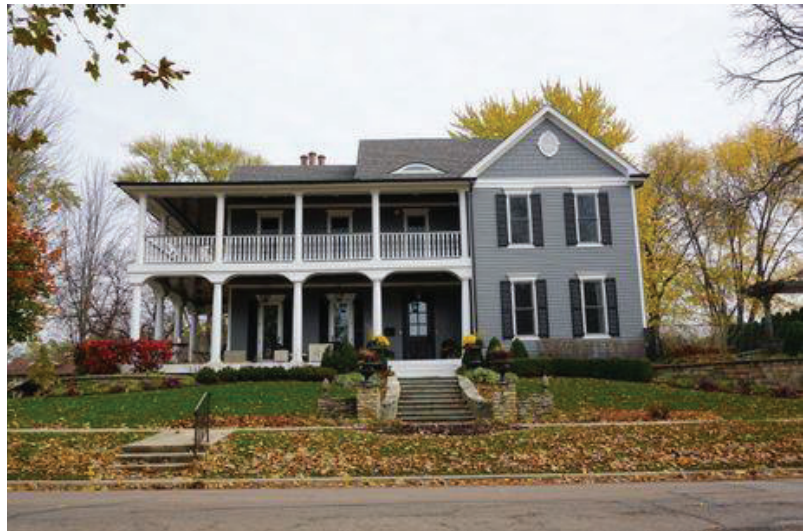
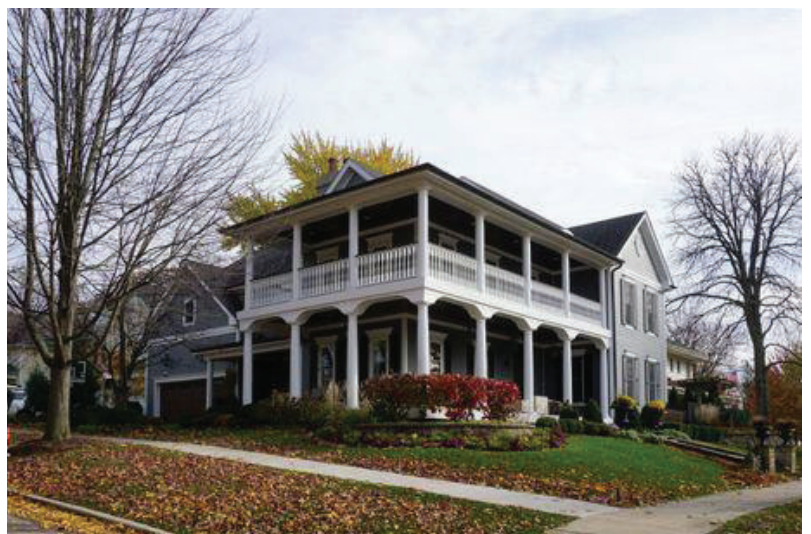
Main roof is a cross-gable with projecting gable ends at the north and west; Roof over the added two-story veranda is hipped; Eyebrow dormer at the west face of the roof.

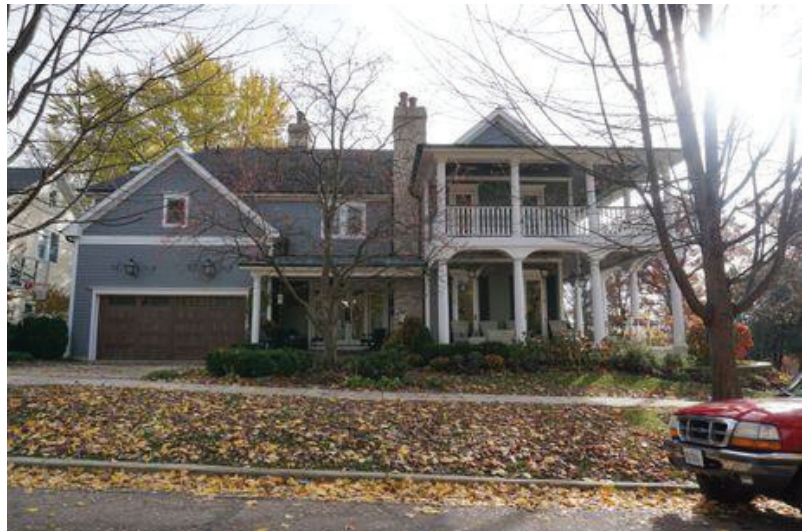
One-over-one double-hung; Full-light casements or awning.

Classical window hoods.

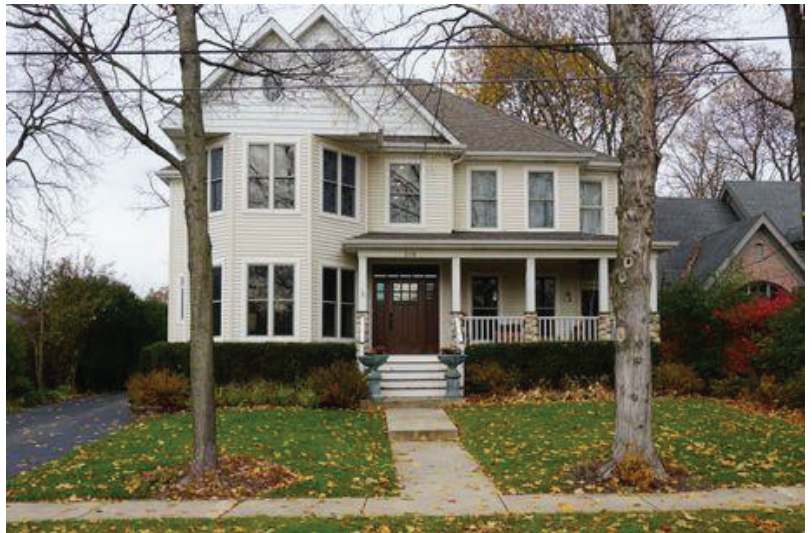
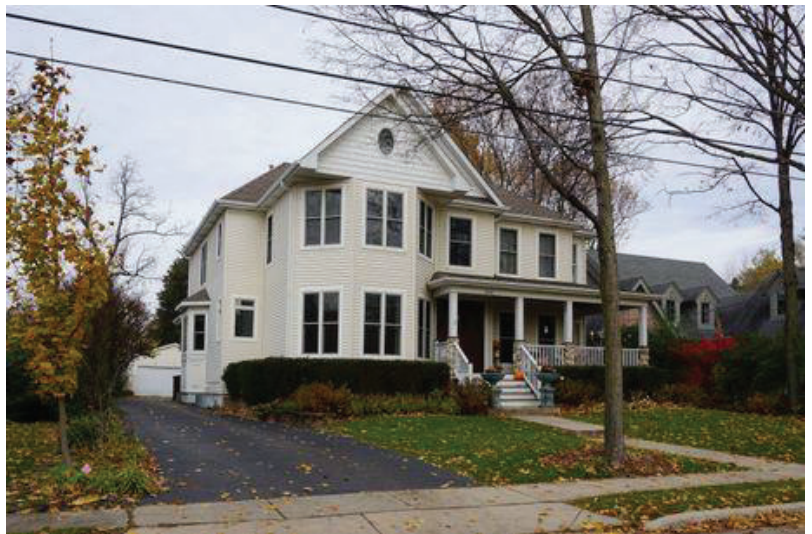
Intricate roof form with a main hipped roof with a gabled end at the south facade and cascading hipped roofs off of the main hipped roof at the east and west facades.

The porch spans approximately two-thirds the width of the front (south) facade. The roof of the porch is supported by a series of square wood columns resting on piers clad with faux-cobblestones.

Residence has been re-sided; Porch has been rebuilt; Windows and doors have been replaced.

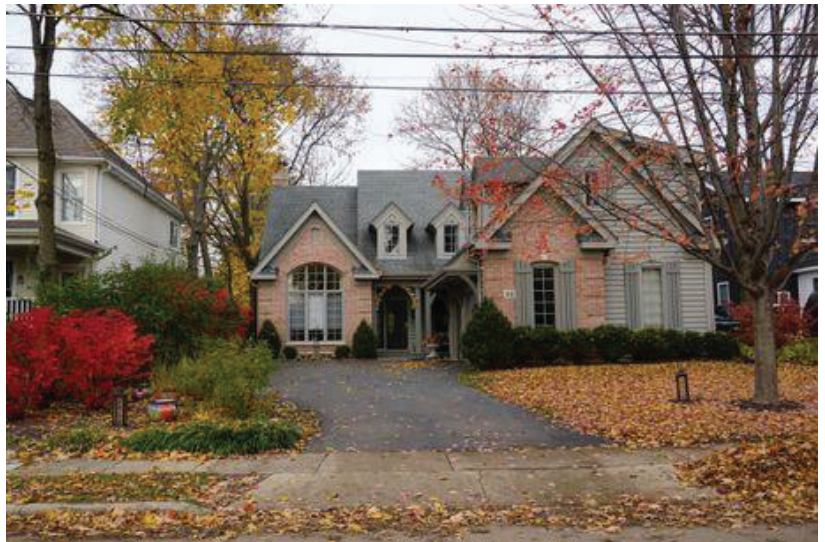
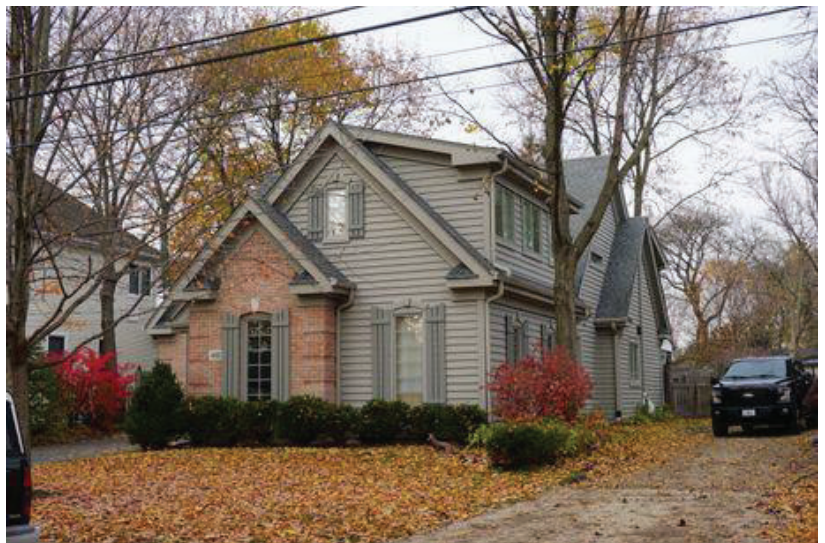
Main one-and-a-half-story side-gabled roof form with one-story side-and-front gabled projections at the west, east, and south facades; Shed wall dormer at the east facade; Gabled dormers at the south and west facades; Gabled dormers and front-facing gabled ends have wide raking cornices and/or cornice returns to mimic a classical pediment.

Windows are set within segmental arch openings crowned with a faux-brick header and faux-stone keystone or trimmed with a piece of arched wood moulding.

Square columns support the roof over the porch and are embellished with simple curved wood brackets.

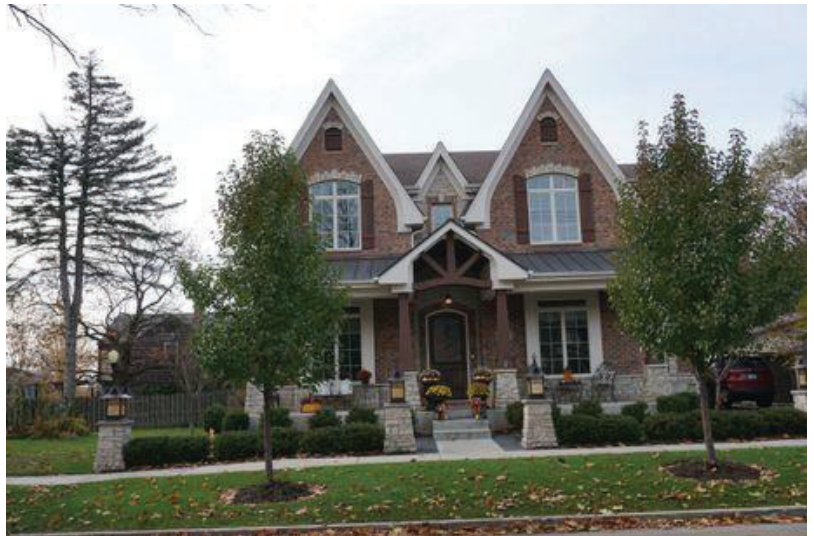
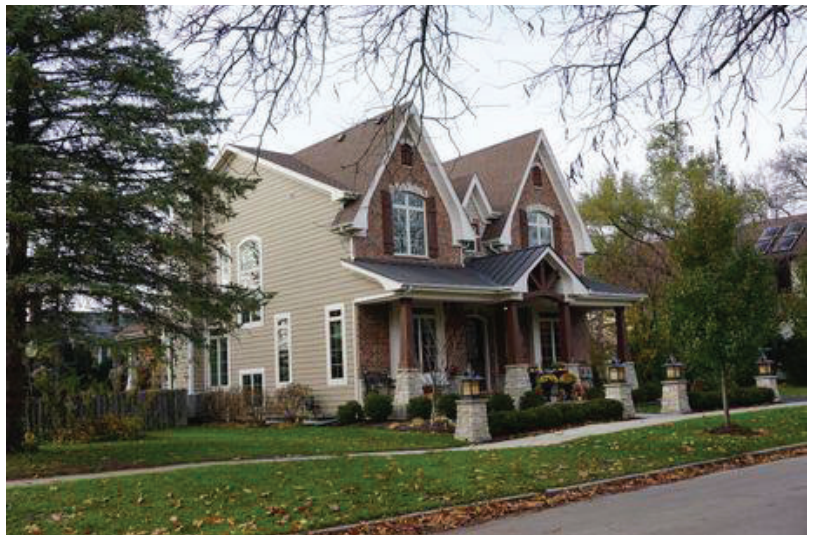
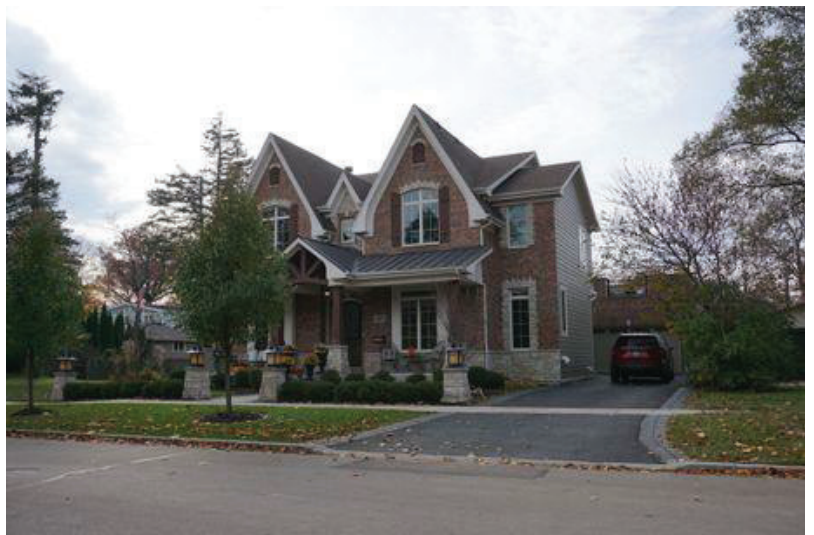
Main side gable roof form with a prominent pair of front-facing gable ends at the front (east) facade and a lower through-cornice gable roof between the pair, all front-facing gables are embellished with a raking cornice and boxed eave.

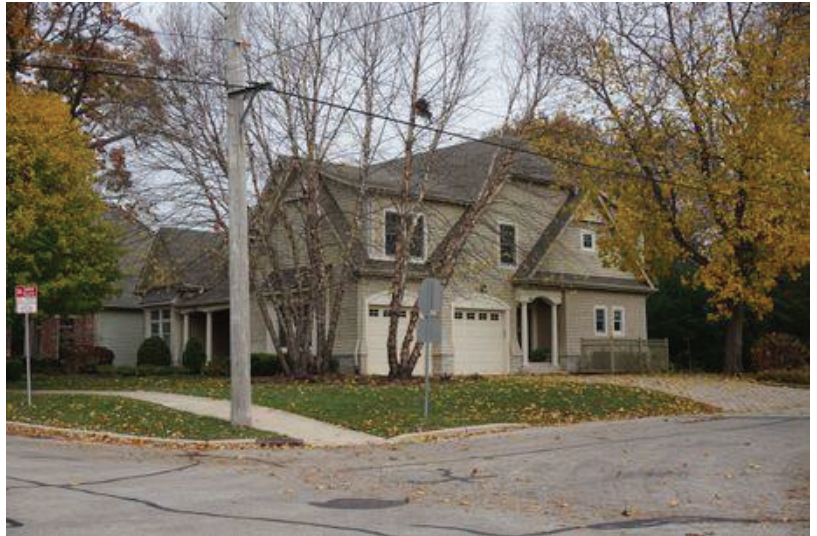
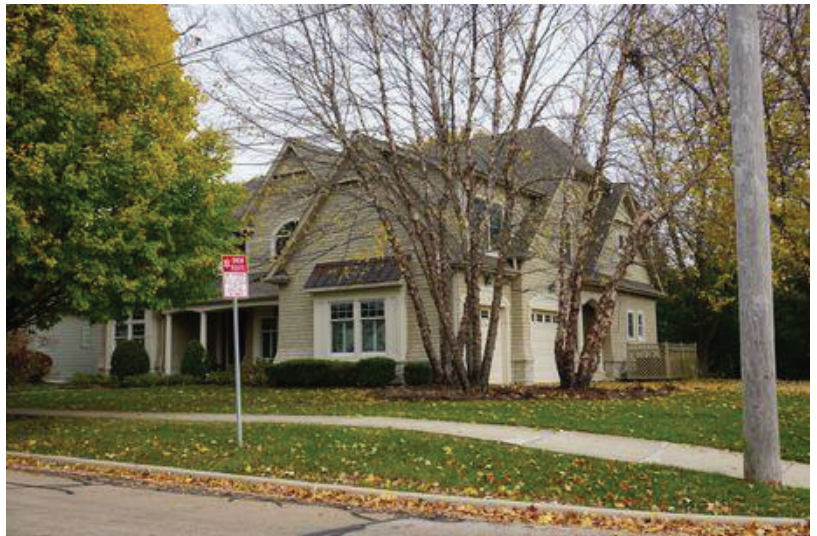
Complex gable-on-hip roof form; Gabled dormers; Gabled wall dormers.

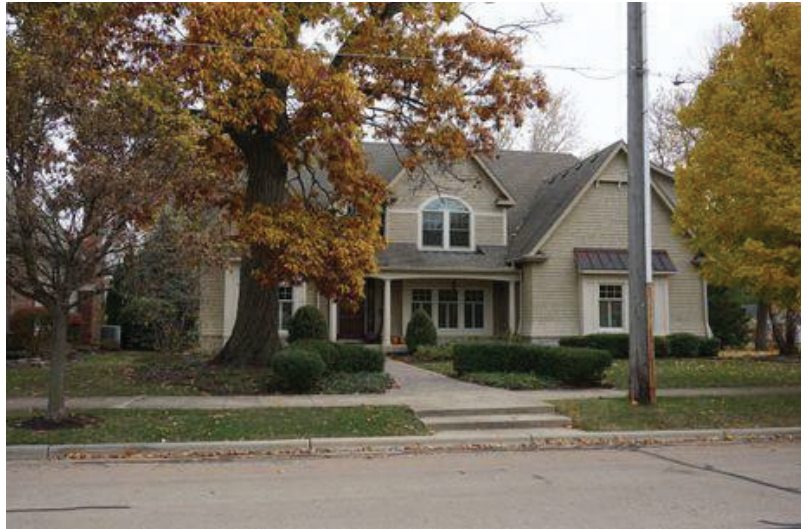
Oriel windows with a pair of six-over-one double-hung windows at the west facade; Windows are original to the initial construction.

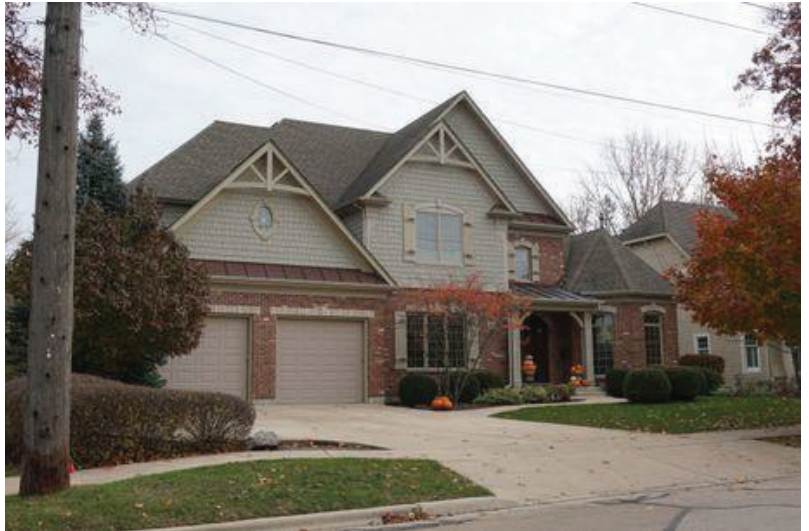
New Traditional

Steeply pitched hipped roof with projecting gabled ends, the face of the gabled ends are clad in shingles and ornamented with decorative vergeboard.

Multi-light fixed windows (Original); Multi-light transom windows, mullions mimic historic Gothic tracery (Original); Multi-light oval window (Original).

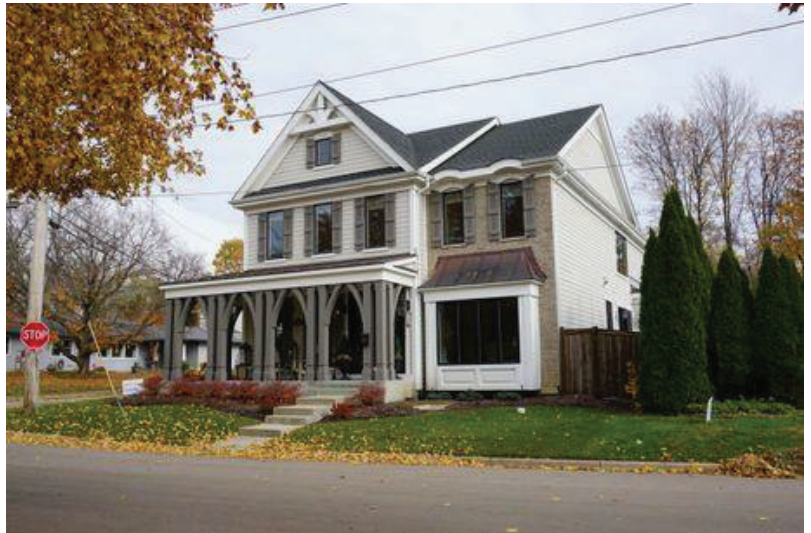
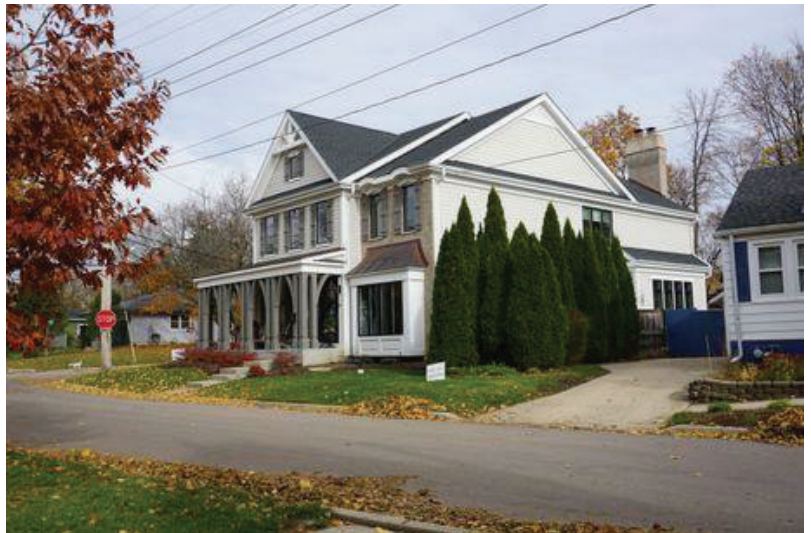
The main roof is a pair of side-gable roofs with a front-facing gable roof wing projecting from the west face of the main roof and a cross-gable roof over the attached garage section at the rear of the residence; The face of the front-facing gable wing is ornamented with vergeboard.

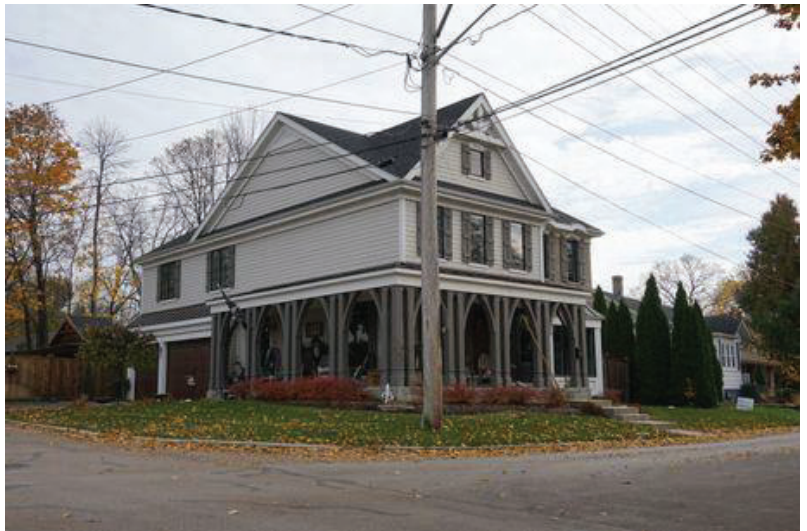
Plank shutters; At the front (west) facade the window at the attic and the two windows at the south end of the second floor are crowned by faux arched headers; Oriel window with a Mansard roof at the south end of the front (west) facade at the first floor.

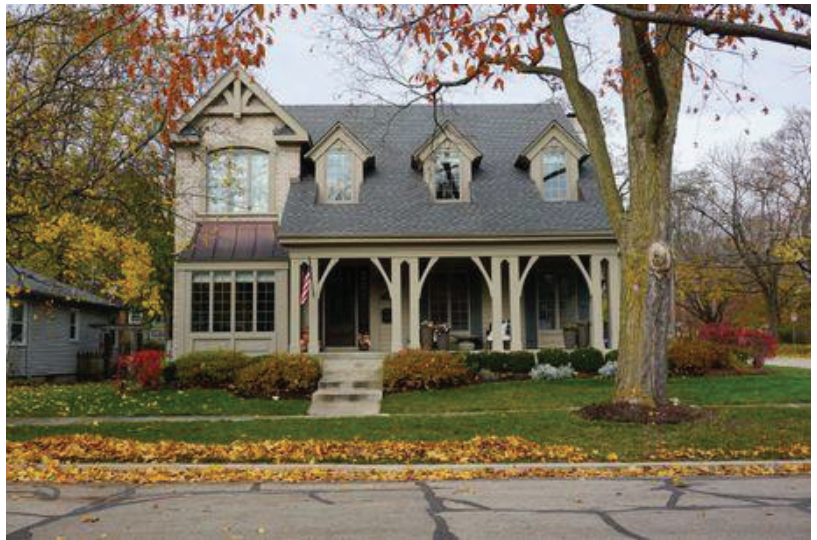
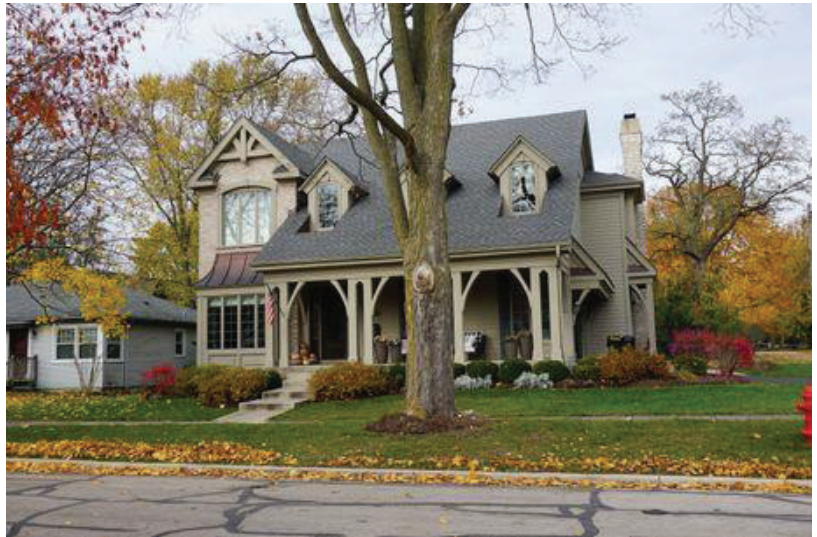
The residence features a complex roof form with a main roof that is a side gable with a projecting full-height wing at the rear (northeast corner) with a cascading hipped roof and a full-height projecting wing at the front (southwest corner) with a cross gable roof that is ornamented with a raking cornice, decorative vergeboard, and cornice returns; Gabled dormers at the front (south) face of the main roof.

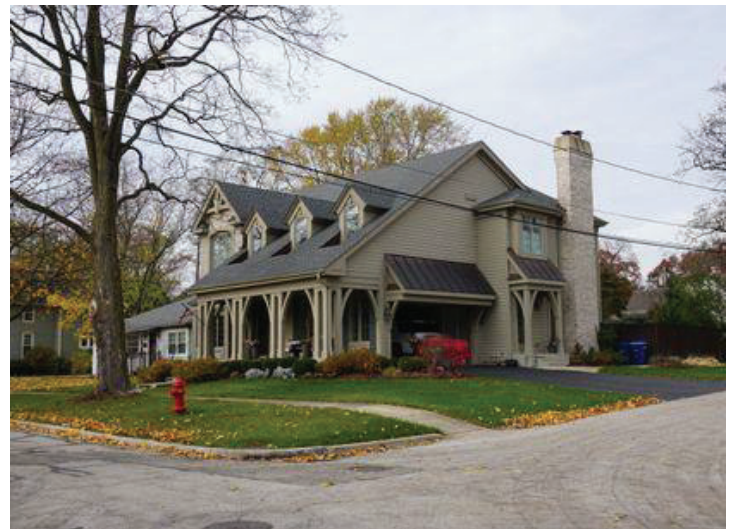
Some windows are ornamented with a wood surround which mimics a historic arched window header; Oriel window with a faux-Mansard roof at the first floor of the west end of the front (south) facade; Oriel window with a shed roof at the first floor of the side (west) facade; Square bay window at the second floor of the side (east) facade.

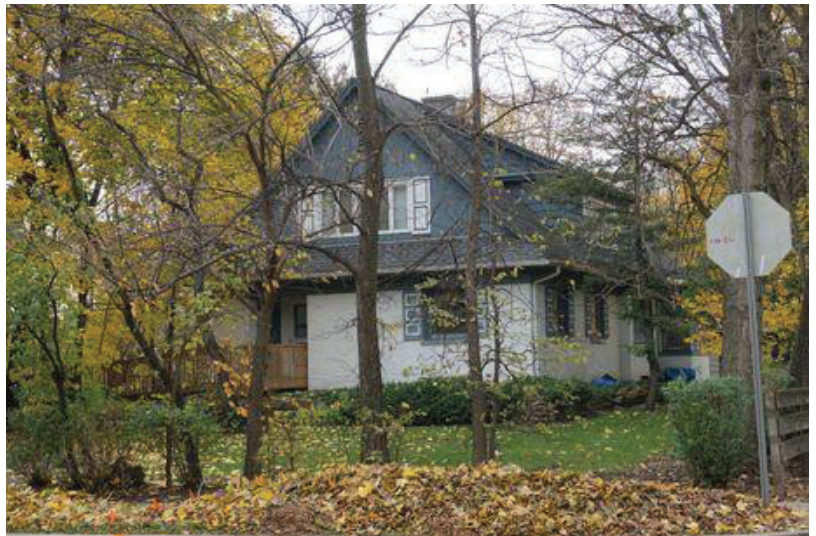
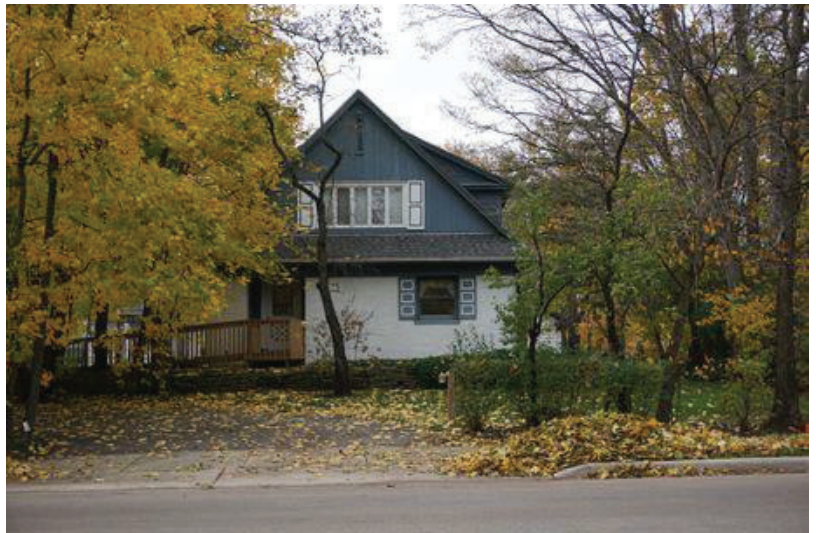
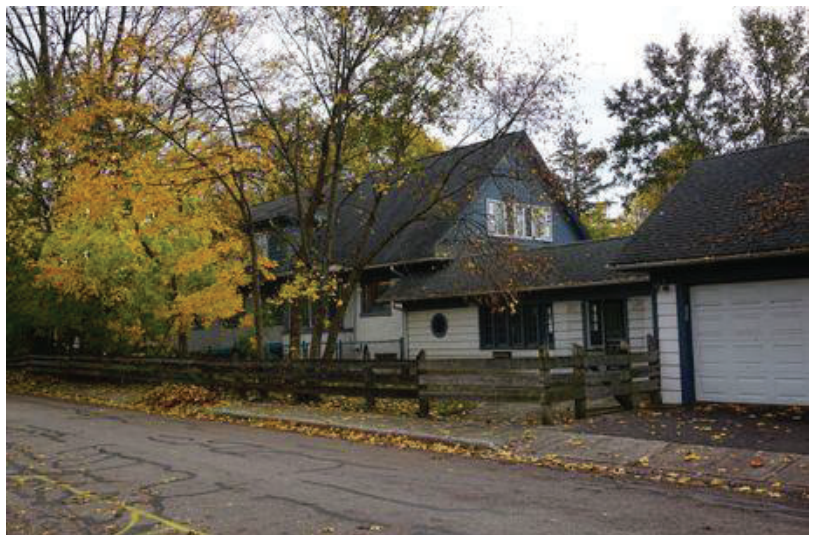
Shed roof dormers at side (north and south) facades; Gabled end of the main roof features a simple raking cornice and is clad in vertical wood siding.
