**BUILDING INFORMATION****HISTORIC NAME/USE**

Charles Sanborn-William H. and Daisy B.  
Morter Residence

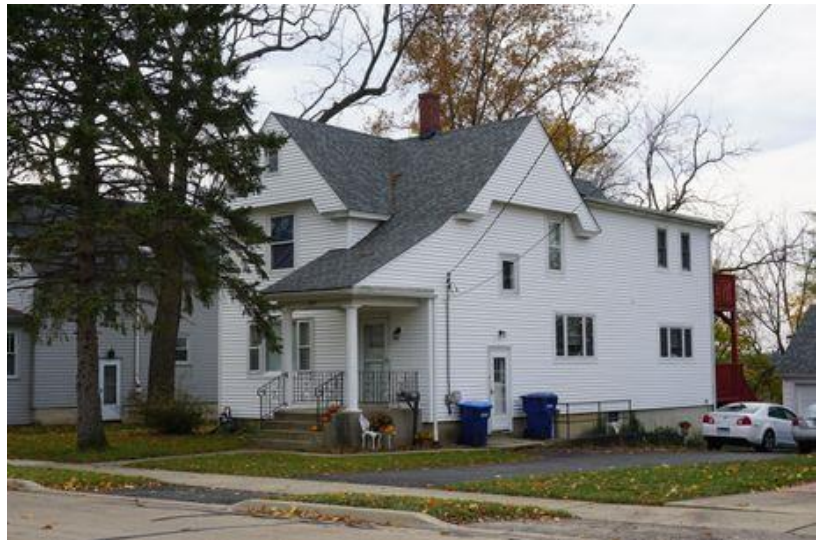
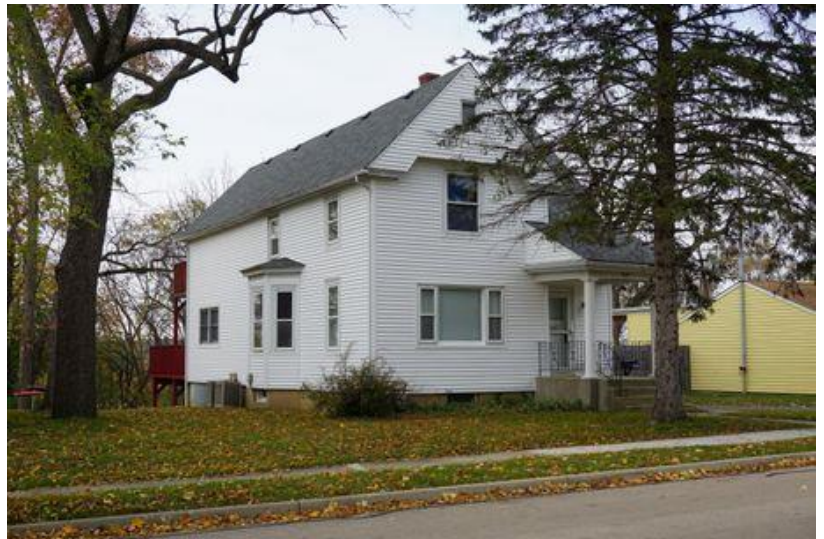
Main front-facing gable roof form with a projecting gabled wing at the north face of the main roof; The face of each gable projects from the main facade.

Hexagonal bay window at the center of the first floor of the side (south) facade.

Wood stile and rail door with three lower horizontal panels and an upper large, square light at the main (east) entrance; Aluminum paneled door with an upper light at the side (north) entrance.

The porch is covered by a shed roof that extends from the eaves where the two gabled roofs meet, the roof is supported by a pair of cylindrical fluted Doric columns located at the exterior corners of the porch.

The exterior has been re-sided; Windows have been replaced; Railing at the front porch has been replaced; The eaves of each gabled roof have been boxed in.

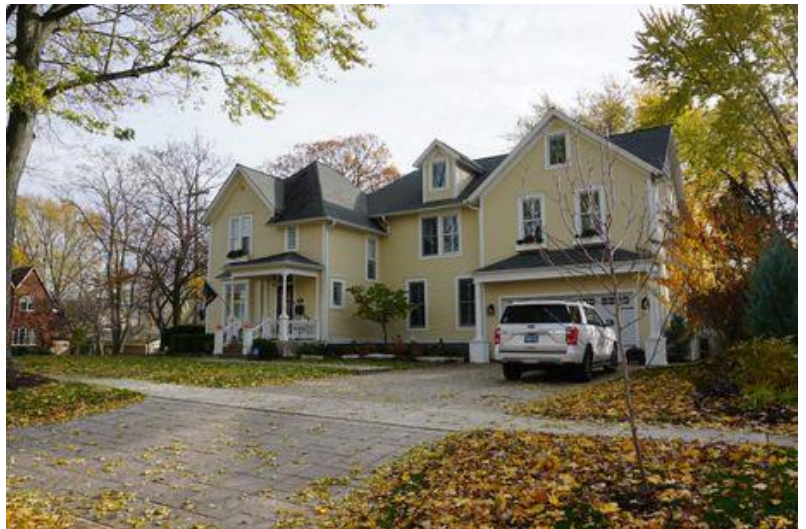
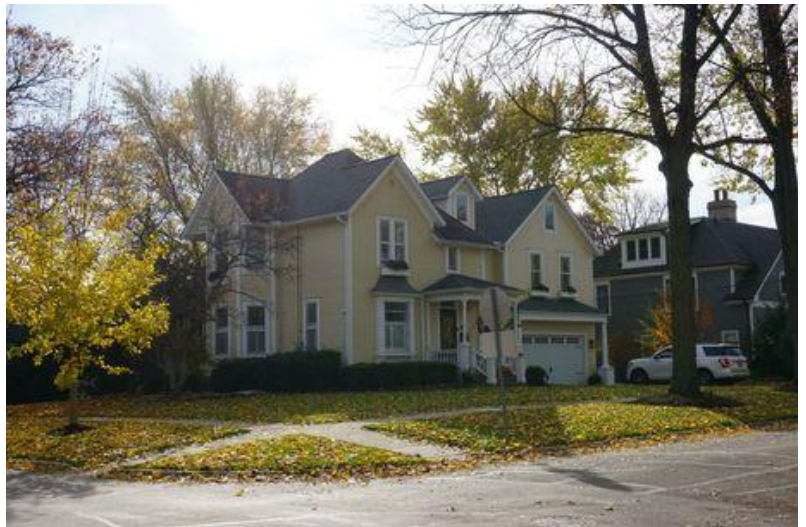
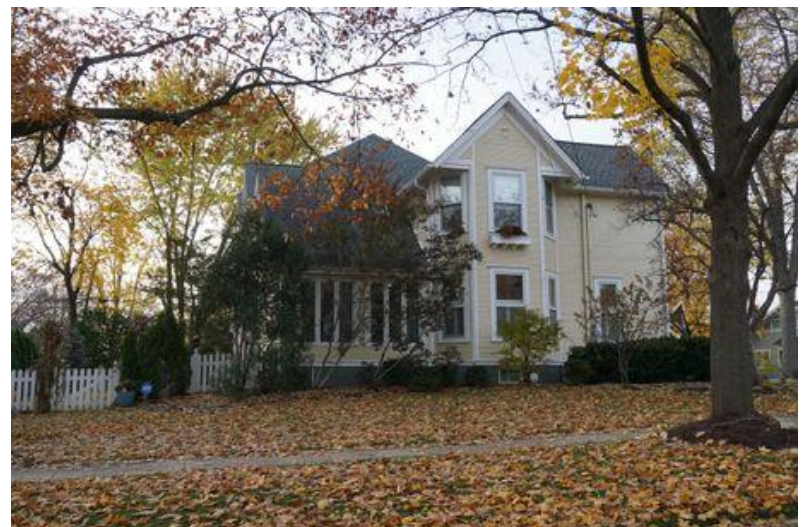
Gable-on-hip roof form; Gabled dormers; Full-height projecting gabled wing with chamfered corners at the side (east) facade.

Oriel window at the first floor of the front (north) facade, the window is crowned by a Mansard roof, supported by a pair of classical corbels at the base, and the window opening is flanked by rectilinear Doric pilasters; Original/historic windows remain at the first floor of the side (west) facade and above the front (north) entrance porch at the second floor; Some windows are ornamented with a wide, rectilinear trim crowned with a dentillated window hood which mimics a classical entablature.

The porch is covered by a low-pitched hipped roof supported by four tapered cylindrical Doric columns which rest on rectilinear piers; Dentillated fascia; Simple railing with turned spindles.

A large addition has been constructed at the front (north) facade of the building; Exterior re-sided; Windows have been replaced; Former porch at the southeast corner of the residence has been enclosed.

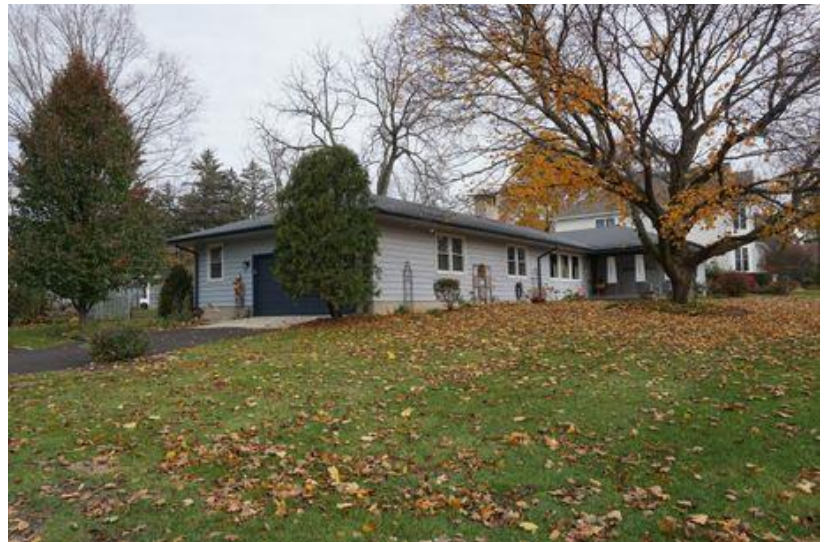
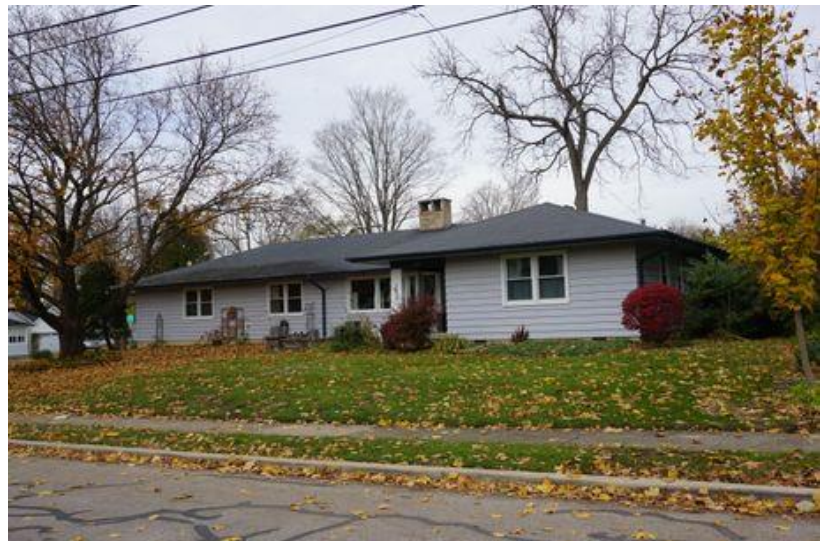
Cross-hipped roof form.

Semi-enclosed entrance porch at the interior corner of the exterior where the two hipped roofs meet.

The hipped roof on the north-south axis extends over the porch and is supported by two battered wood columns on brick piers.

Windows replaced; Residence re-sided.

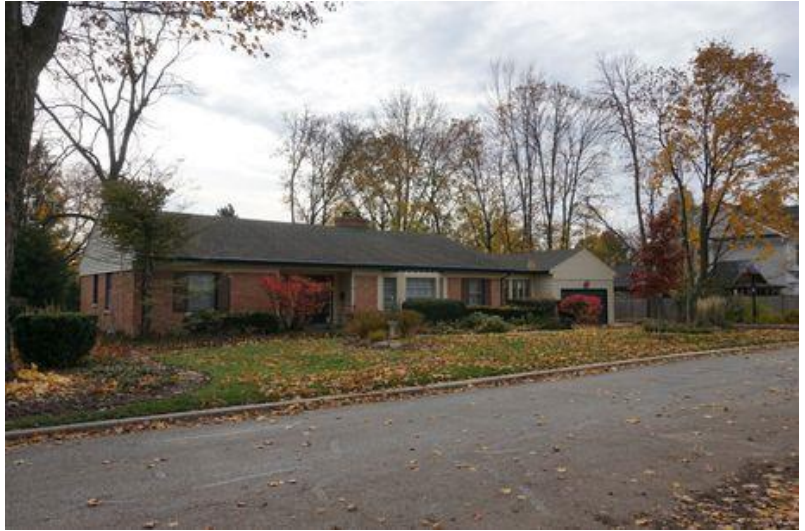
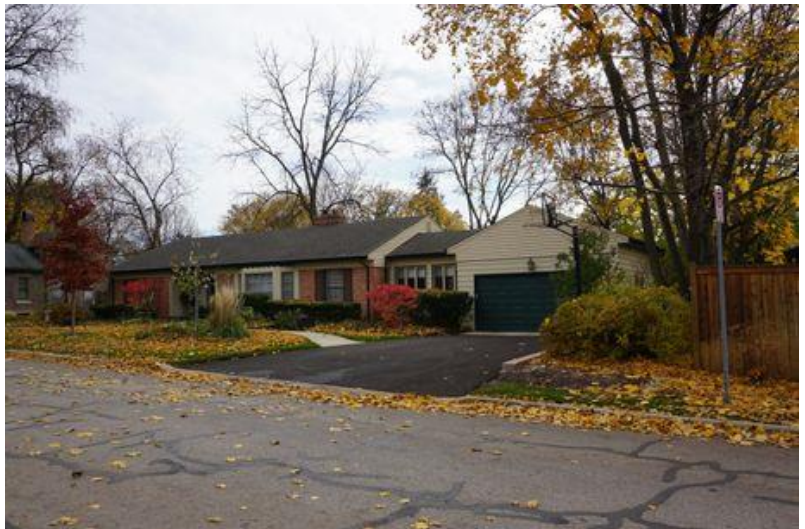
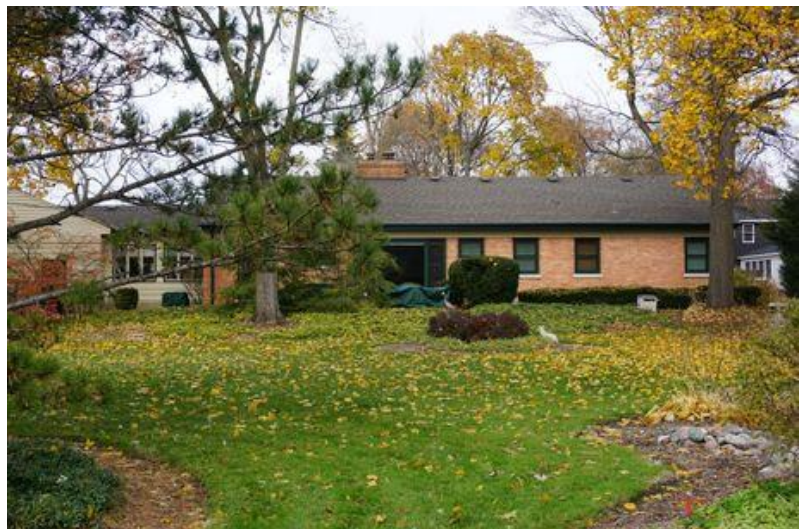
Side gable roof form.

Original wood windows; Bay window at the center of the front (south) facade.

Non-historic door is flanked by five-light historic wood sidelights; Entrance is recessed from the main plane of the front (south) facade to create a protected entrance area.

Hyphen and attached garage have been re-sided. Windows at the hyphen may be replacements.

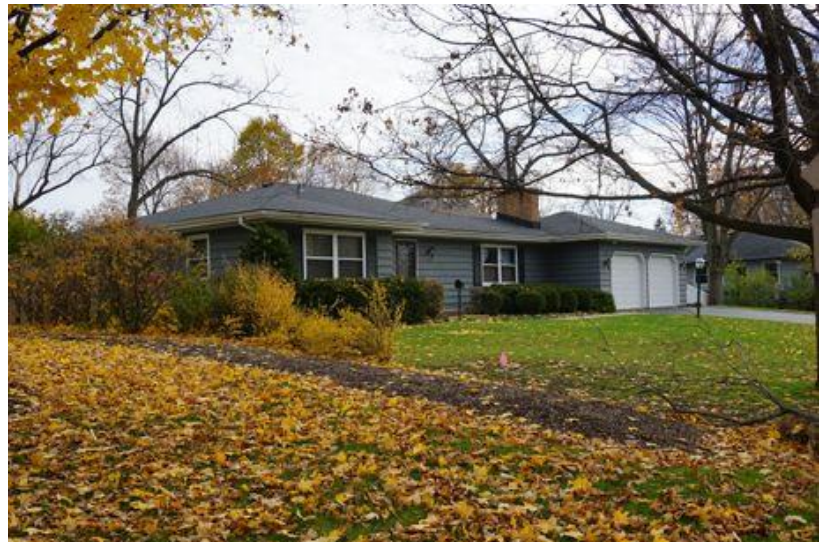
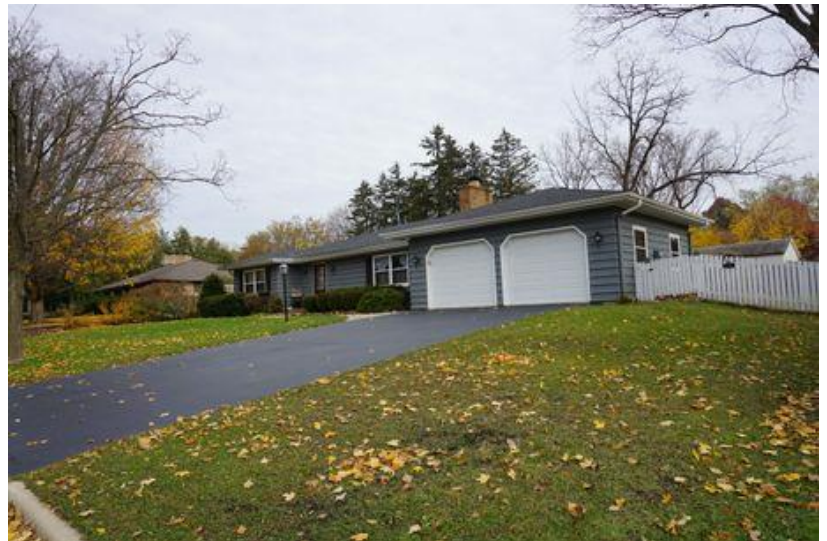
Cross-hipped roof with cross-hipped roofs over the living room alcove and garage; Wide eave overhangs.

Stile and rail wood door with large upper light and lower panels (may be historic, but difficult to see due to storm door); Pair of metal overhead garage doors.

Opening for the garage doors is chamfered at the upper corners.

Windows have been replaced.

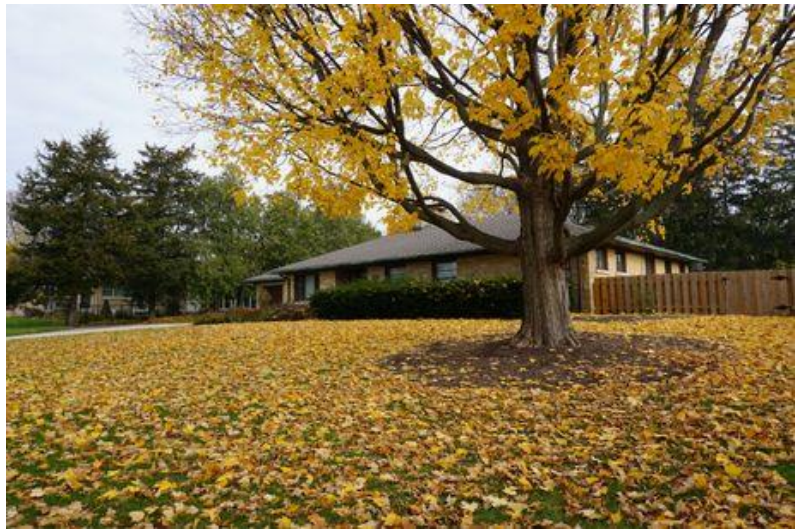
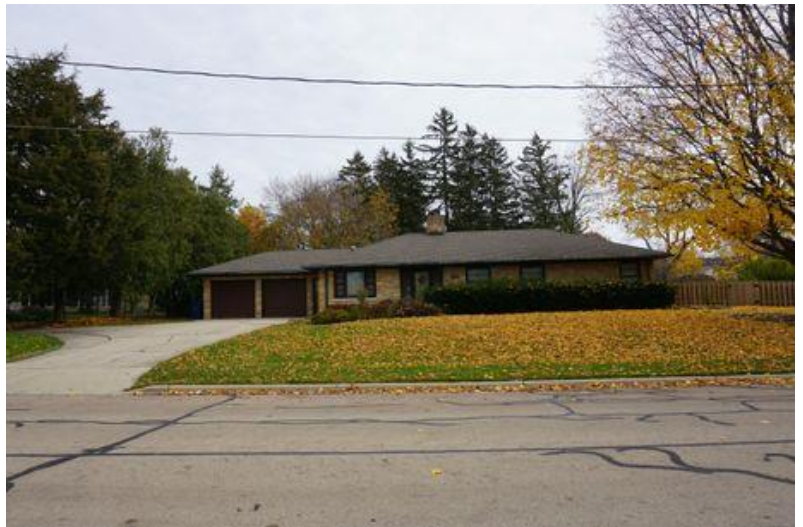
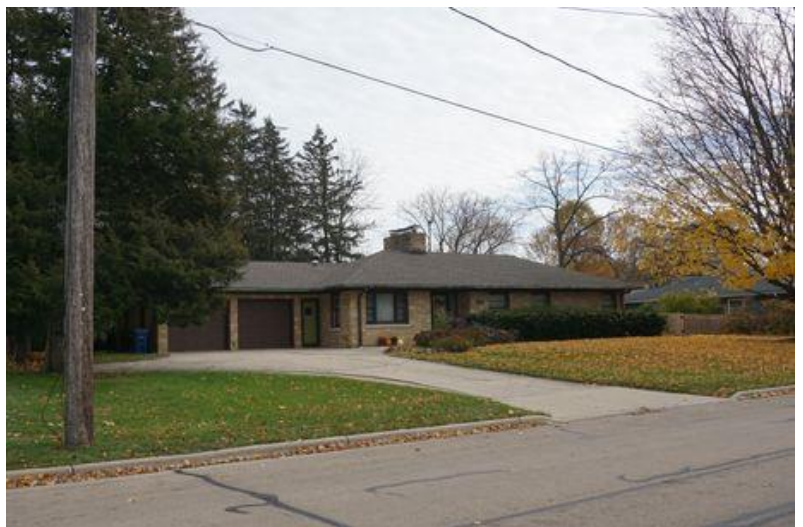
Cascading hip roof form; Wide eave overhangs.

Two-over-two (horizontal mullions) wood double-hung windows (historic); Fixed wood picture window (historic); Glass block (may be historic, but difficult to see from public right-of-way)

Main entrance door is flanked by glass block sidelights.

Overall Ranch form; Cascading hipped roof form; Wide eave overhangs; Original windows; Formstone exterior cladding.

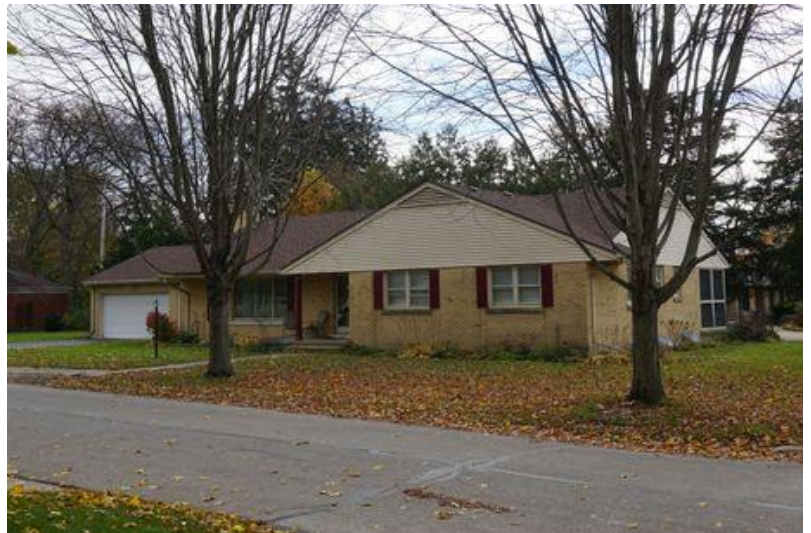
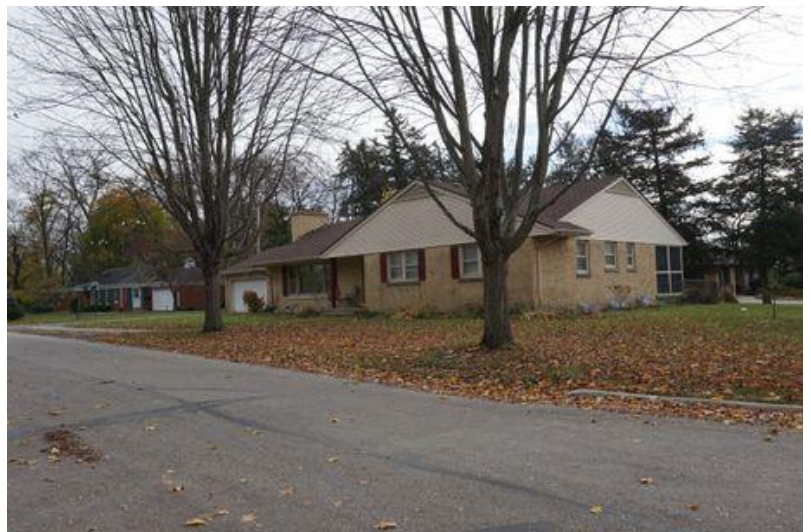
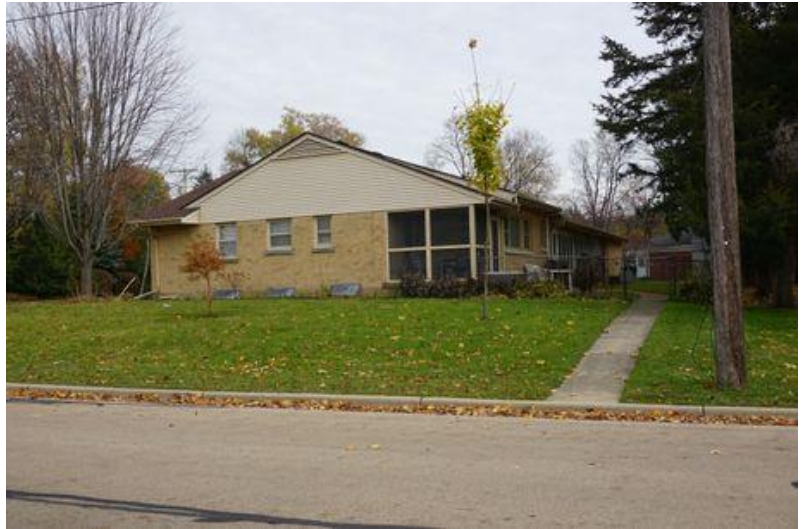
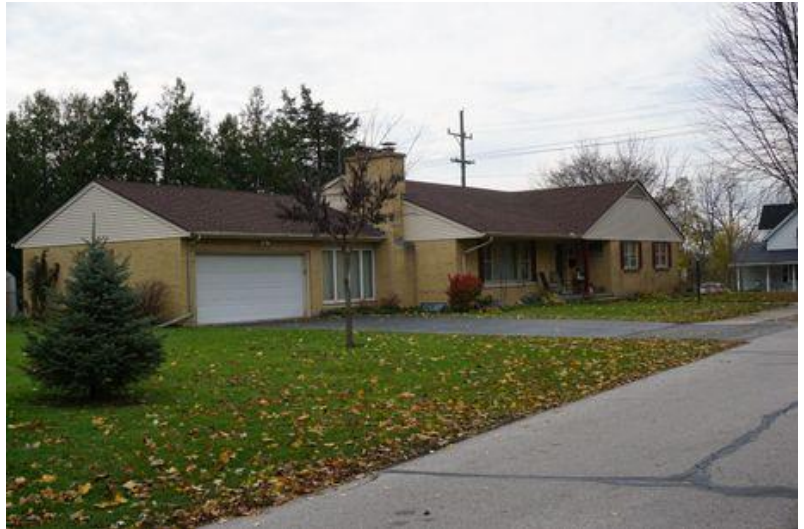
Cross-gable roof form; Wide eave overhangs.

Two-over-two (horizontal mullions) wood double-hung windows (historic); Fixed wood picture window (historic); Vinyl casements (non-historic).

Flush wood door with three square lights down the center (historic).

Front entrance porch located below the east half of the front-facing gable roof, cantilever is supported by a single open metal column embellished with scrollwork, and landing/steps are concrete.

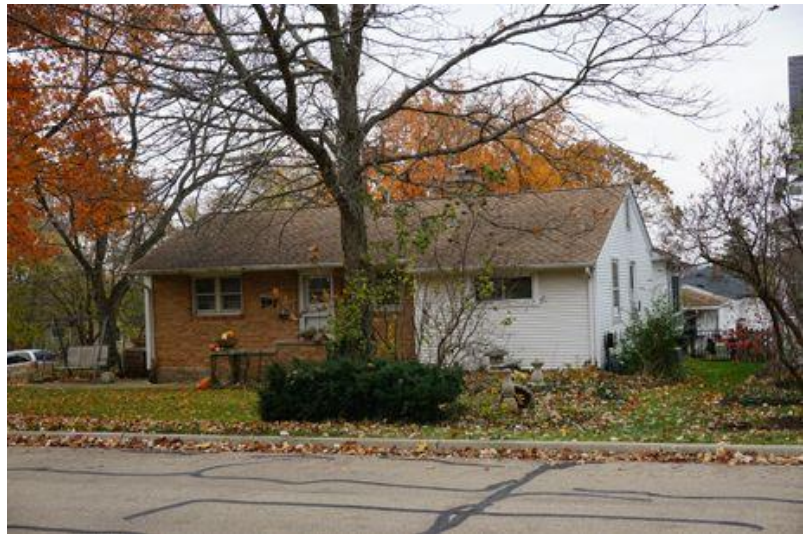
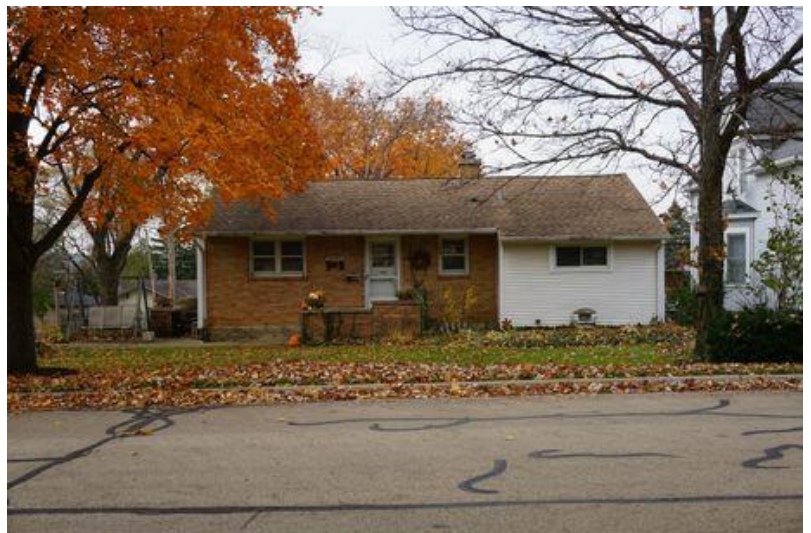
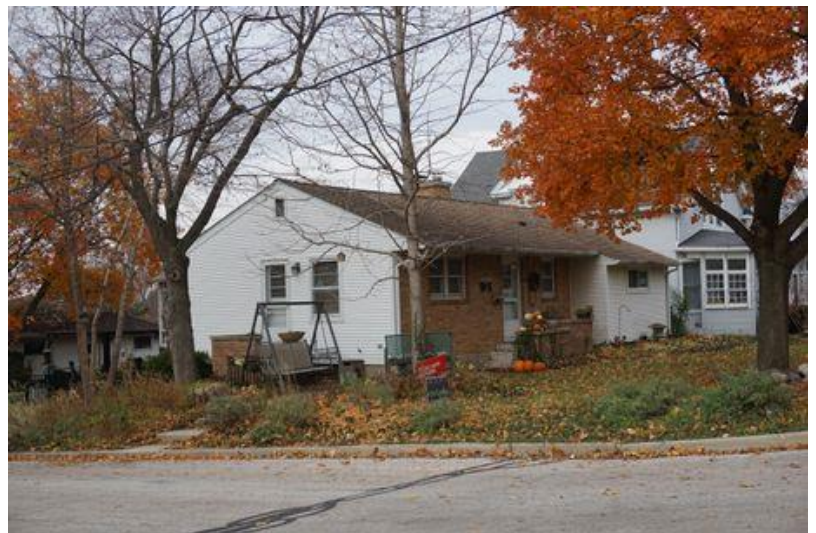
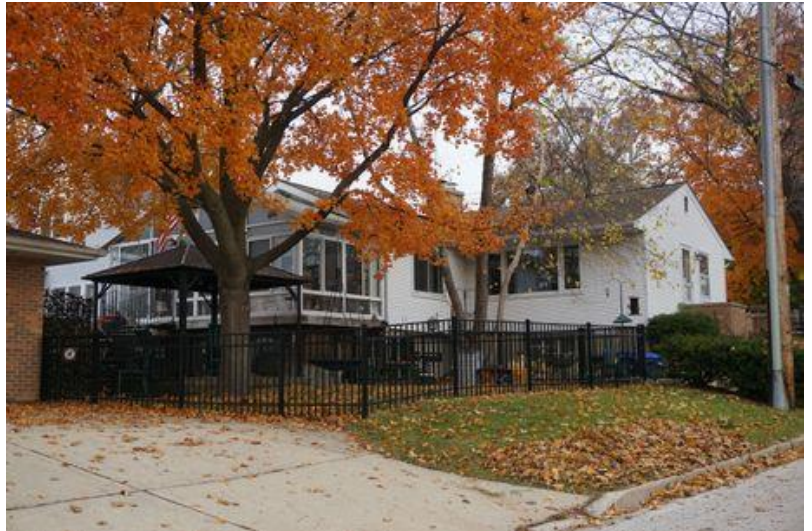
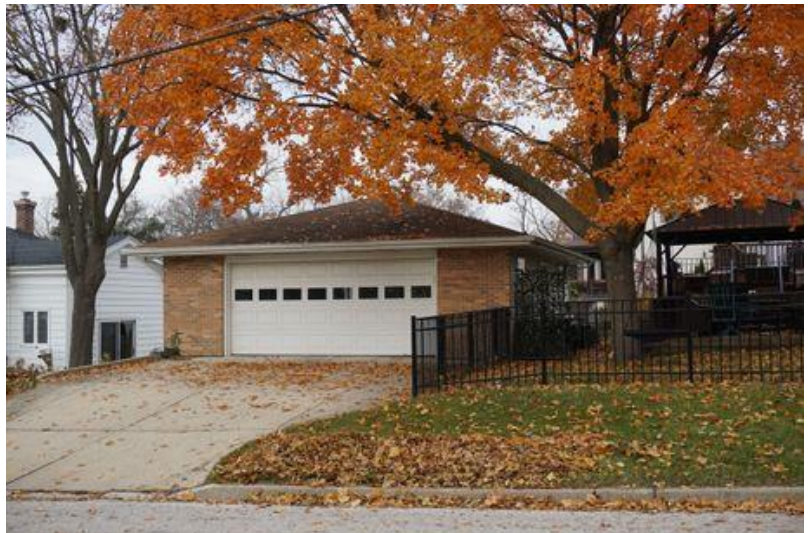
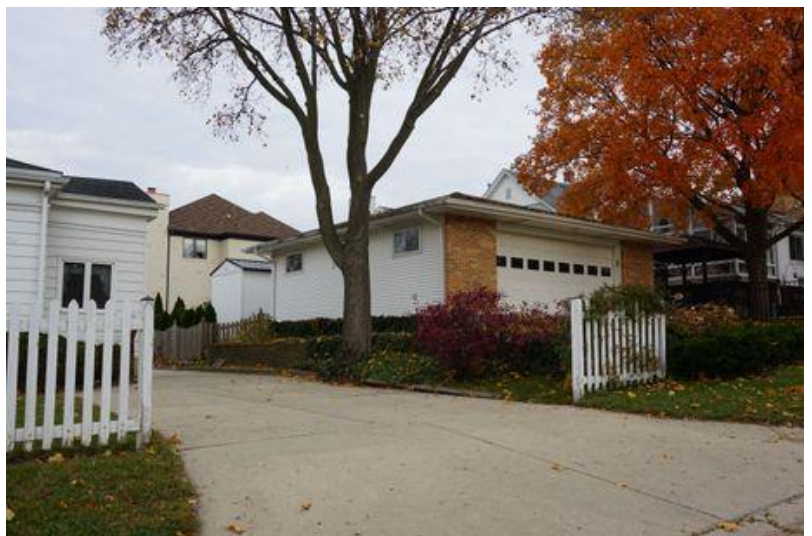
Cross-gabled roof form with wide eave overhangs.

Two-over-two (horizontal mullions) wood double-hung windows (historic); Vinyl sliding window (non-historic)

Brick sills at historic windows.

Covered, open-air entrance porch.
